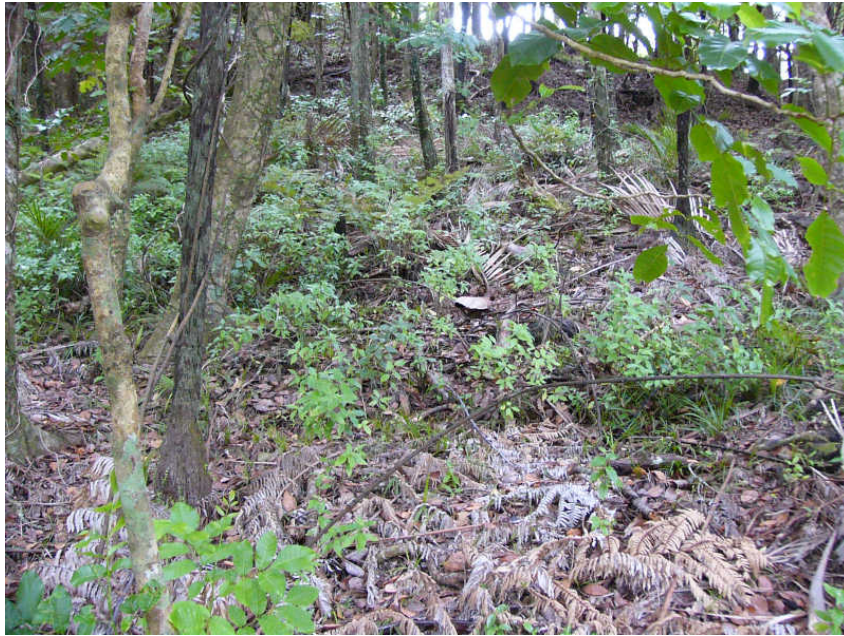
**Photo 5**

NDH. Native forest understorey at Dome Hill showing the recently disturbed patches of open ground where erosion can begin.

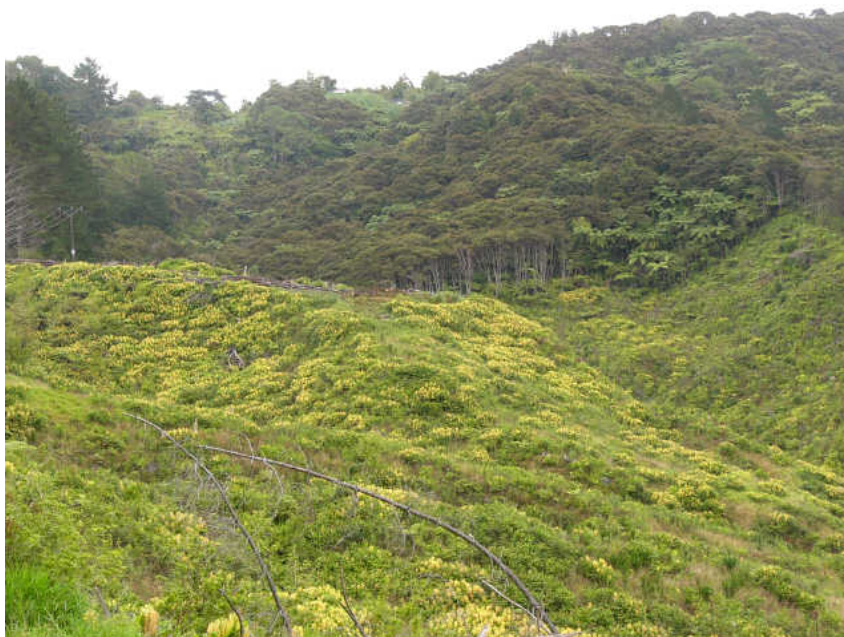
**Photo 6**

View north across the Manhurangi River left branch to the native forest at Dome Hill above the clear felled pine (foreground) which has been left to develop a substantial growth of weeds including wild ginger

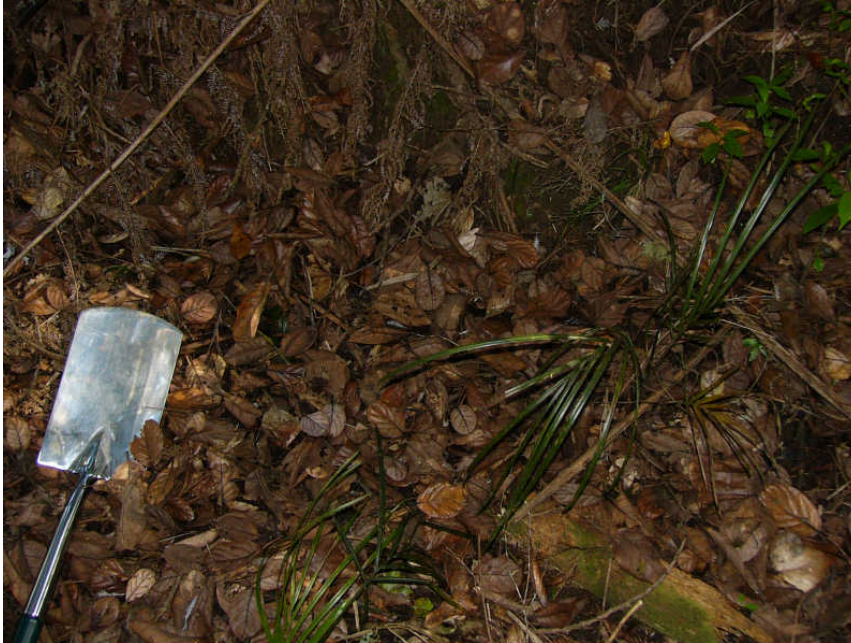
**Photo 7**

NMH. Native forest understorey at Moir's Hill showing the dense leaf litter over very tightly packed fine fibrous roots. This is old undisturbed forest.

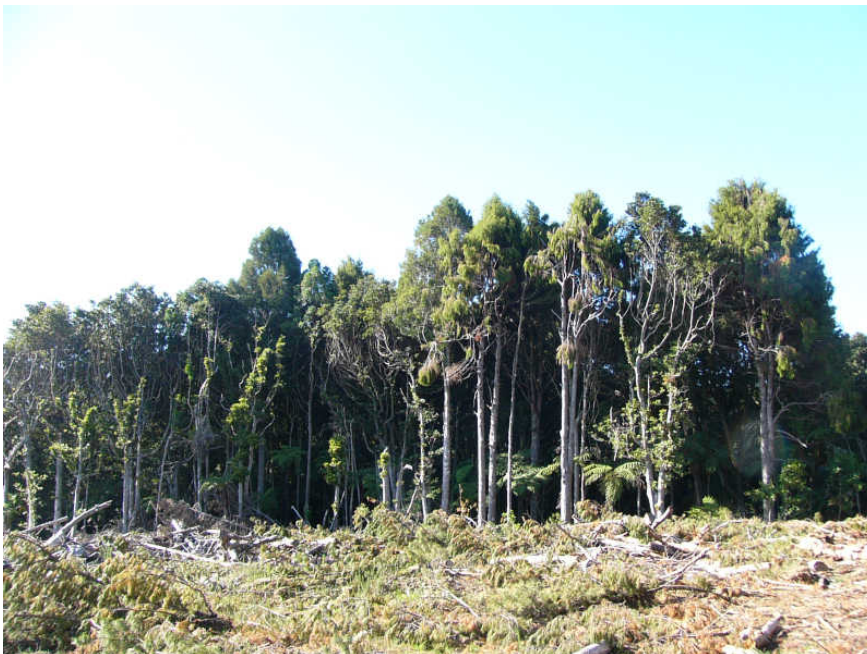
**Photo 8**

View of the native forest at Moir's Hill from the adjacent recently felled pine forest. The size of the trees indicates that this forest has not been disturbed for some time.

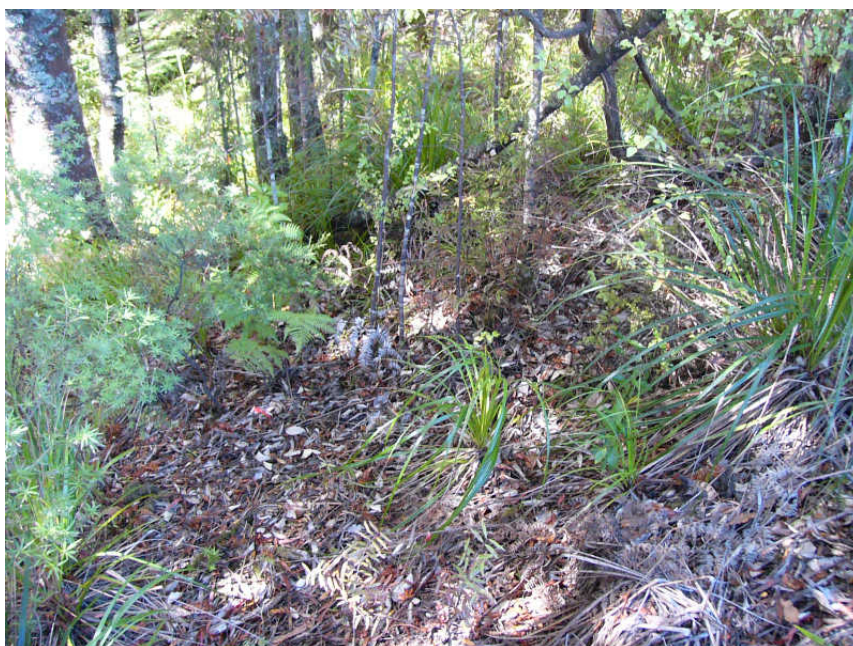
**Photo 9**

NCBR. Native forest understorey at Cowan Bay Road. This is heavy leaf litter beneath Kauri and Rimu regrowth and is essentially undisturbed in recent times.

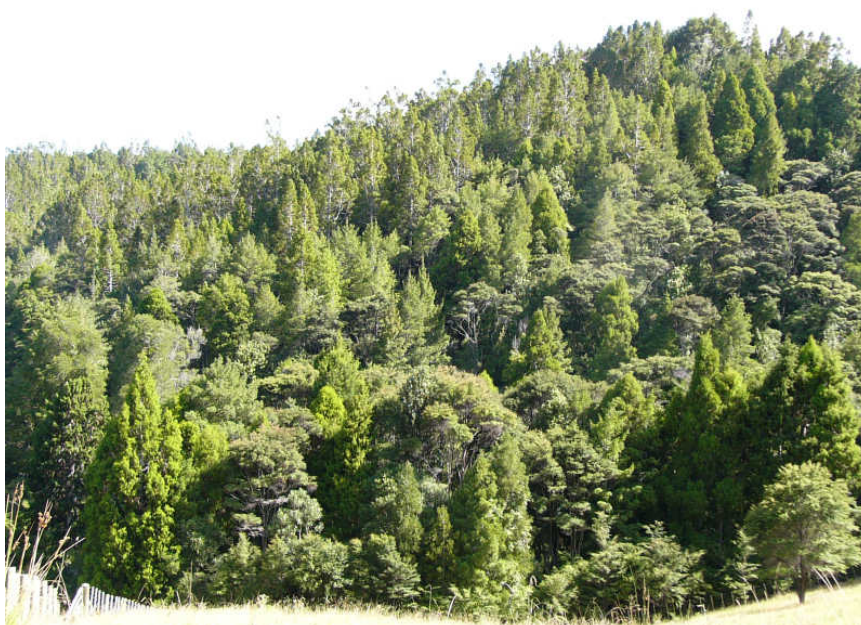
**Photo 10**

View north across the native forest at Cowan Bay Road. The size of the trees indicates that this forest has not been disturbed for some time.

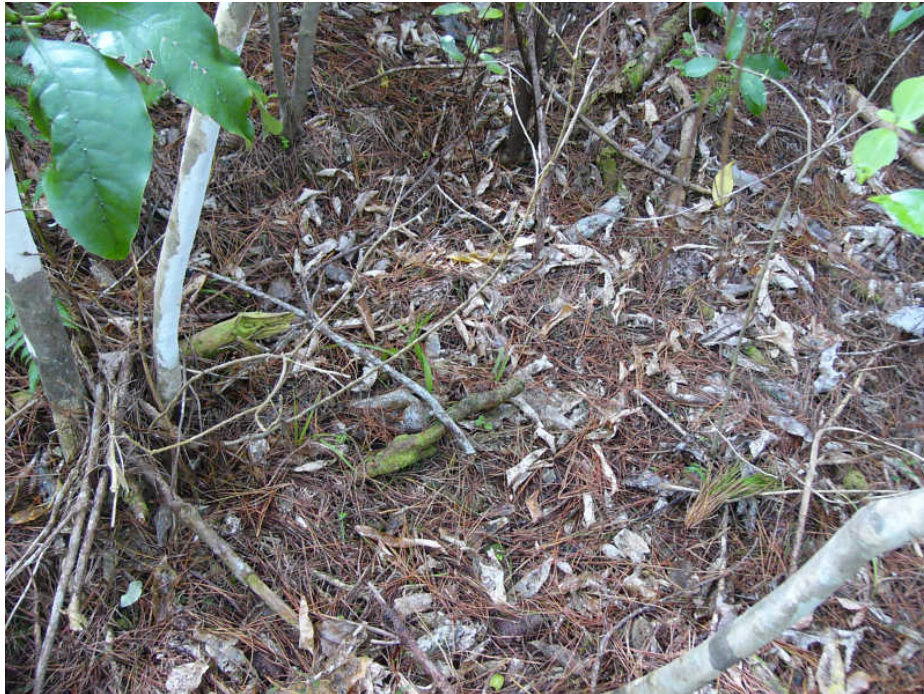
**Photo 11.**

EDH1. Exotic pine forest at Dome Hill showing the undisturbed understorey and leaf litter.

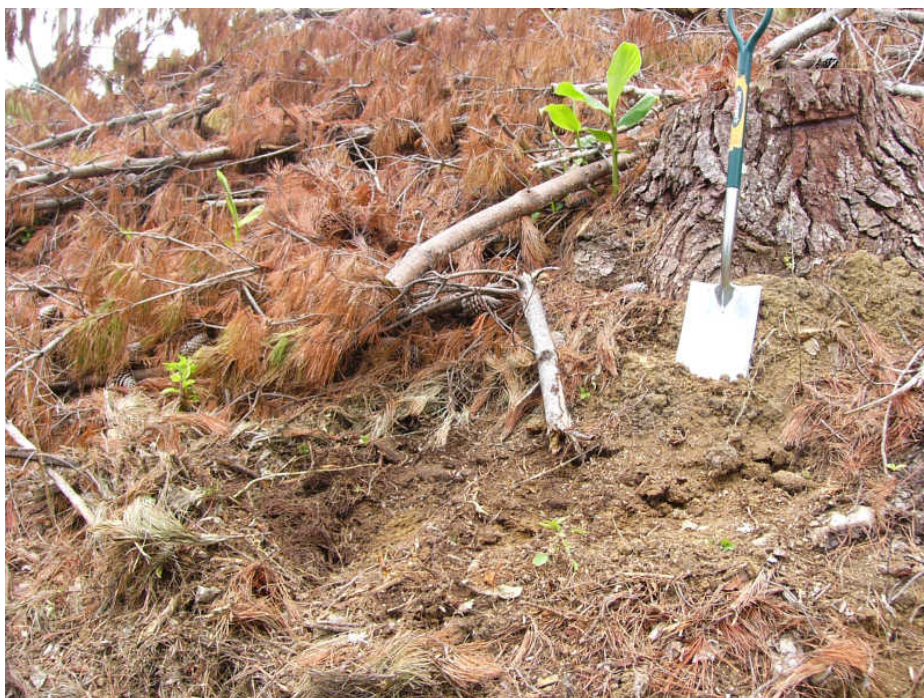
**Photo 12**

EDH2. Exotic pine forest at Dome Hill showing the disturbed and partially eroded and exposed subsoil.
