Purewa Cemetery Trust Board – 4 Parsons Road, Meadowbank
Submission on Proposed Auckland Unitary Plan

PUREWA CEMETERY- SURVEY OF TREES IN LOT 5 DP 67742 BETWEEN ST JOHNS & PARSONS ROADS - 14/2/14

PUREWA CEMETERY- ARBORICULTURAL COMMENT ON PROPOSED BUILDING PLATFORMS IN LOT 5 DP 67742 - 26/2/14

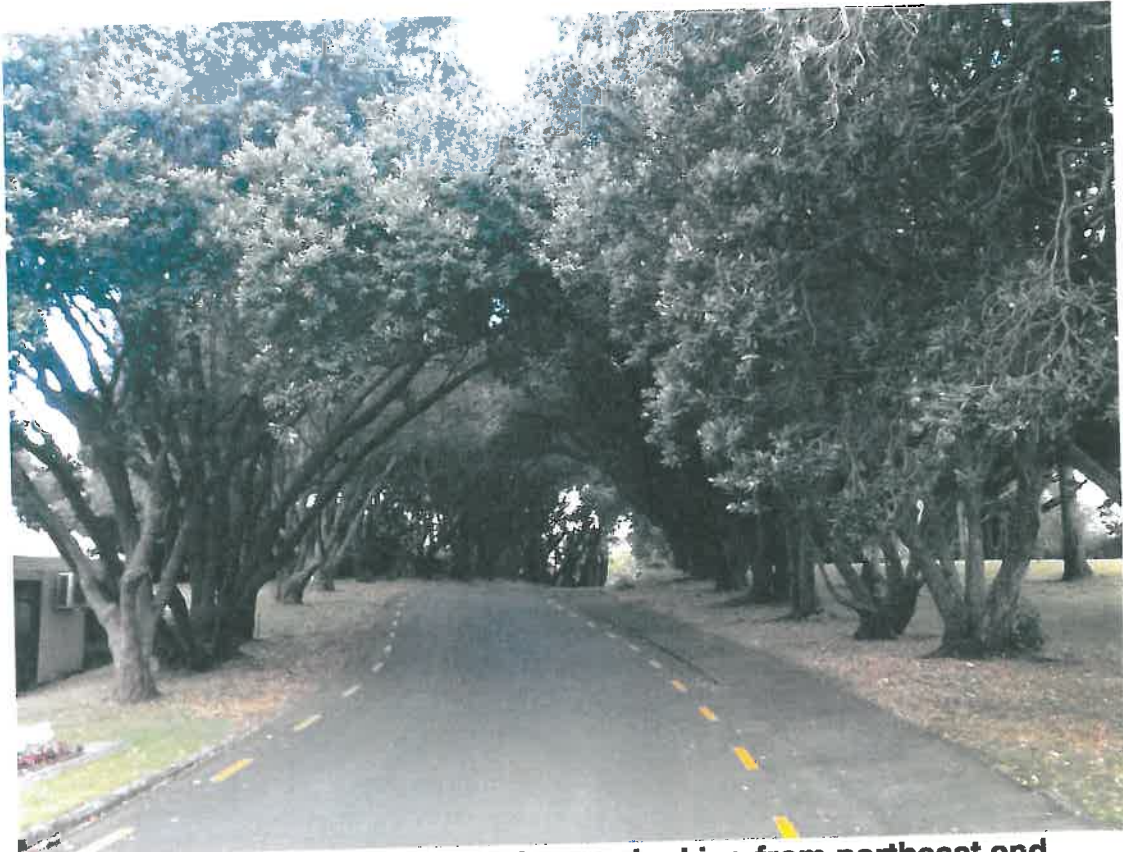
Fig 1 – view of avenue of Pohutukawa – looking from northeast end

4. There is a distinct avenue of Pohutukawa trees for a considerable length of the northeast portion of the roadway. They are identified in the third column as being an 'Avenue tree'. These trees have been identified as being a mix of New Zealand Pohutukawa specimens, Kermadec Island Pohutukawa specimens and hybridised specimens of both. As is commonly the case with trees that comprise an avenue, some become more elite than others.

In this case, certain trees display either suppressed form or weak condition – or a combination of both. The recommendation 'retain?' given to these trees indicates this particular characteristic but conveys the idea that they are, nonetheless, integral to the contiguousness and character of the avenue as a landscape feature.

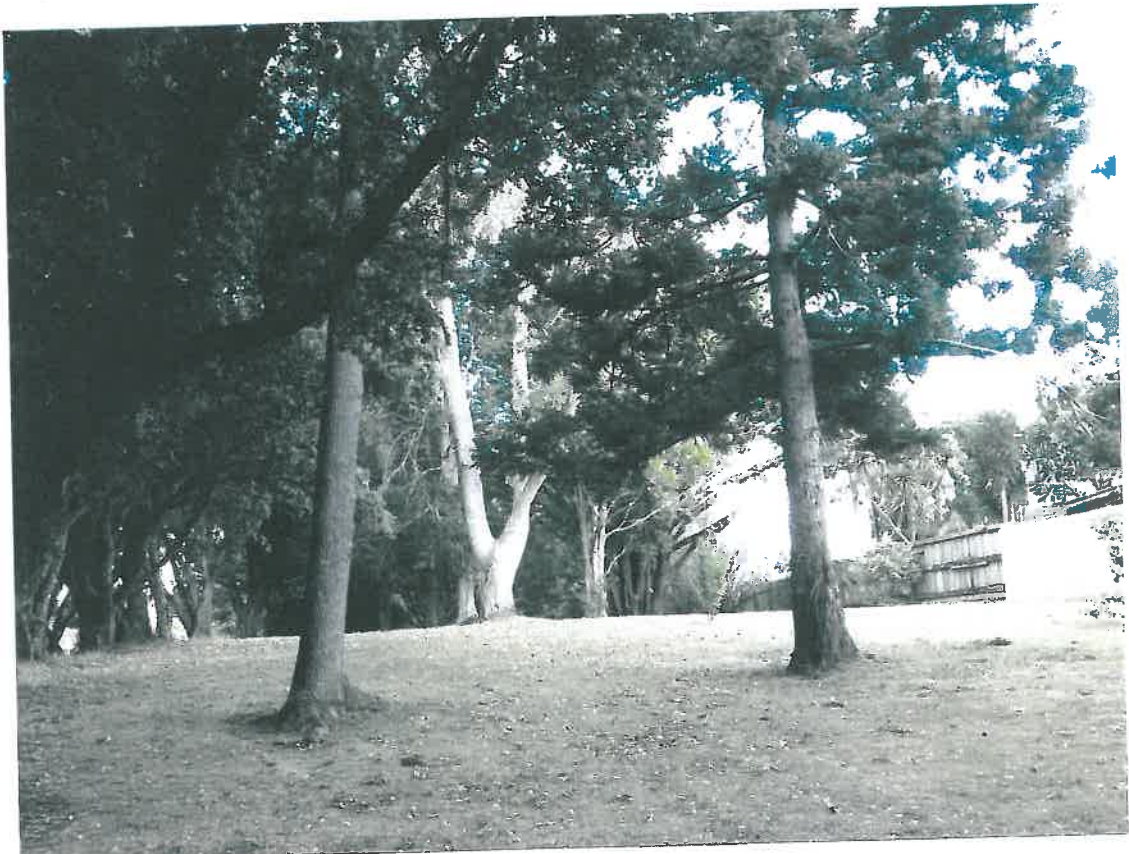
Fig 2 – Trees 19-21

17	Swamp cypress	Good health and structure	Retain
18	Totara	Good health. Semi-mature. Upright form	Retain
19	Silky oak	Good health. High crown. Sound structure	Retain?
20	Japanese cedar	Good health. Typical form	Retain?
21	Black poplar – <i>Populus nigra</i>	Large tree with high broad crown. Sparse foliar cover	Remove
22	Monkey apple		Remove. Not protected
23	Pin oak	Good health. Slightly suppressed crown. Good structure	Retain

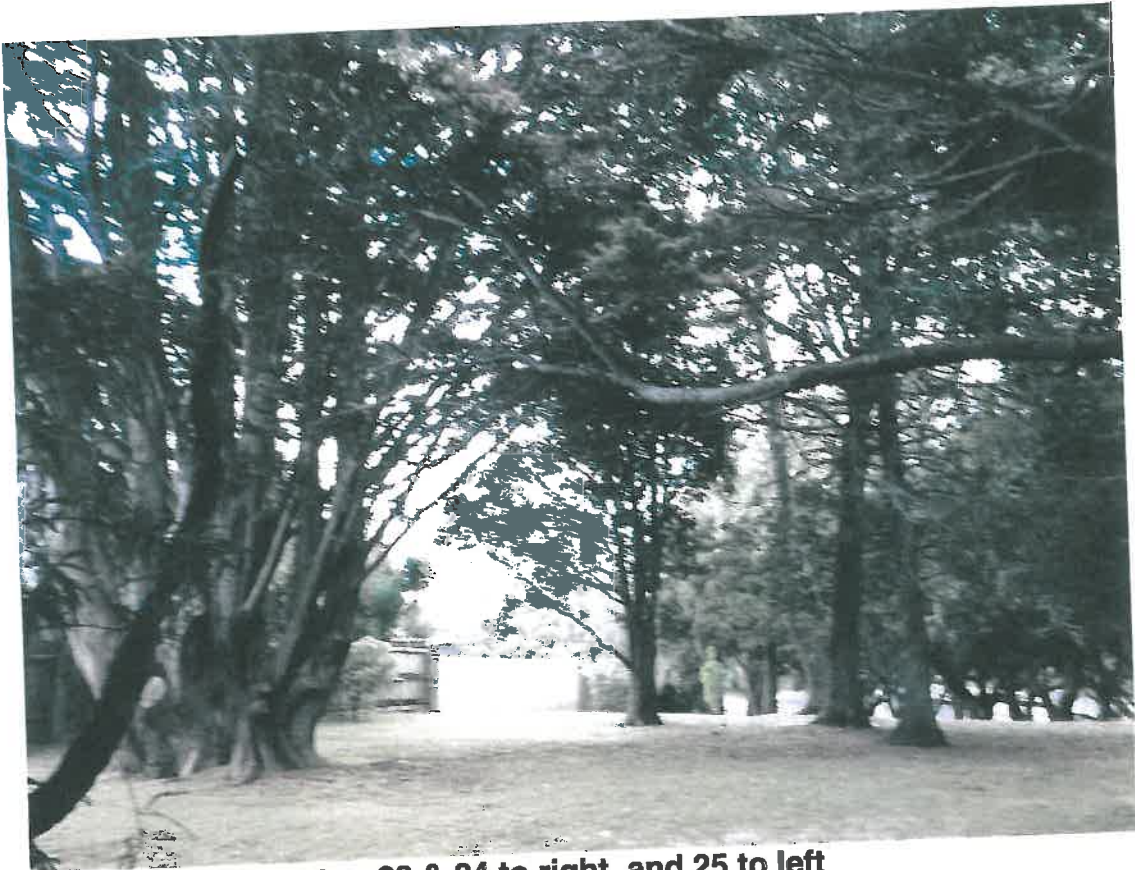
Fig 3 – Tree 22 centre, 23 & 24 to right, and 25 to left

24	Pin oak	Good health and structure. Merged with 23 – more suppressed of form	Retain?
25	Golden macrocarpa	Large broad-crowned specimen. Has cypress canker. Suppressed one side by tree since removed	Remove
26	Totara	Good strong tree	Retain
27	Kowhai – <i>Sophora microphylla</i>	Spindly suppressed specimen	Remove OK
28	Puriri	Very good large specimen in all respects	Retain
29	Pohutukawa hybrid – with Kermadec Island Pohutukawa	Avenue tree. Good state of health and sound of structure	Retain
30	Pohutukawa hybrid – with Kermadec Island Pohutukawa	Avenue tree. Weak of health. Spindly suppressed form	Retain?
31	Pohutukawa	Avenue tree. Large specimen. Good health and structure	Retain
32	Karaka	Semi-mature. Good health and structure	Retain
33	Puriri	Very good large specimen in all respects	Retain
34	Puriri	Good specimen. Some dieback in places.	Retain
35	Swamp cypress	Good health and structure	Retain
36	Japanese cedar	Semi-mature. Good health. Close to 35 – slight lean	Remove OK

1. Tree 22 is the only tree of the 124 listed in the schedule that is not protected. It is included because it is plotted by survey and stands as a feature tree amongst the other trees. It is listed with pink text in the schedule.

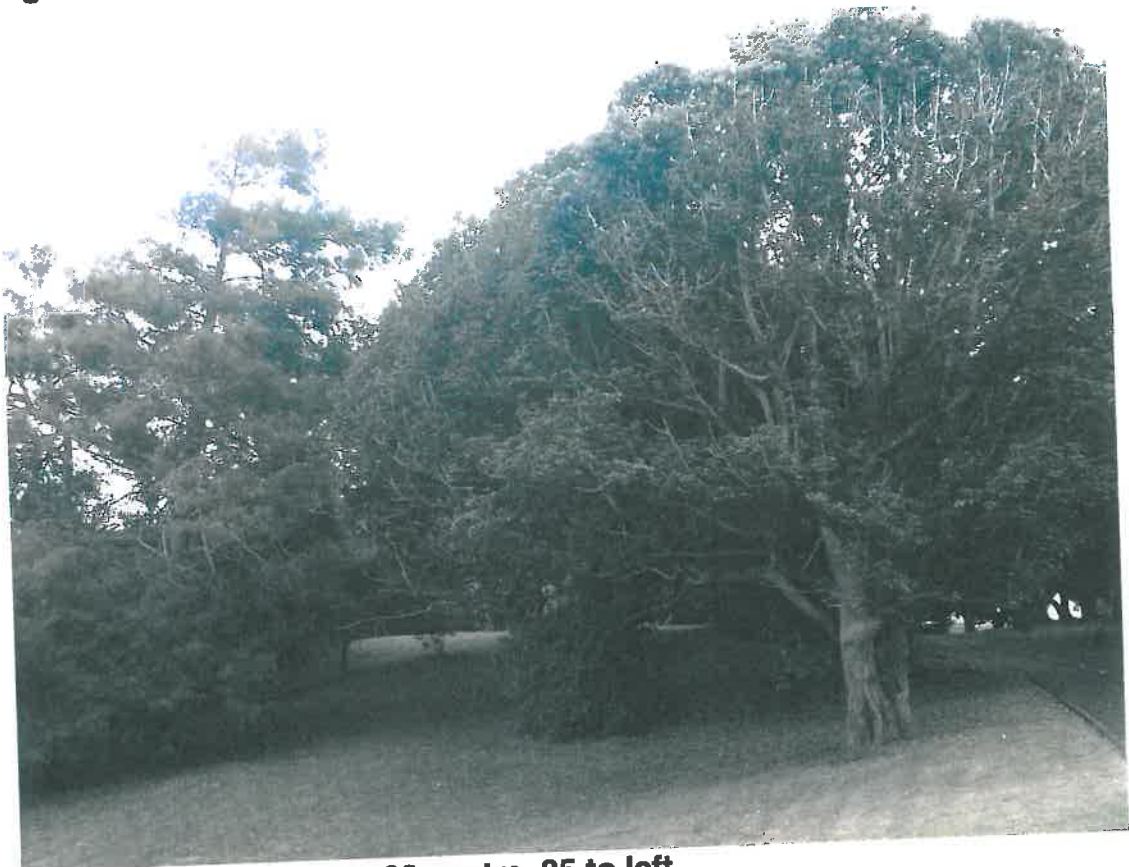
Fig 4 – Tree 34 to right, 33 centre, 35 to left

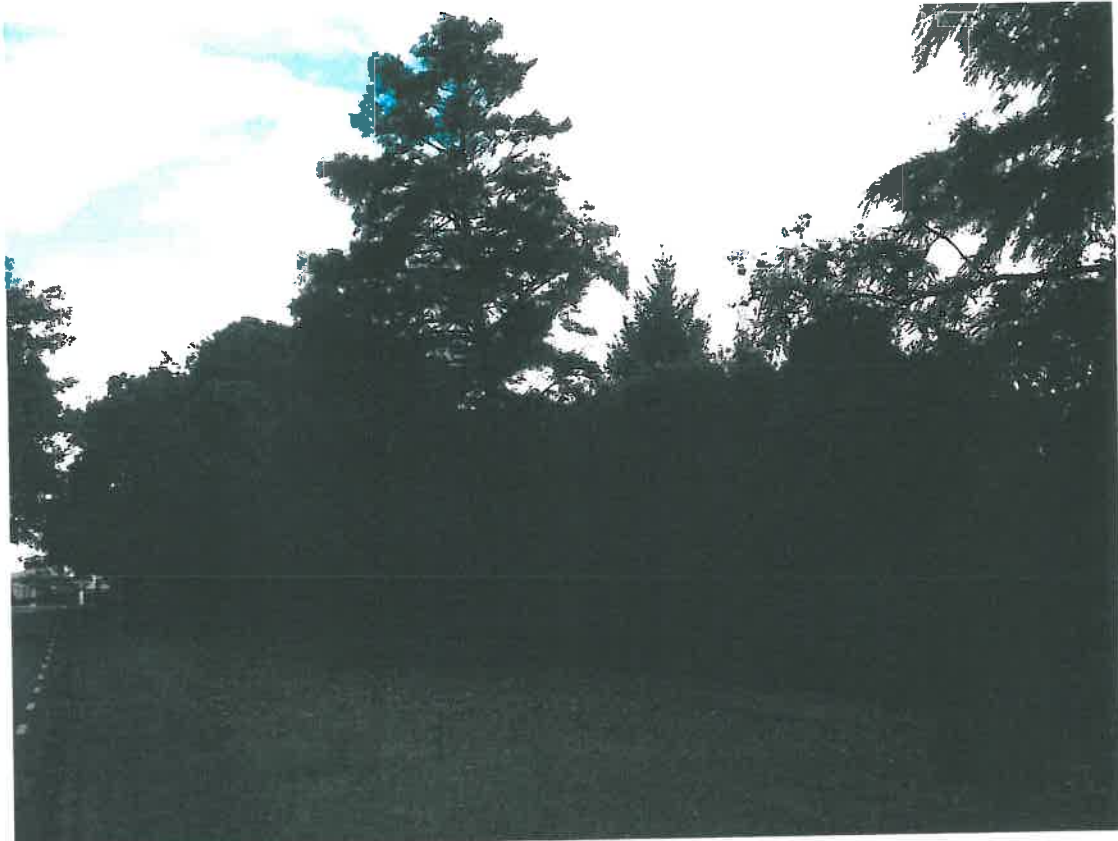
Fig 5 – Tree 43 in centre, 44 behind

43	Swamp cypress	Very good strong specimen	Retain
44	Kohekohe	Small tree. Heavy lean. Decay in stem wood – esp. at site of included stem union.	Remove
45	Pohutukawa hybrid – with Kermadec Island Pohutukawa	Weak, suppressed, spindly tree with dieback. Leans heavily into 44	Remove
46	Karaka	Good health. Trunk wound from failure. Steel stake embedded. Leans from 47. 3m from MH	Remove OK
47	Puriri	Semi-mature. Drawn up form. Decay in stem wood. Close to boundary. 2m from MH	Remove OK
48	Pohutukawa	Large tree. Good health. Extends far over neighbour's yard	Retain
49	Karo	Heavy lean towards road	Remove
50	Karo	Heavy lean towards road	Remove
51	Pohutukawa	Same comments as for 48 above	Retain
52	Pohutukawa	Same comments as for 48 & 51 above. More splayed stems	Retain
53	Claret ash	Large tree. Good health. Sound structure	Retain
54	Karaka	Good health. Some decay in trunk. Under canopy of 53	Retain
55	Wharangi	Good health. Minor tree. Under canopy of 53	Retain

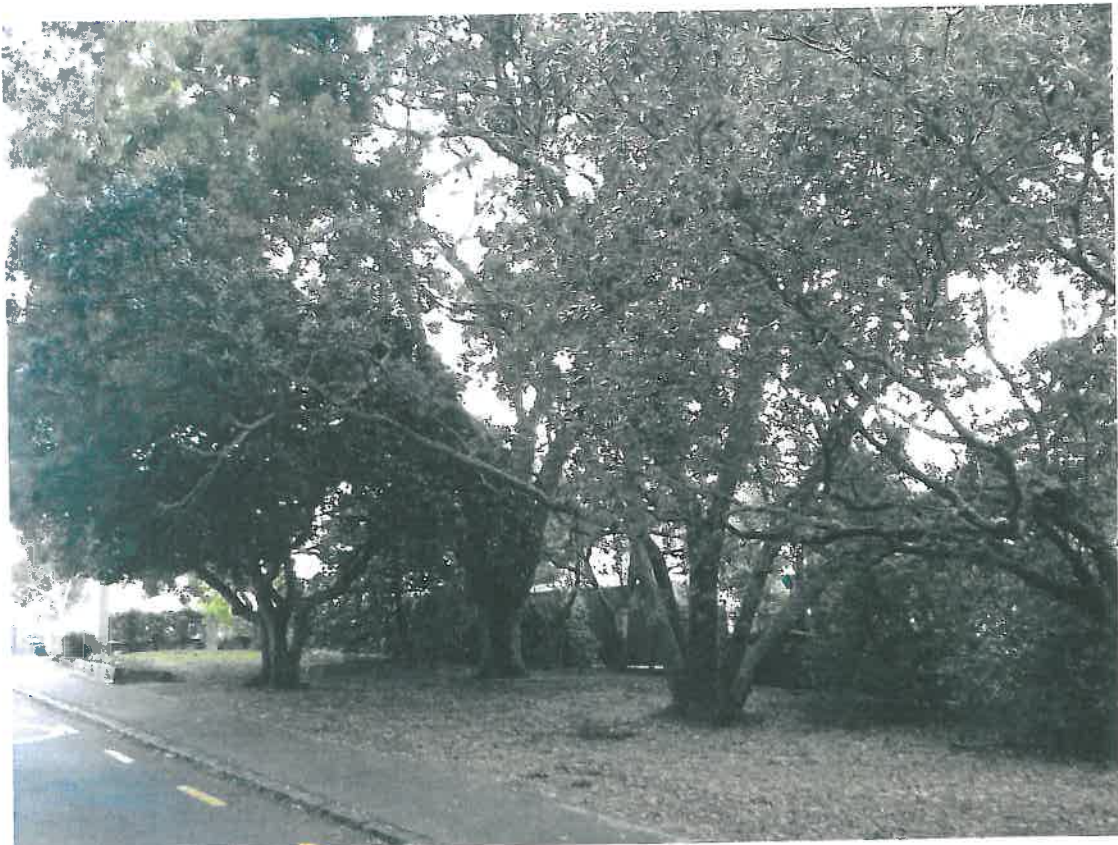
Fig 6 – trees to west of St Johns Rd entrance

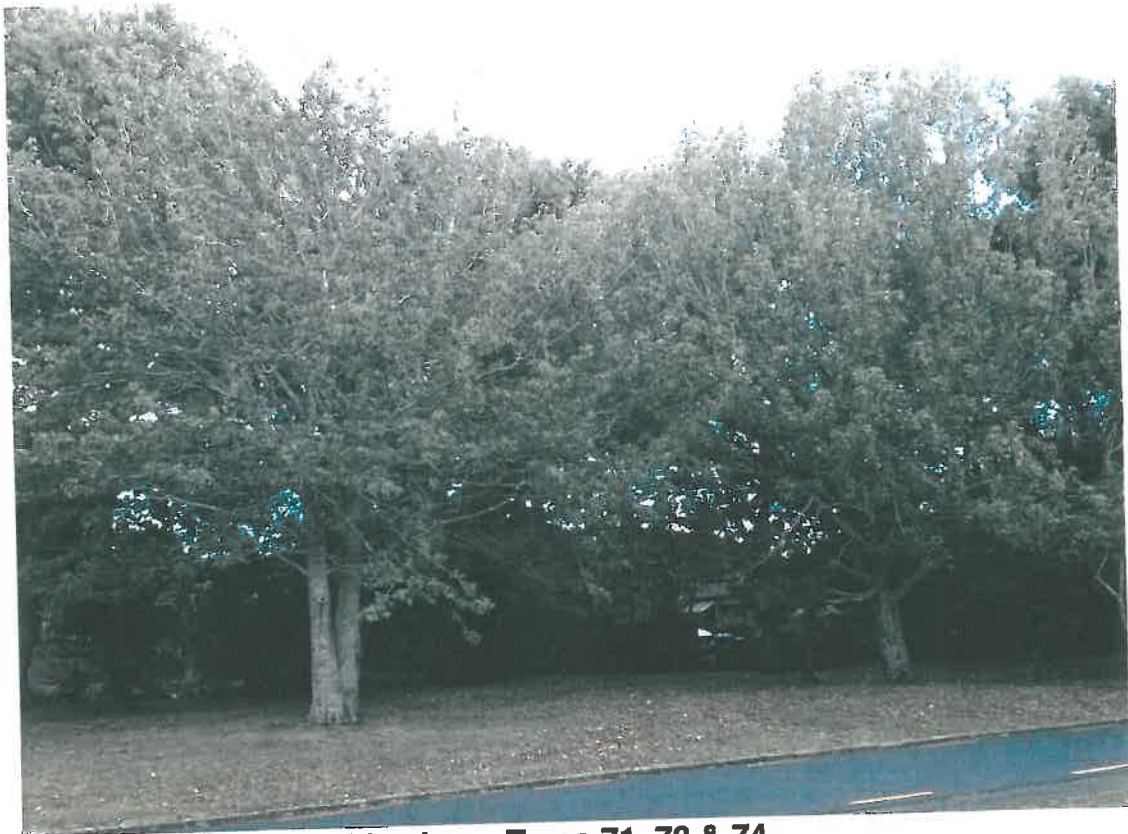
Fig 7 – Group of Liquidambar – Trees 71, 73 & 74

60	Willow myrtle	Typical form. One dead stem with Ganoderma bracket	Remove OK
61	Akiraho	Good example of native species rarely seen at this size	Retain
62	Fraxinus sp.	Tall strong healthy specimen. Twin-stemmed but union sound	Retain
63	Puriri	Weak specimen. Under canopies of adjacent trees. Decay in stem wood.	Retain?
64	Bottlebrush	Spindly	Remove
65	Pohutukawa	Strong large healthy elite tree	Retain
66	Karaka	Semi-mature. Good health. Under canopies of adjacent trees	Retain
67	Pohutukawa	Large healthy tree – merged with 65	Retain
68	Puriri	Large tree. Full crown. Some stem wood decay and dead wood, but sound	Retain
69	Pin oak	Large tree. Good health. Inclusion between stems. <1.5m MH	Retain?
70	Box elder	Small suppressed weak tree with dieback	Remove
71	Liquidambar	Semi-mature. Phloem necrosis in stem wood. Full crown. Tightly packed limb unions	Remove OK
72	Titoki	Young tree. Good health. Steel stake in trunk. Under canopy of 71	Remove OK

73	Liquidambar	Semi-mature. Phloem necrosis in stem wood. Drawn up form	Remove OK
74	Liquidambar	Semi-mature. Phloem necrosis in stem wood. Two stems from base with included union. Canopy a bit sparse with some tip dieback	Remove OK

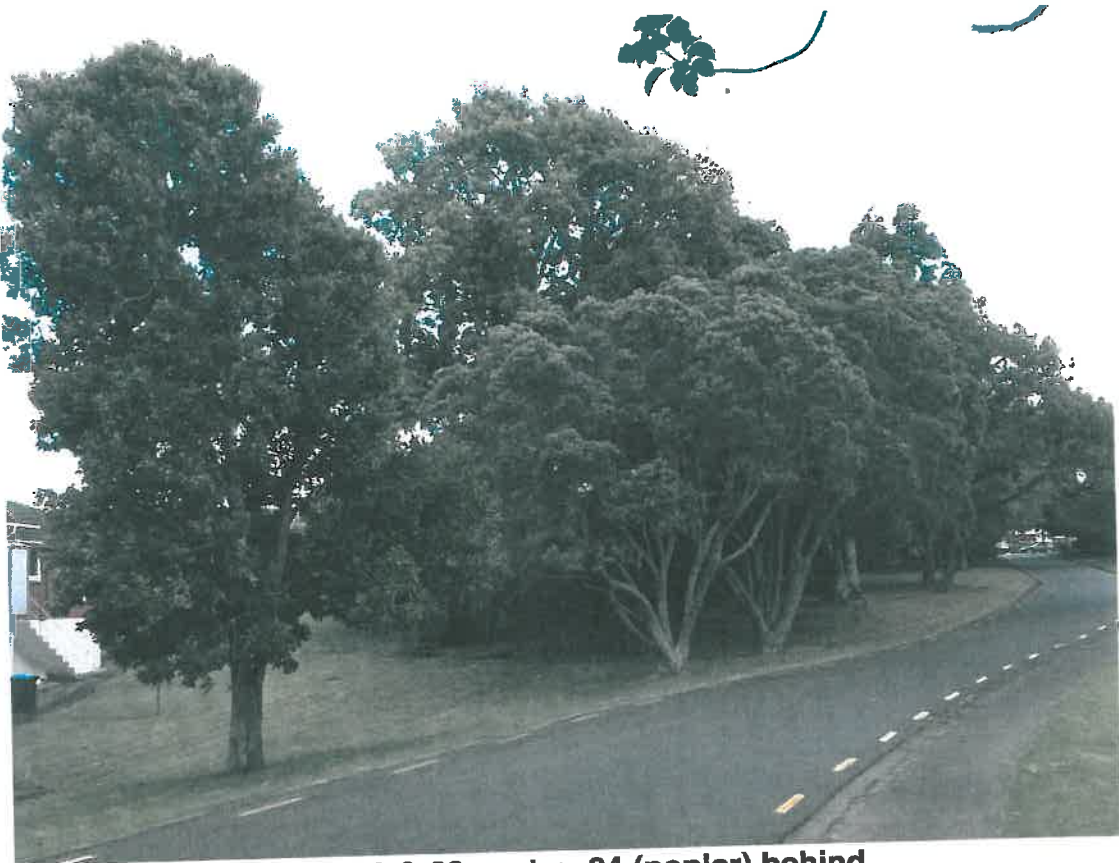
Fig 8 – Tree 90 to left, 88 & 89 centre, 84 (poplar) behind

87	Bottlebrush	Suppressed under 83. Weak and spindly	Remove
88	Pohutukawa	Medium size. Good health	Retain?
89	Pohutukawa	Medium size. Good health	Retain?
90	Firewheel tree	In open. Good health. Included unions – one opening	Remove OK
91	<i>Camellia japonica</i>	In open. Unbalanced form	Remove OK
92	Cabbage tree	A cluster. Main stem completely hollow	Remove OK
93	Bottlebrush	Spindly specimen	Remove OK

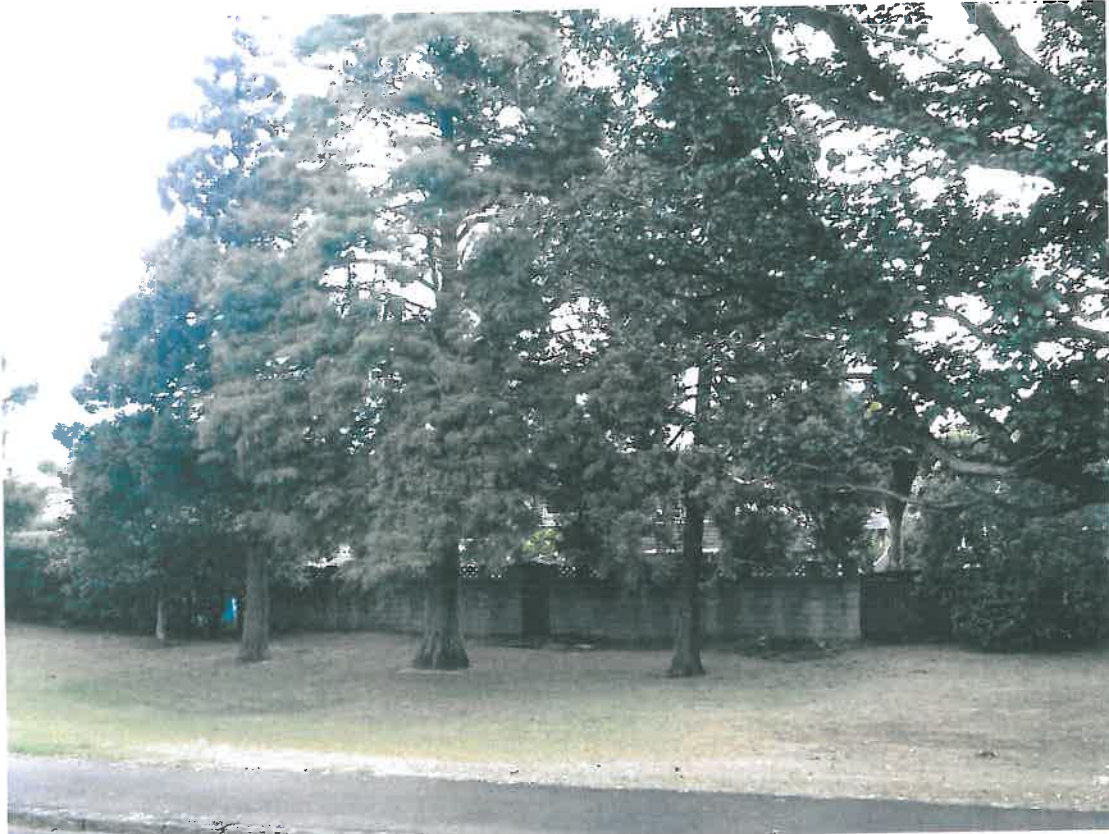
Fig 9 – Trees 36-39 right to left

37	Swamp cypress	Strong tree. Good health and structure	Retain
38	Japanese cedar	Same as 36, but larger	Remove OK
39	Titoki	Young minor tree. Good health.	Retain
40	Swamp cypress	Good health and structure	Retain
41	Japanese cedar	Same as 36 and 38, but weaker	Remove OK
42	Swamp cypress	Good health and structure. Wind-burnt one side due to sudden exposure by removal of adjacent tree	Retain

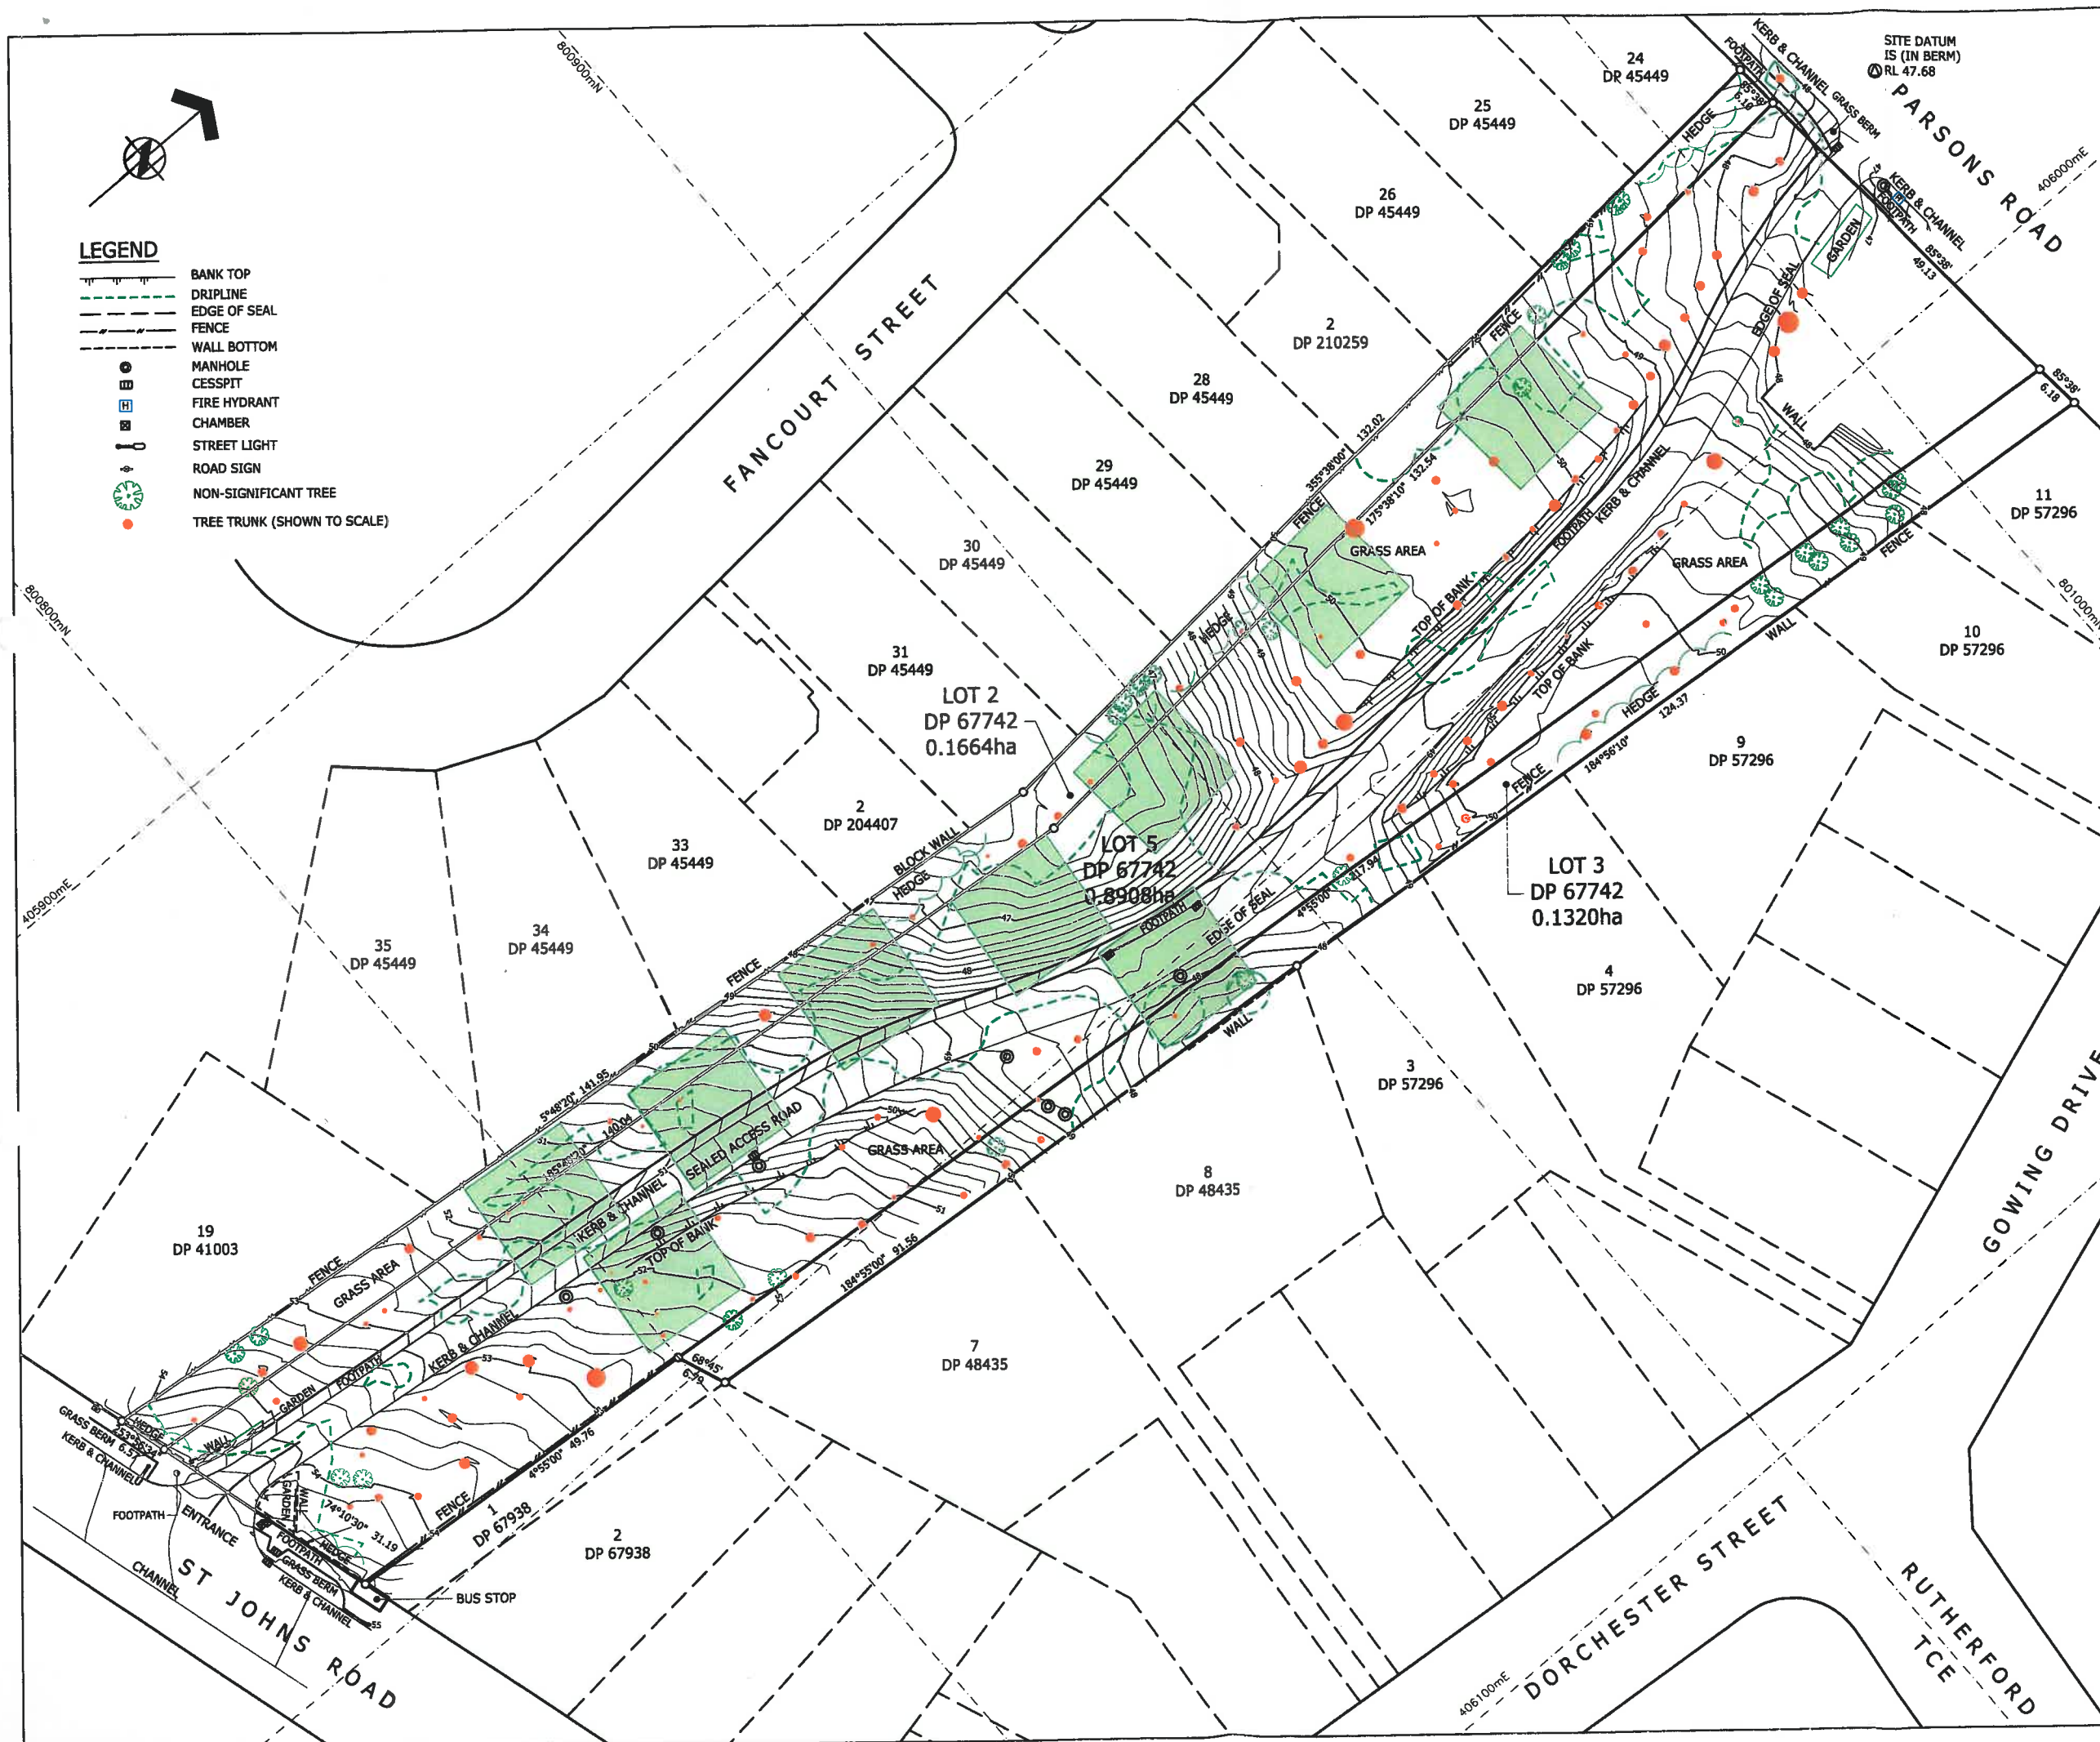
TITLE: POSSIBLE BUILDING PLATFORM LOCATIONS

Nine indicative building platforms (15m x 15m) are shown on the above plan. The locations have been chosen with particular regard taken of the outcome of the tree survey prepared earlier by myself. 124 trees were surveyed, and these were identified four ways, as follows;

Accordingly, the indicative building platforms have been drawn in locations where not one tree that was identified as 'Retain' or 'Retain?' has been captured within a platform footprint – as drawn. However, some do stand in close proximity to certain drawn platforms; although it is acknowledged that actual house footprints would have different shape factors that would offer scope for there to be a greater degree of clearance from those trees. Indeed, there are roomy areas of ground beside some of the platforms that do not have 'retain/retain?' trees. These areas could be utilised for building envelopes – thereby increasing clearances from such trees.

The Building Platform Plan demonstrates that all 88 of the trees deemed desirable to retain can feasibly be retained, subject to a greater level of analysis at the design phases. In addition, many trees that are deemed to be not so significant can feasibly be retained. Overall, just 16 trees are actually captured within the indicative building platforms; meaning that a proposal to obtain nine building sites within this particular parcel of land would not significantly diminish the tree cover that the site offers to the local landscape.
