WYNYARD QUARTER INVENTORY OF CHARACTER ELEMENTS

Inventory of Wynyard Quarter character elements

The following inventory is based on a half day inspection of the Wynyard Quarter. Only publicly accessible areas were inspected.

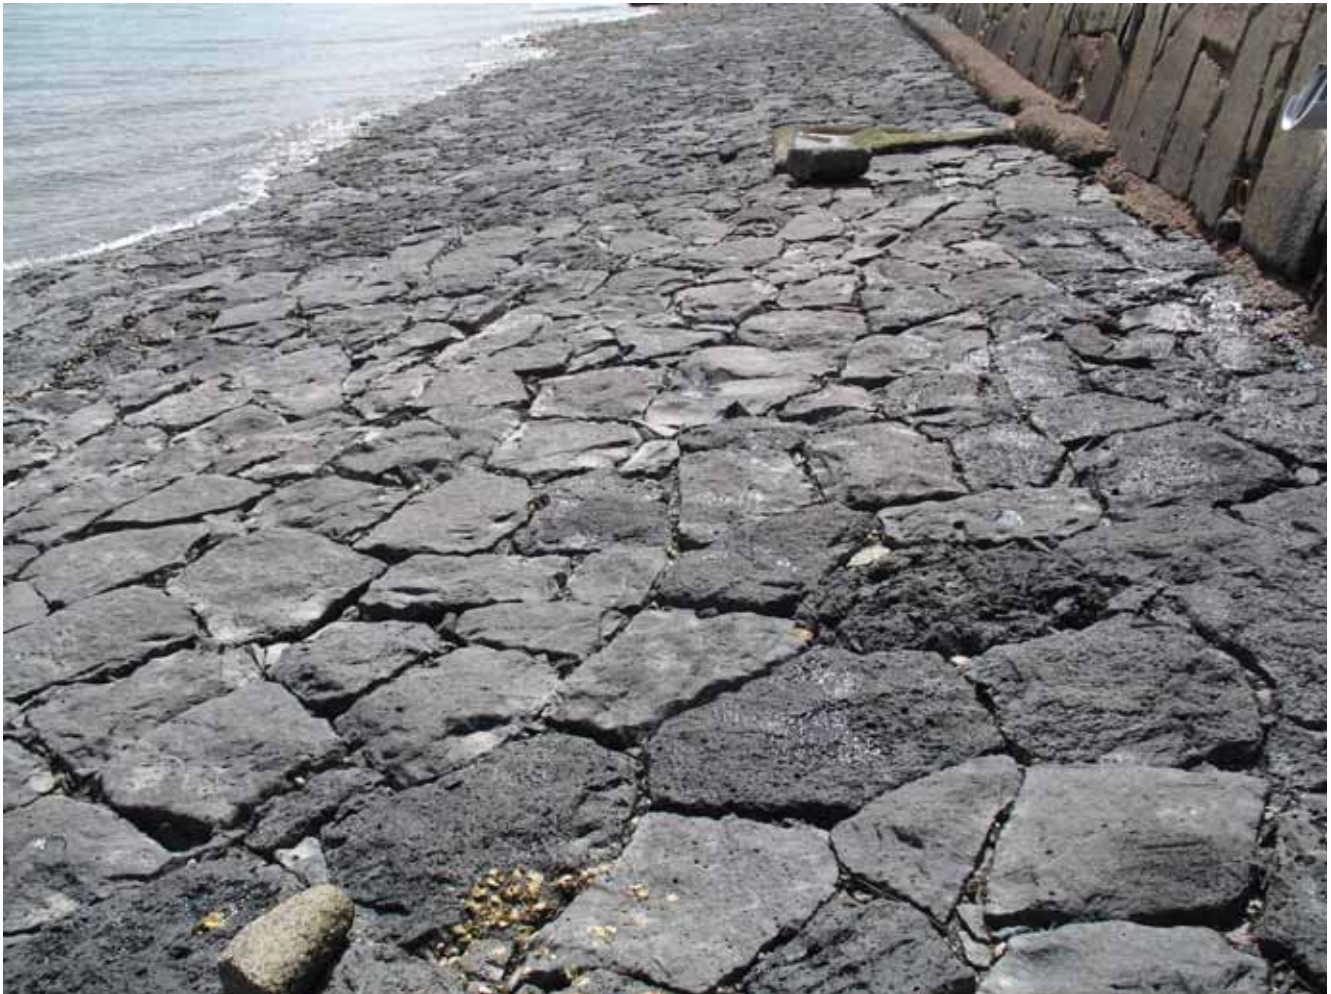
Generally excellent. Part has been capped/overlaid with concrete but this is an early (WWII era) modification and the paved surface appears to be substantially intact beneath. There are also two recent concrete foundation blocks which once provided access to a pontoon, now removed. Condition of southwest end unknown (under rubbish or in commercial premises). Concrete panel seawall (age not determined) behind.

Haul ashore surface, looking north. Concrete panel seawall to right.

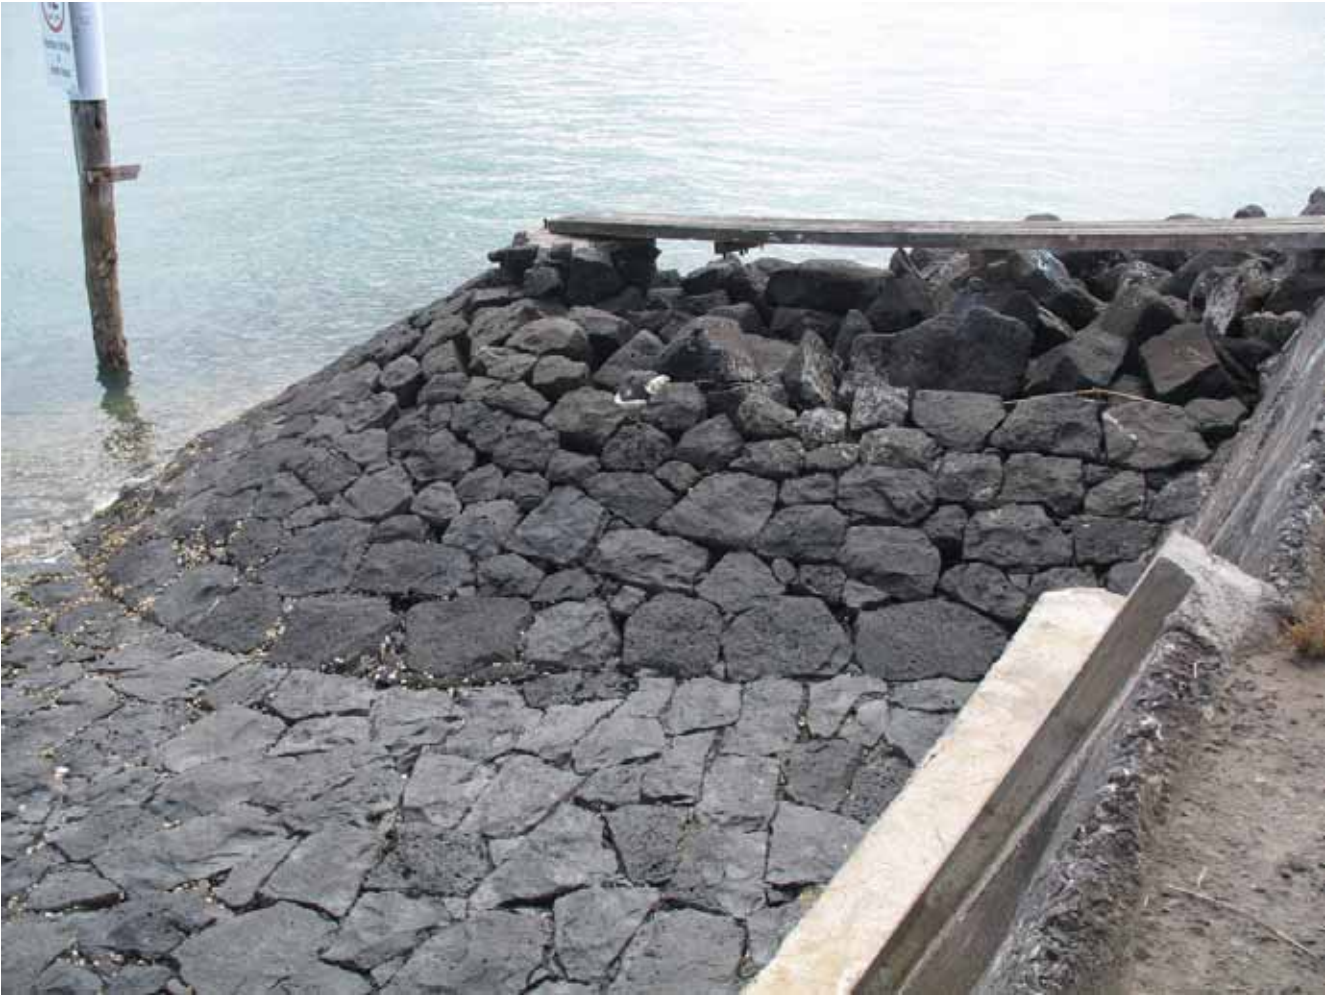
North end of haul ashore - start of rip-rap revetment.

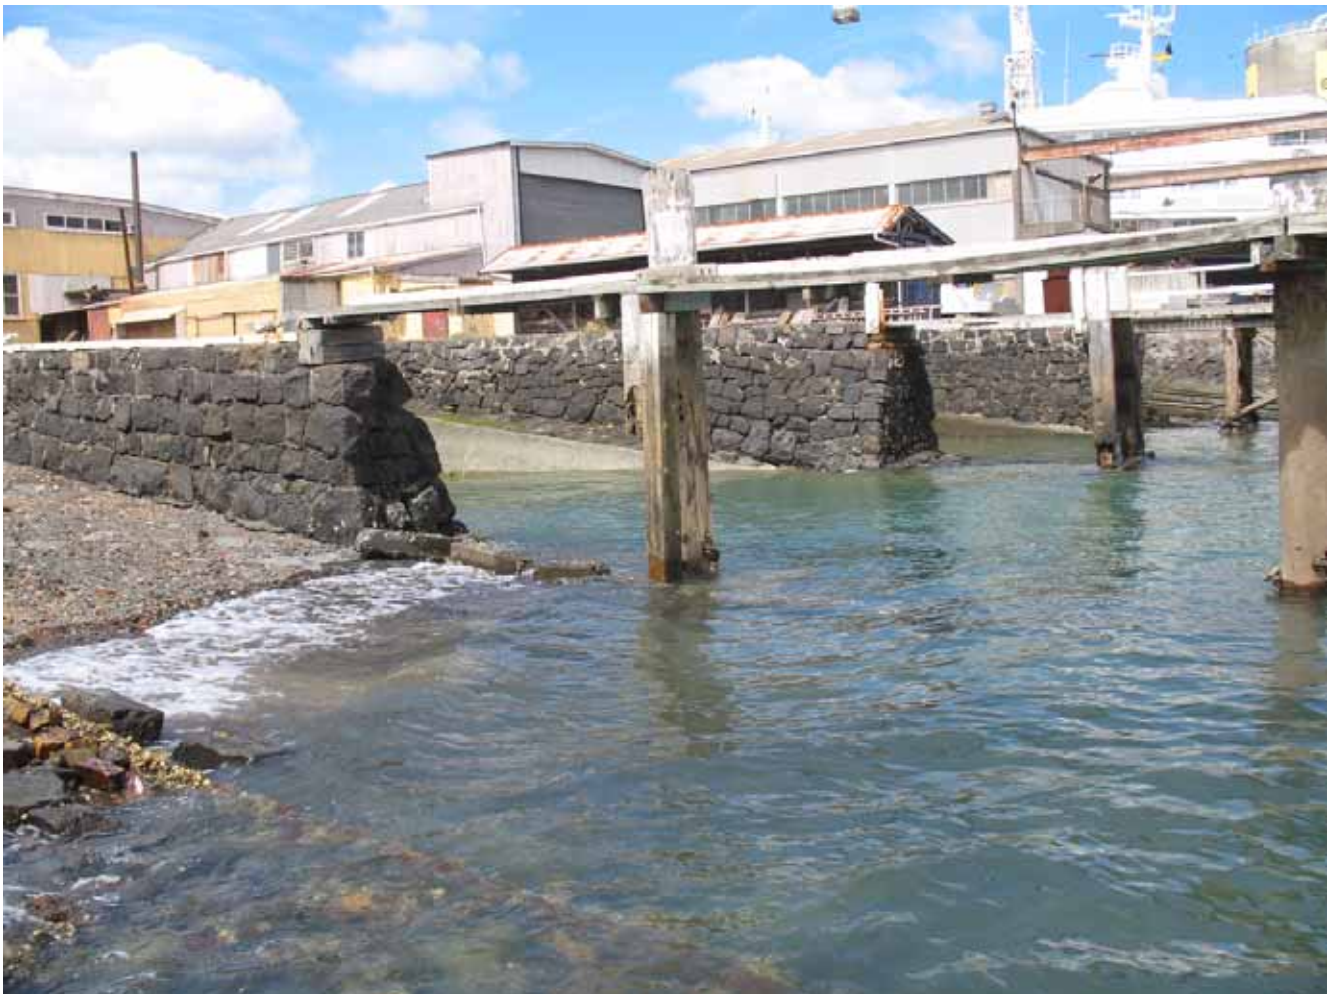
Good. Not accessed or viewed at close range. Some collapse of front face of closest finger evident. Northern end may have been partially modified. Timber foreshore structures appear poor condition. Associated buildings and substantial timber entrance posts remain.

Bluestone slipways and fingers, former Vos boatyard.

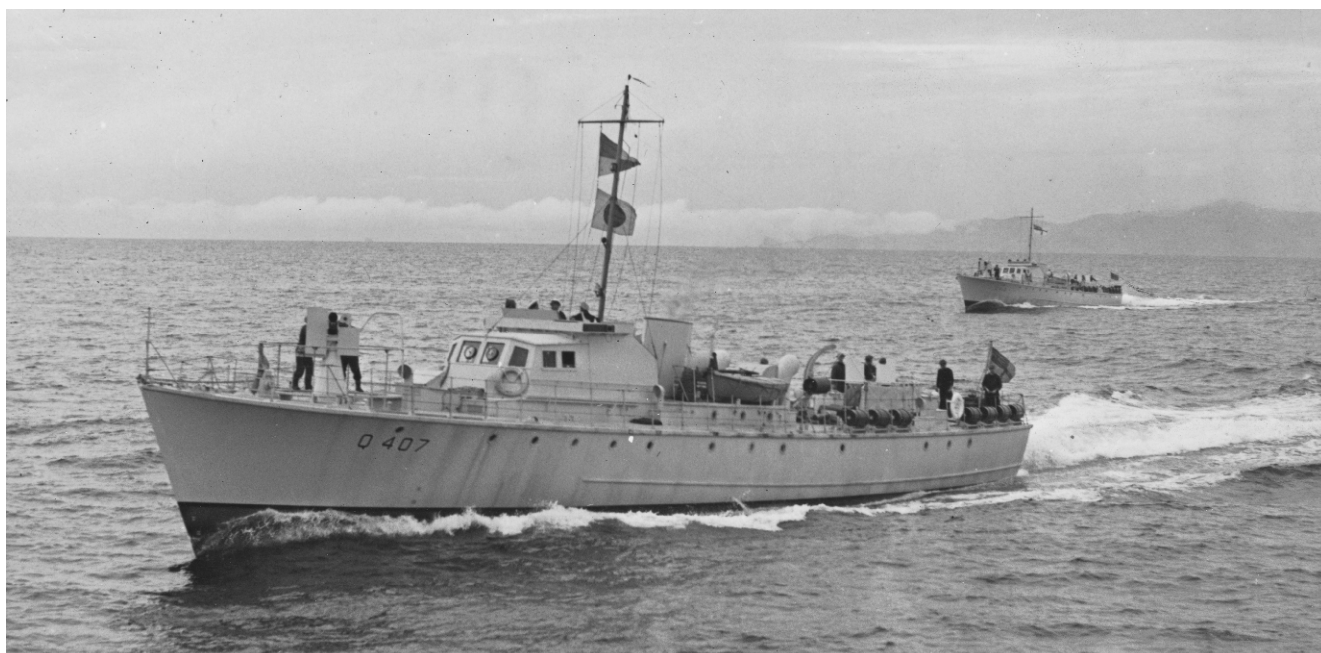
A sister ship (Q407) to the Fairmile motor launches built by Percy Vos. Alexander Turnbull Library.

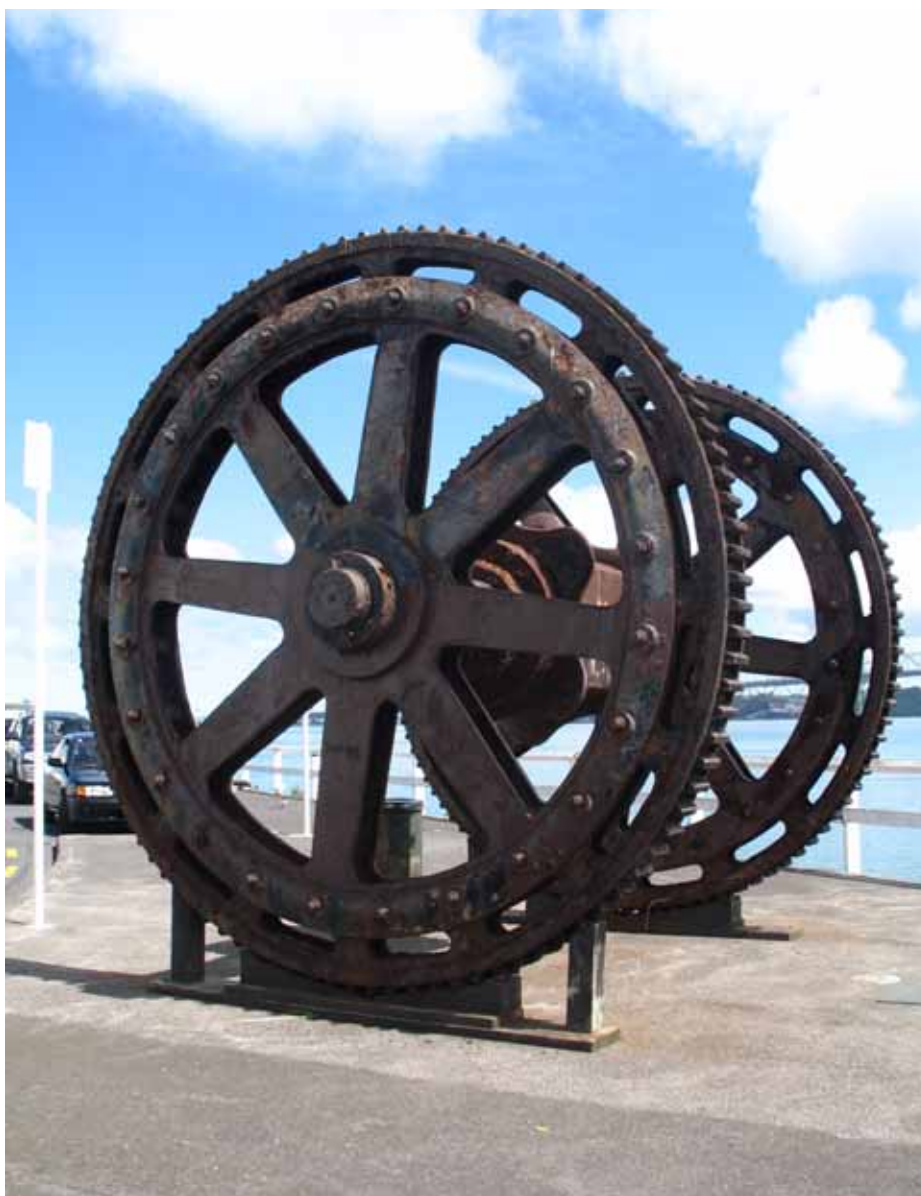
Excellent, surface corrosion.

Mounted driving wheels and plaque (set in concrete, lower right).

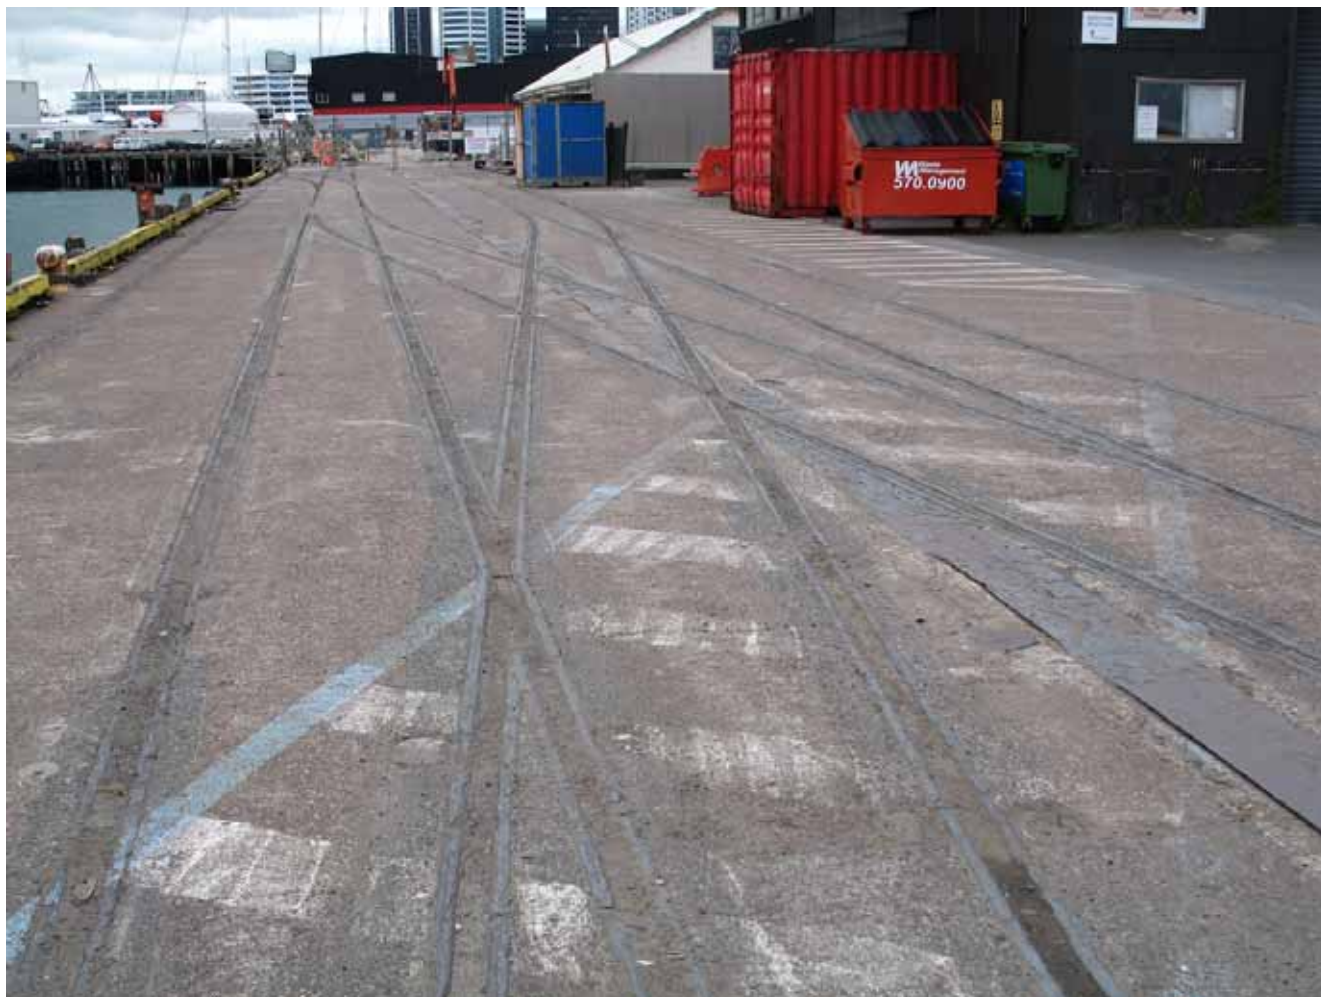
Variable. Generally in corroded condition, especially plates which are in poor condition in places.

Crane and rail tracks exposed in surface of North Wharf.

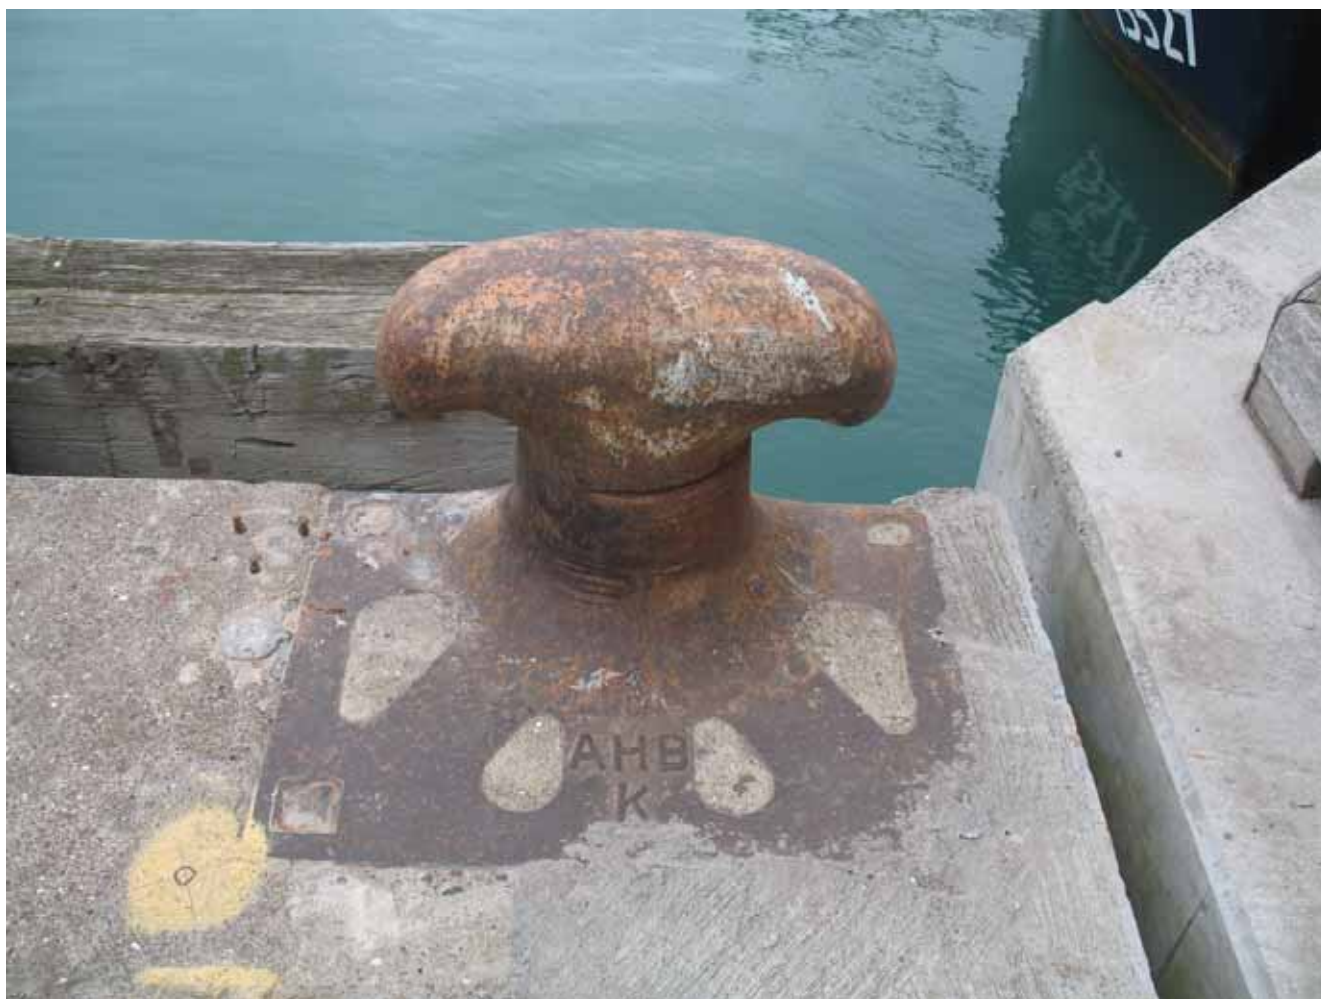
Mostly excellent. Some exhibit surface spalling of corrosion on mounting plate.

Type K bollard at eastern end of North wharf. Note textural difference between exposed aggregate surface of the historic wharf (far left) and modern wharf to right.

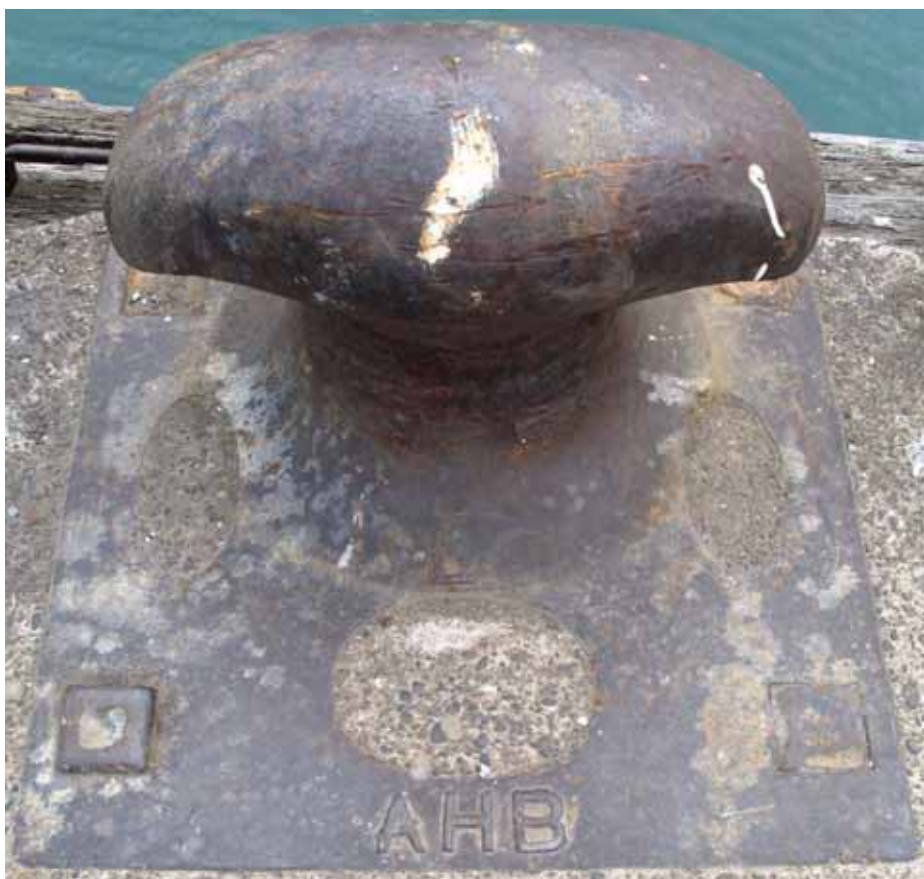
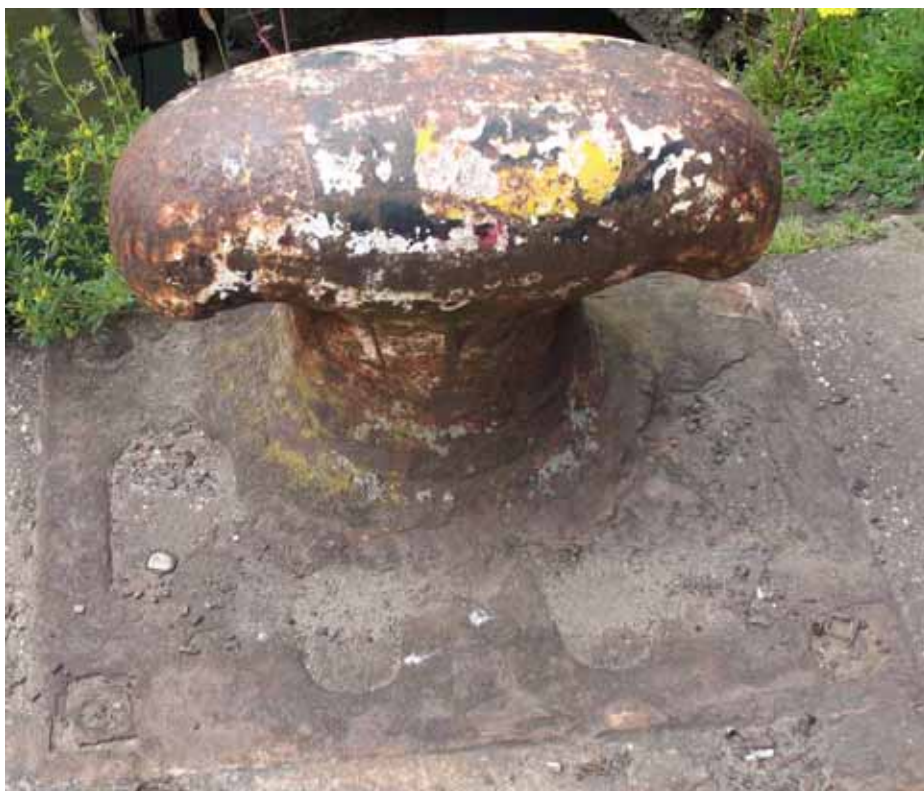
Type L (top, North Wharf) and M (below, Wynyard Wharf alignment) bollards.

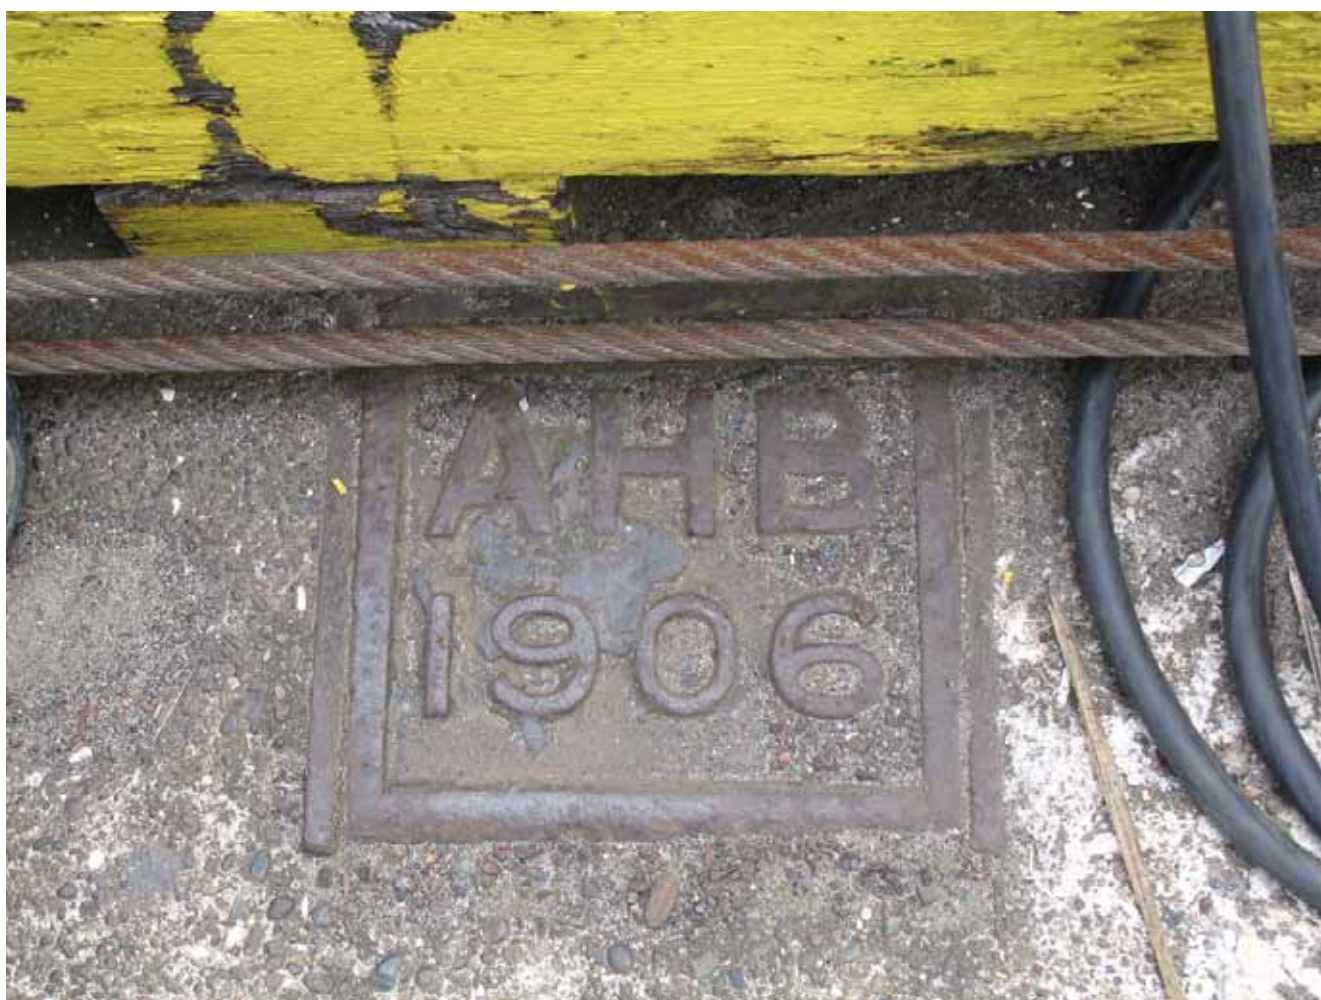
Good.

Service cover, North Wharf.

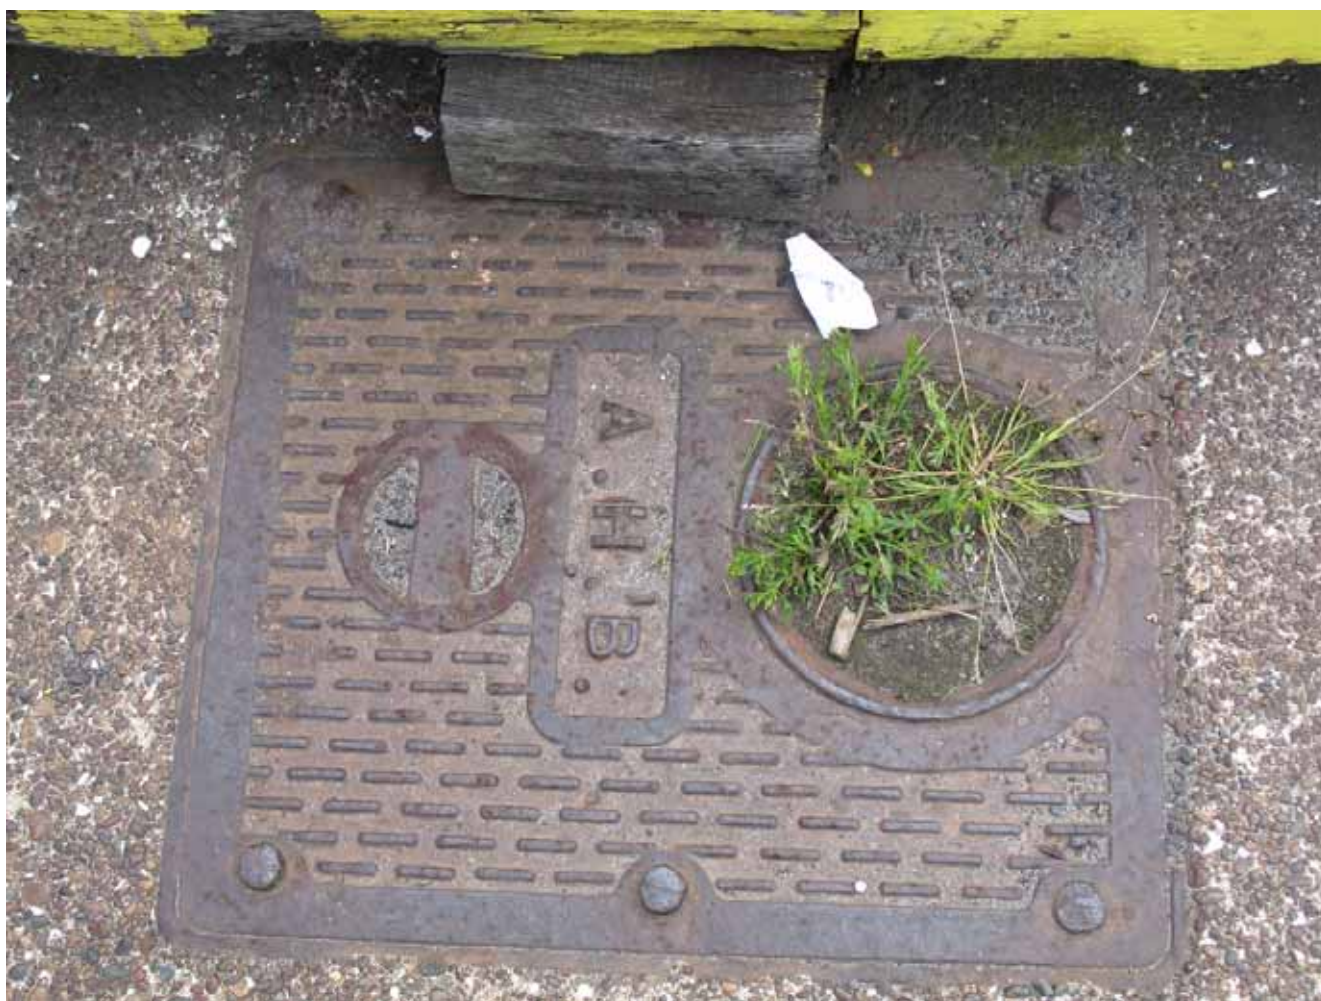
Excellent.

Cast iron fitting (probable davit base), North Wharf.

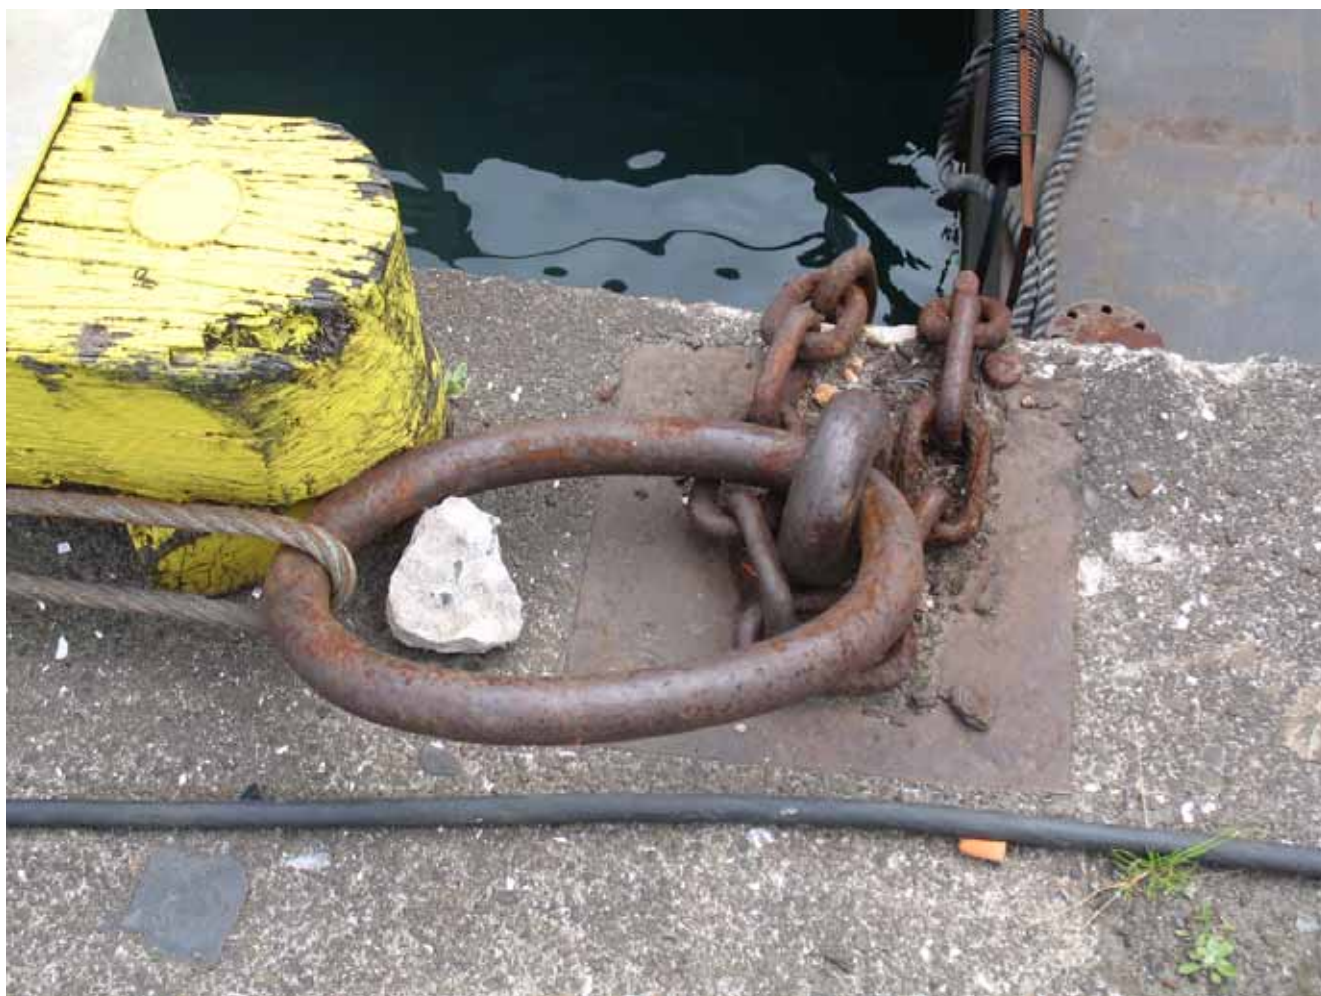
Excellent.

Eye-pin and ring fitting and toe rail (painted, left), North Wharf.

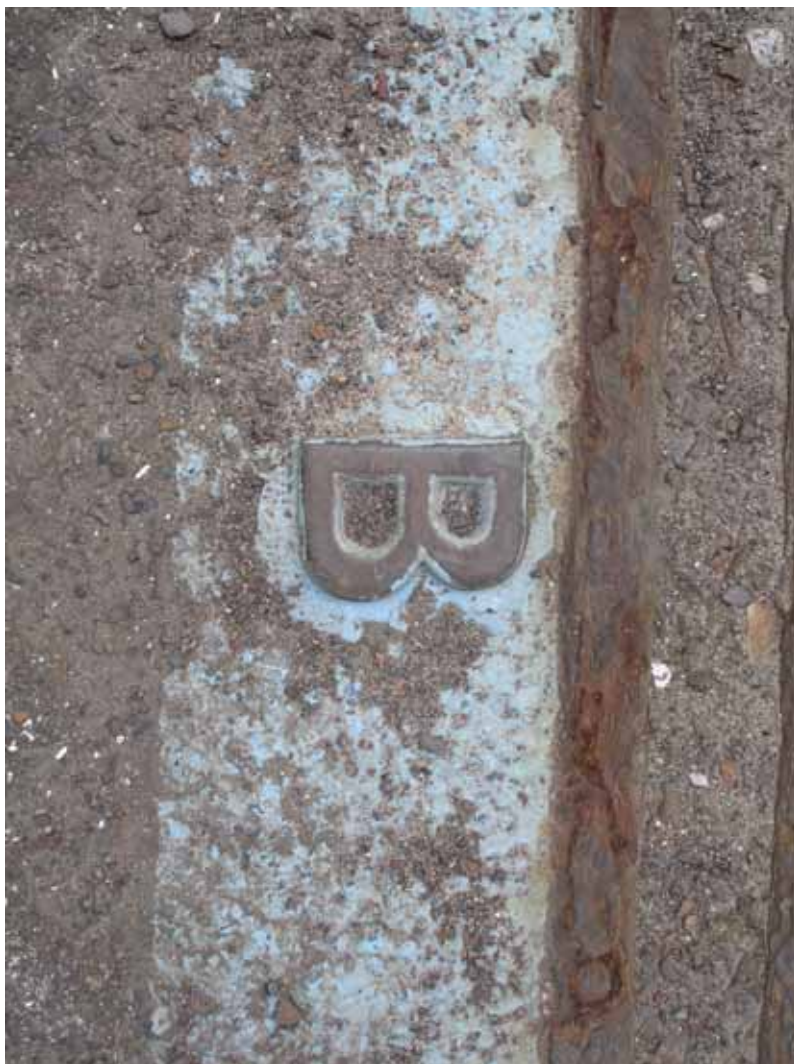
Excellent.

Letter set in concrete, vicinity of intersection of Wynyard and North wharves.

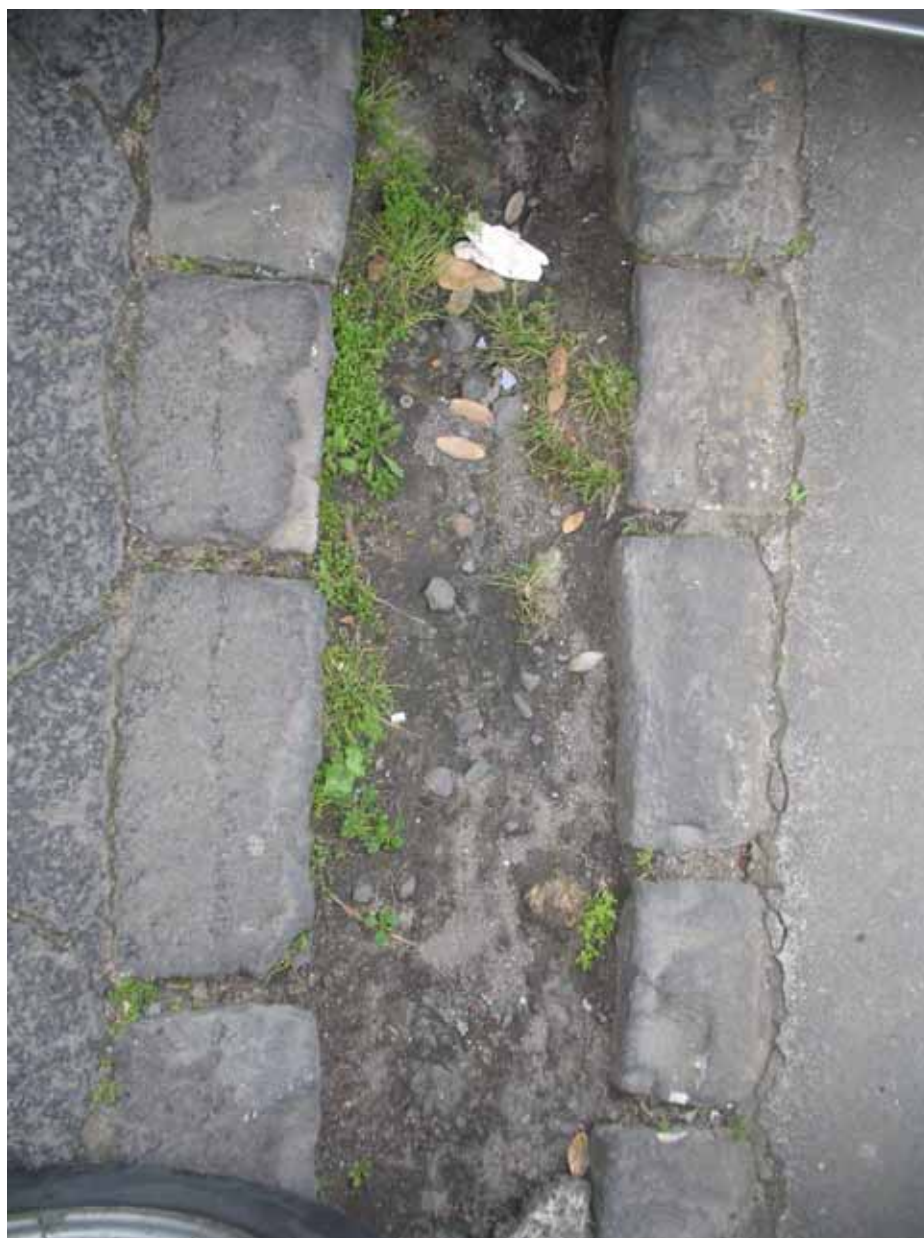
Very good. Partially obscured by asphalt in places & infilled with debris.

Bluestone channel, north side of Jellicoe St.

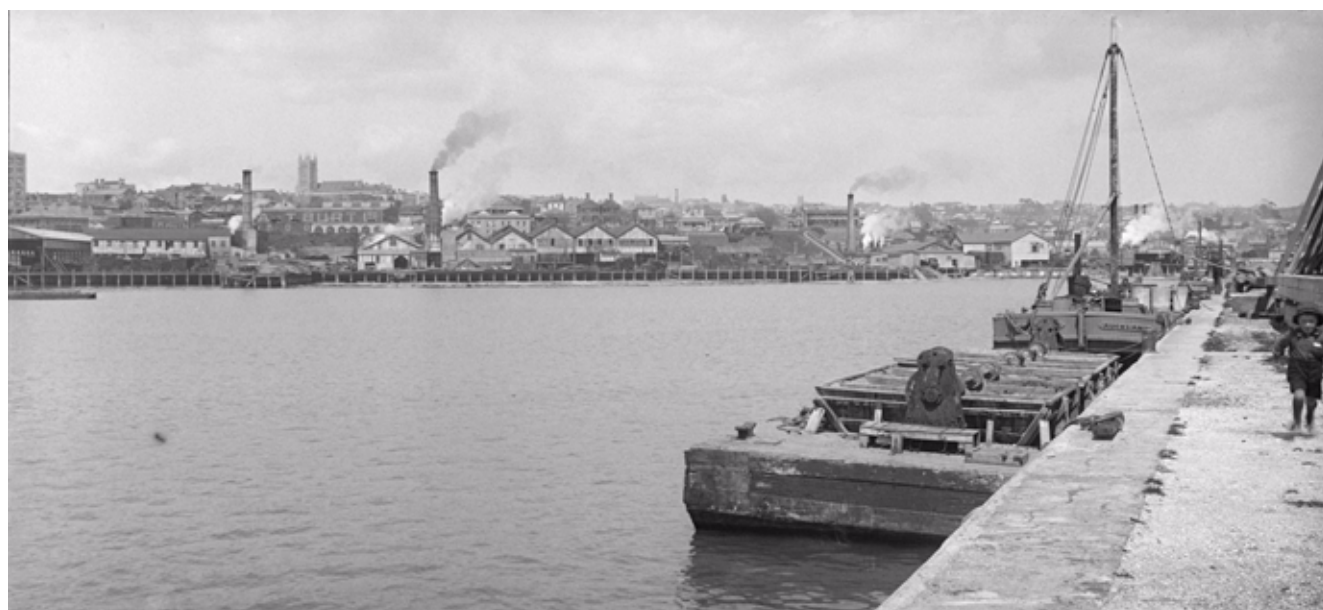
The eastern side of the Freeman's Bay reclamation was defined by a solid concrete wall, known as the east wall. It quickly became known as Julian's wall, after A. T. Julian, the contractor who built it. This wall functioned as a wharf where shallow draft vessels could tie up, and for many years it was the base for Auckland's scow fleet. Julian's wall was substantially buried under the more recent reclamations for the Americas cup base and apartment developments. However a 30 metre section of the wall remains fully exposed, and the top of the edge of the wall and some of the rings to which vessels were tied (item 6.1), are still visible beside the footpath on the eastern side of Halsey Street. The fully exposed section of Julian's Wall retains much of its original character and some original fittings including 2 cast iron bollards (item 6.2). However the modern balustrade that has been added to the top of the wall obscures its antiquity to some extent.

Julian's wall in 1921, with a scow and barge tied up. Auckland Public Libraries.

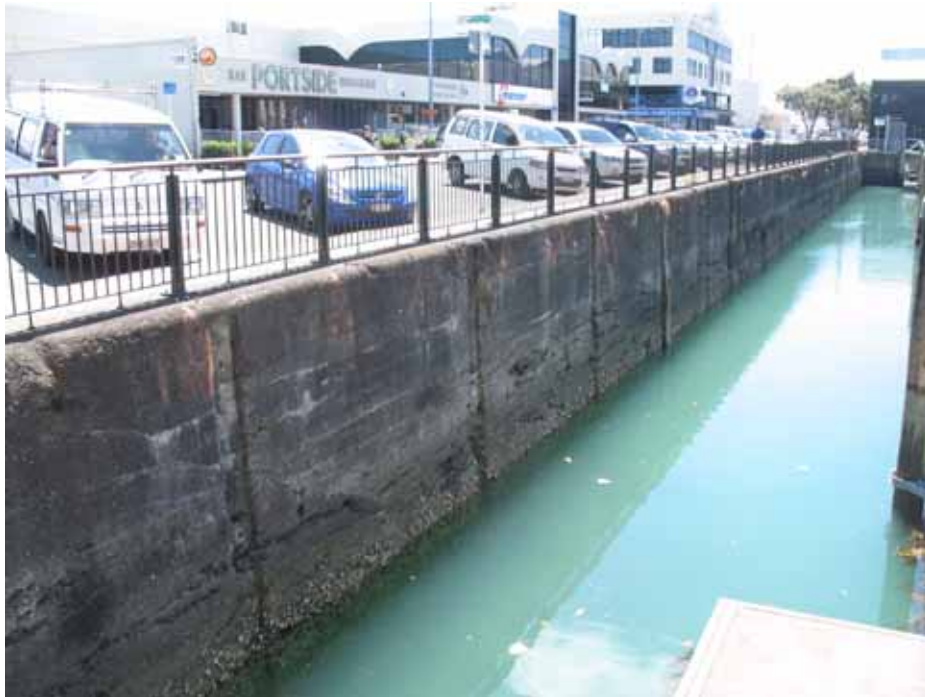
Very good, partially concealed by recent reclamations and later surfaces. Timber fender piles and steel ladder on fully exposed section appear poor (not viewed at close range).

Intact section of Julian's wall, topped with modern balustrade. Note recesses for fender piles and ladders.

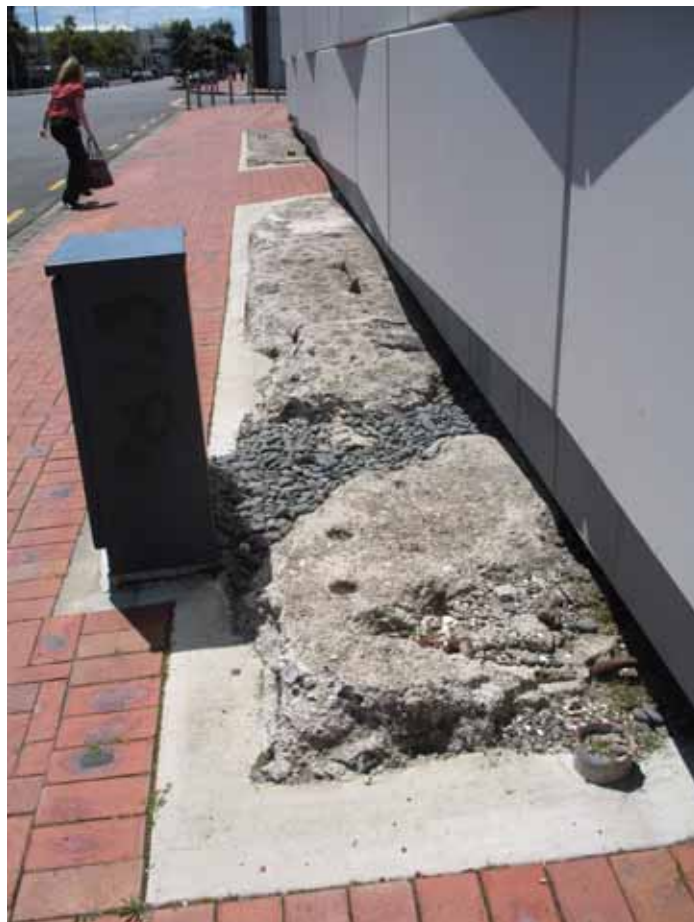
Sections of the top of Julian's wall that have been retained during construction of modern footpath between Viaduct Harbour Ave and Fanshawe Street.

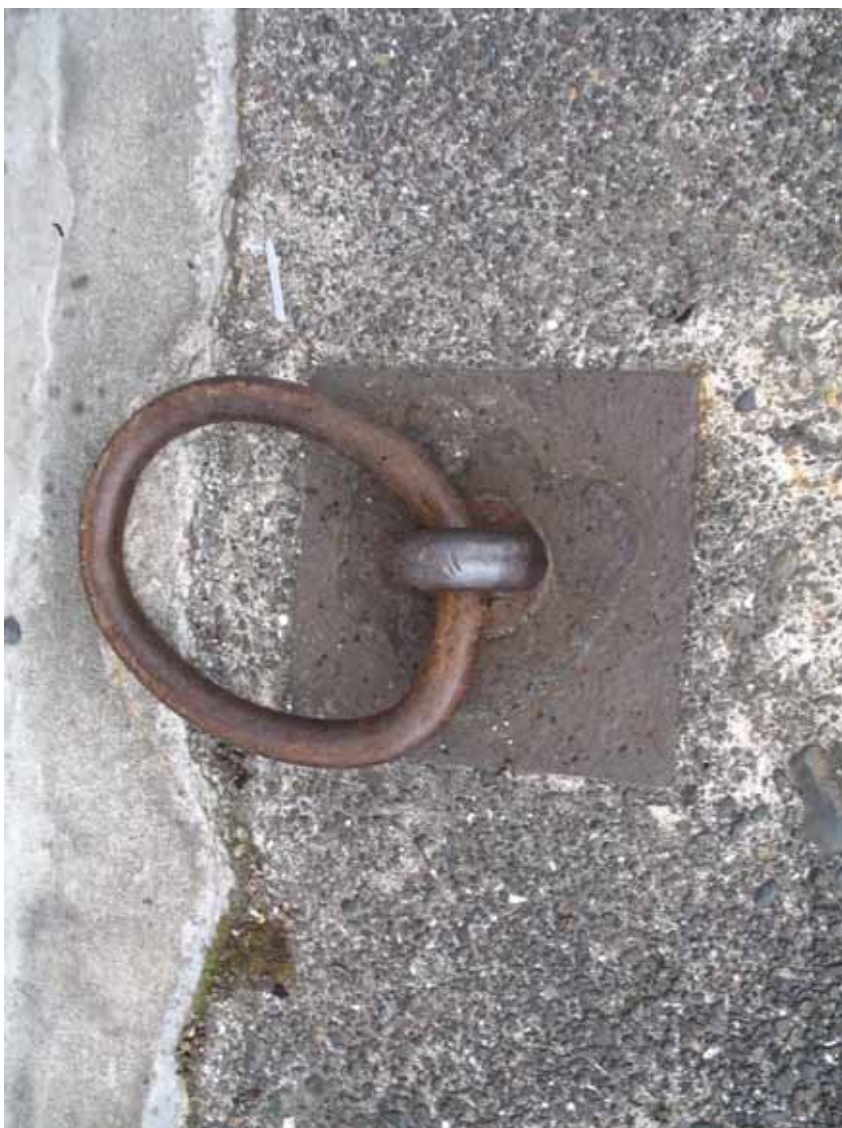
2 excellent, one poor (damaged).

Exposed aggregate surface of Julian's wall (right) with eye-pin and ring fitting.

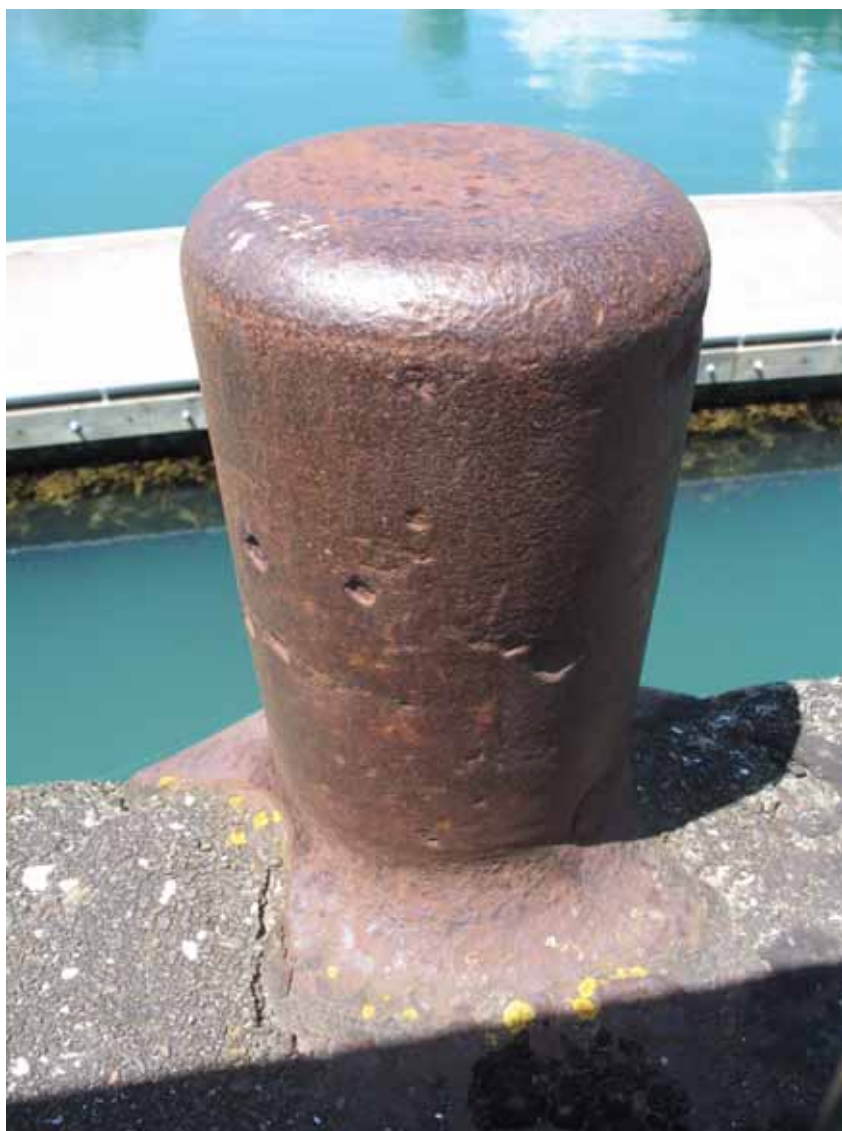
Very good (not viewed at close range).

One of two remaining bollards on the exposed section of Julian's wall.

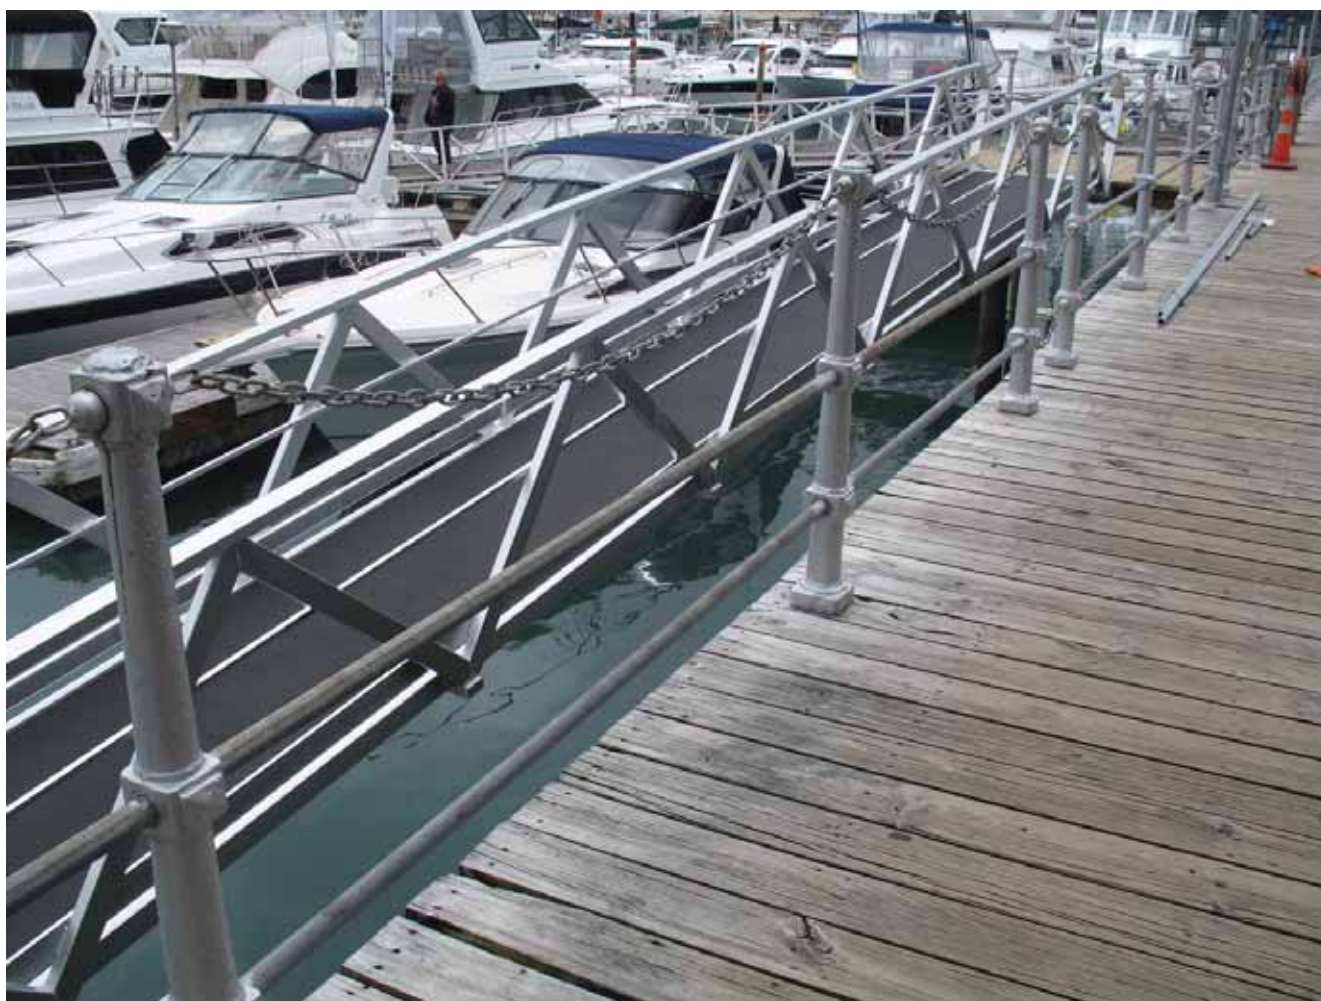
Good, heavily sandblasted.

Modern balustrade incorporating recycled stations, Pier 21.
