WYNYARD QUARTER INVENTORY OF CHARACTER ELEMENTS

Inventory of Wynyard Quarter character elements

The following inventory is based on a half day inspection of the Wynyard Quarter. Only publicly accessible areas were inspected.

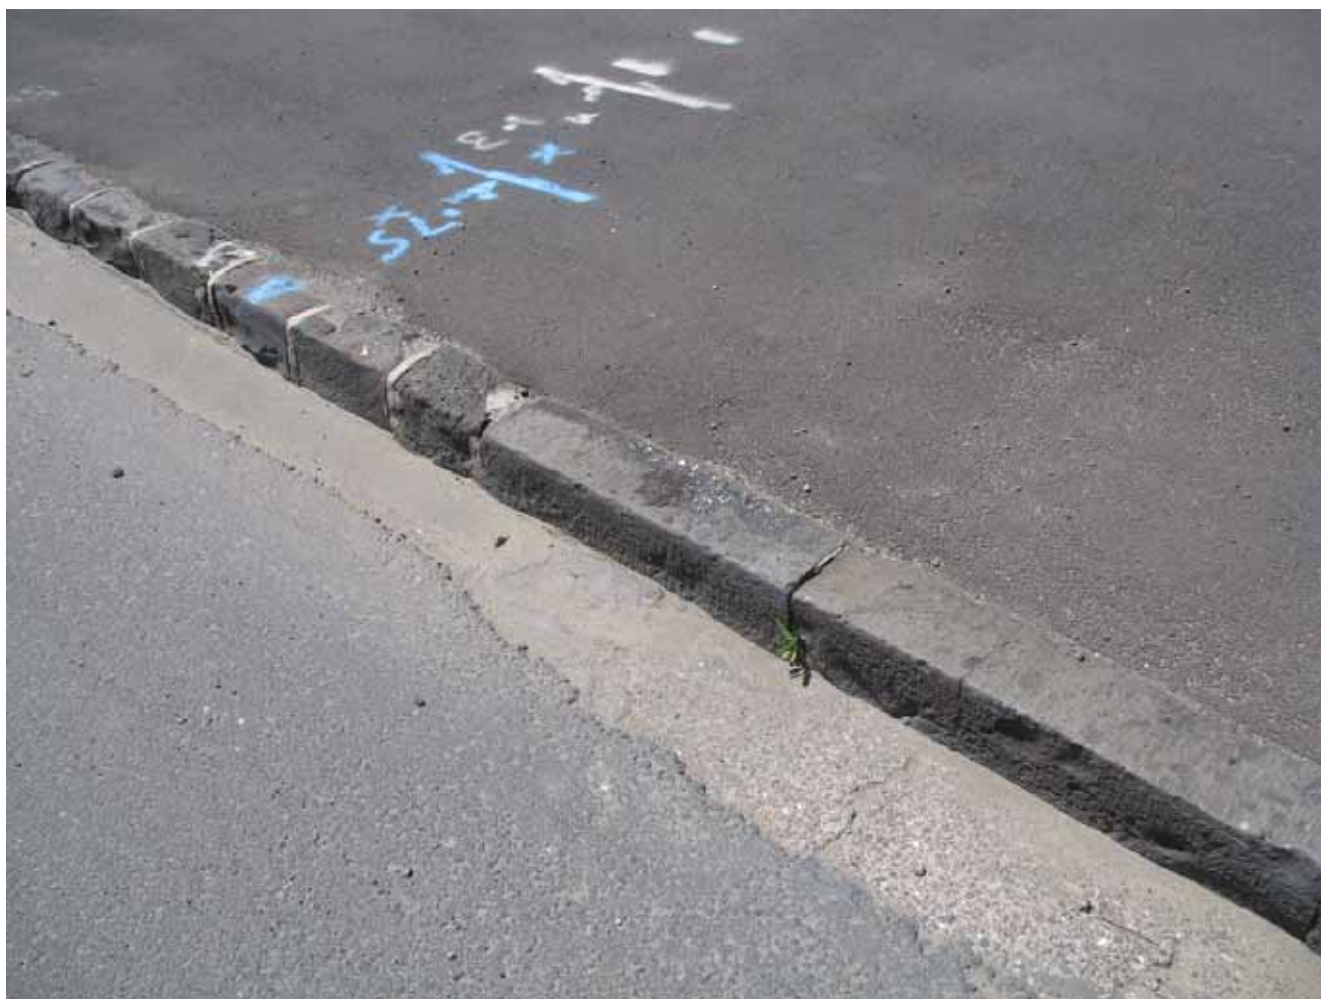
Generally very good. Only a small proportion has been re-layed and thus much of the kerbing retains its original spacing and detailing, now lost over much of the city.

Bluestone kerbing , Beaumont St: Kerbing with original stones & detail on right, modern replacement on left.

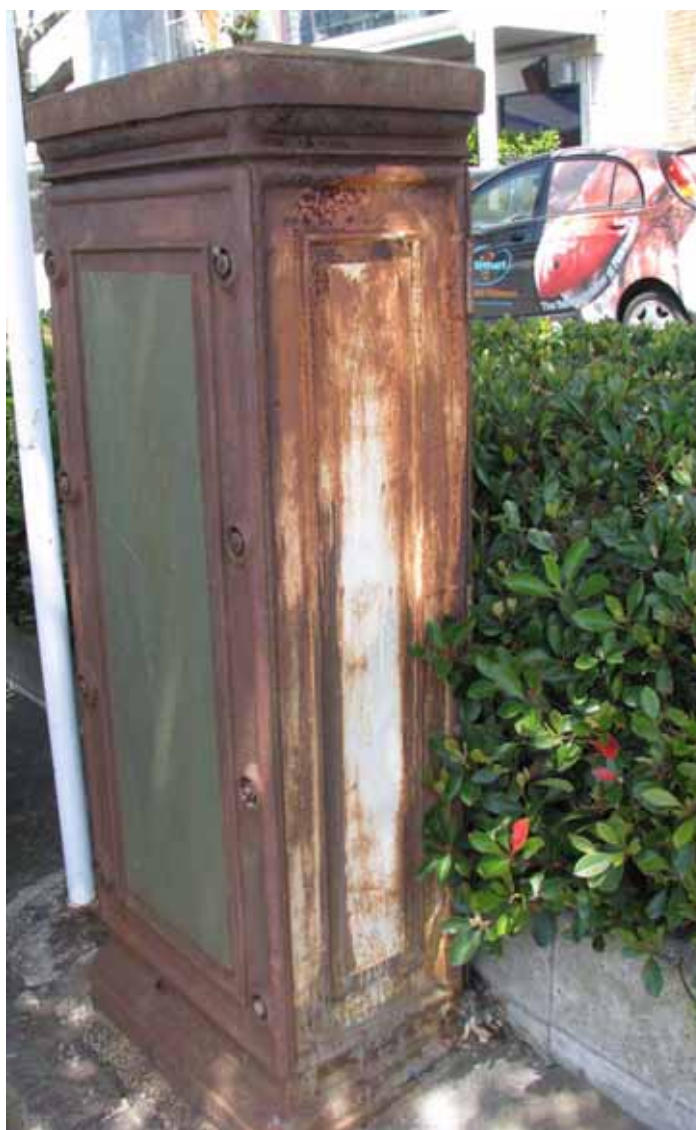
Excellent, cosmetic surface corrosion.

Cable junction box, Jellicoe Street
