Three Kings Renewal (Option 15H-1) – Contaminated Land Overview

Fletcher Residential Limited

✧ July 2014

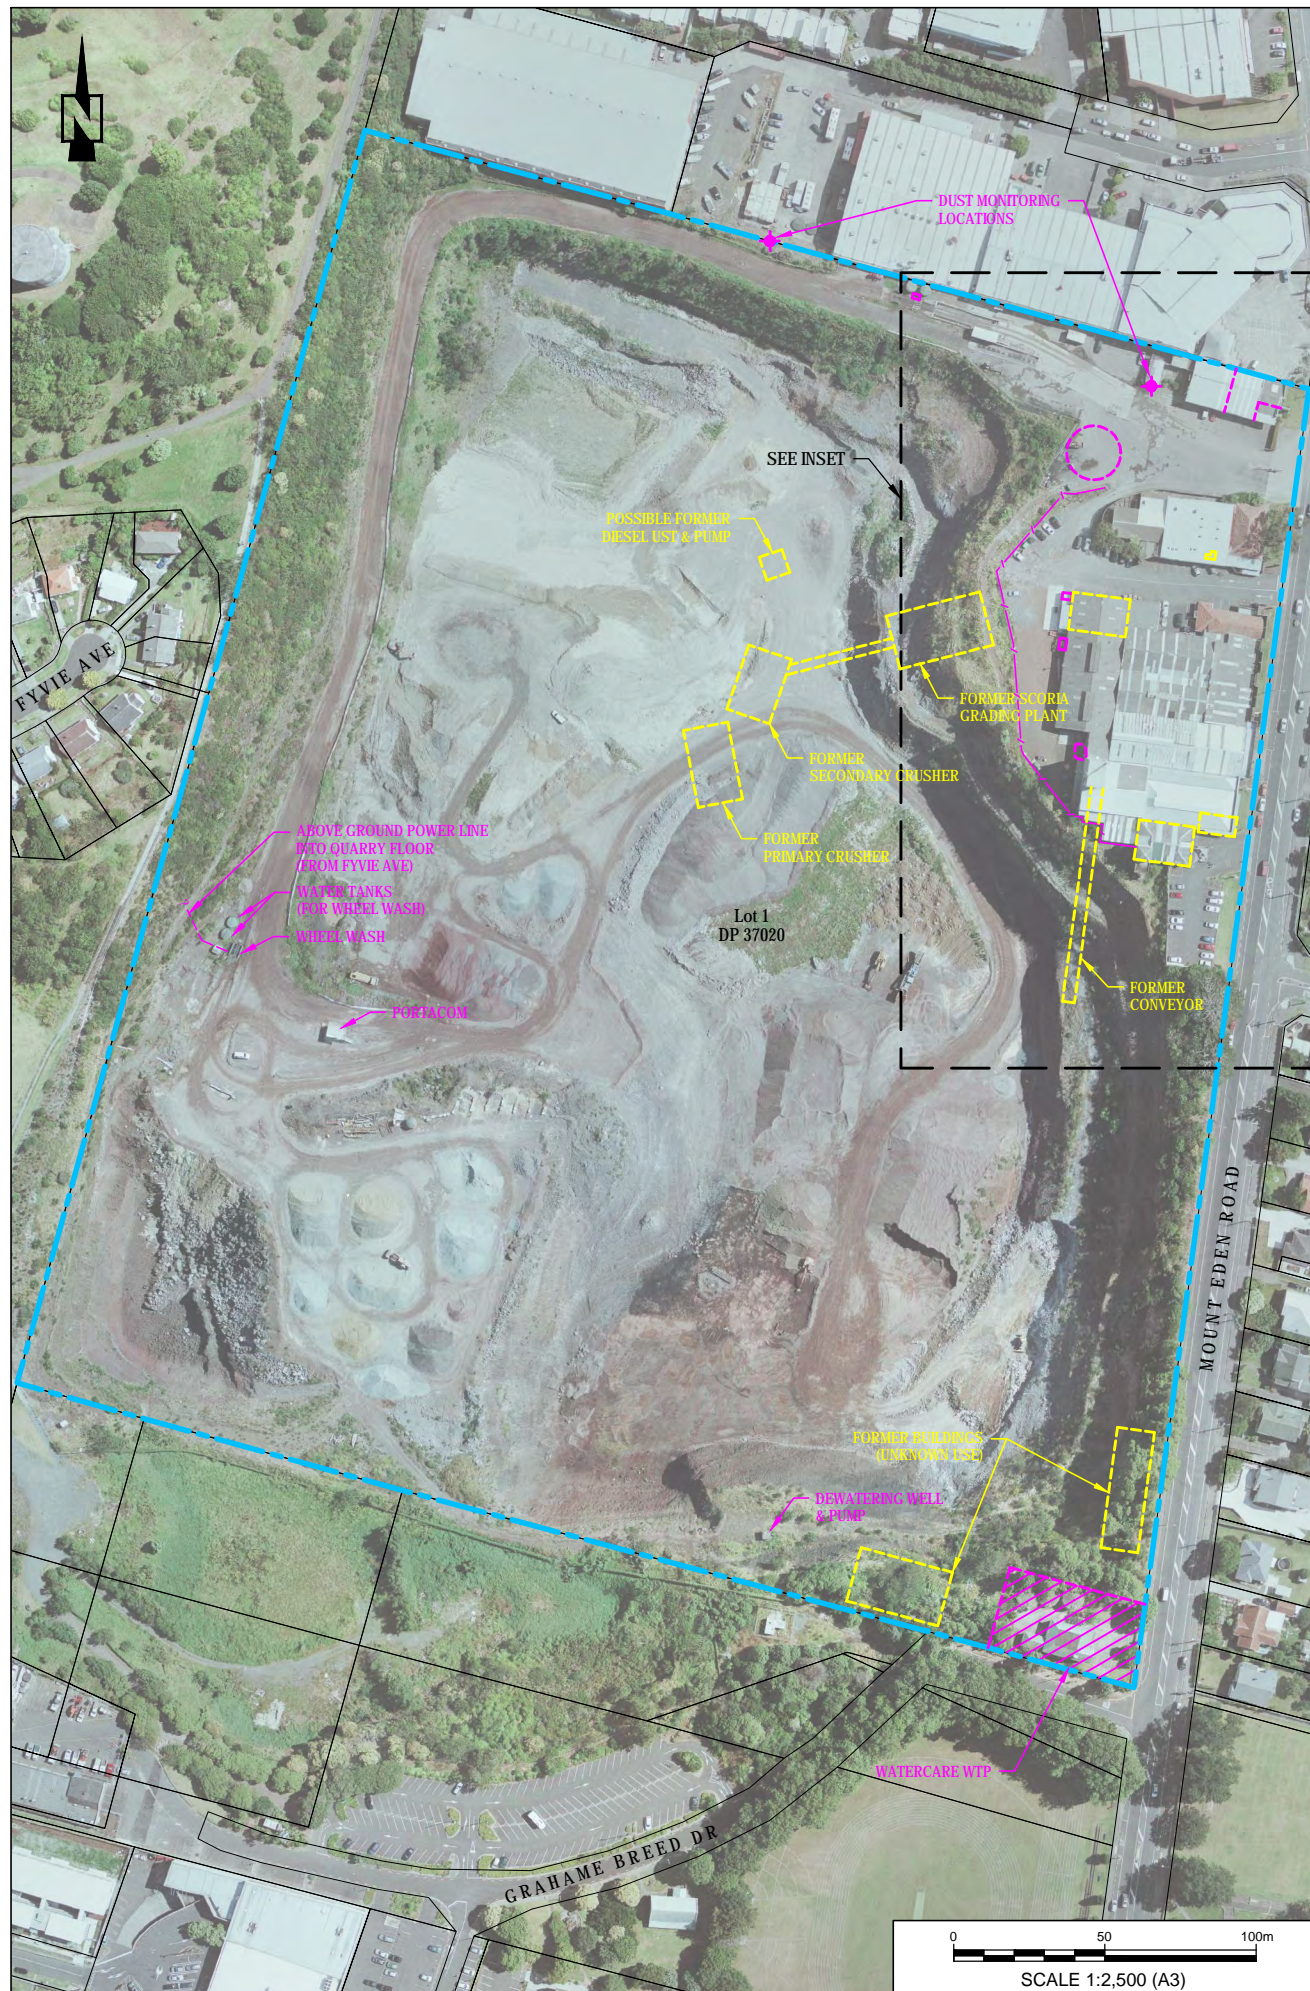
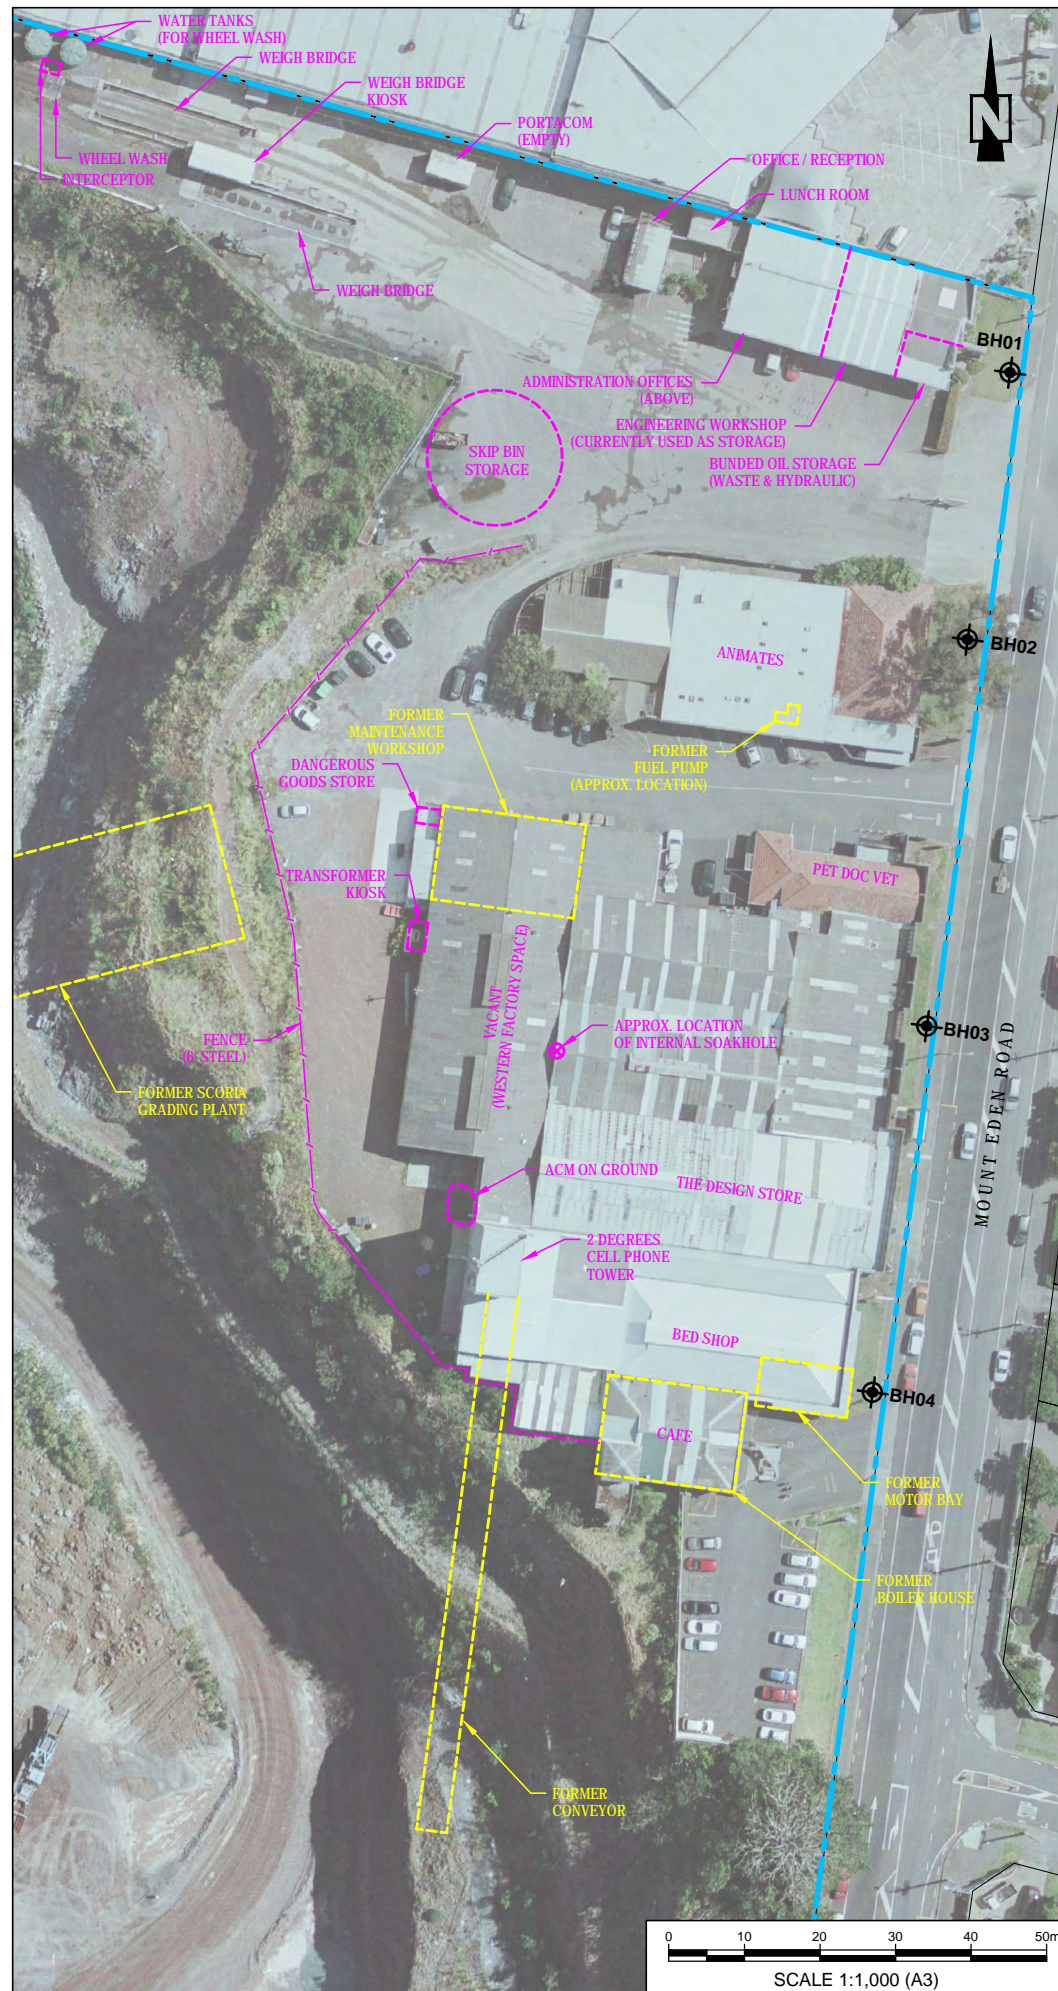
PROJECT NO. :	FIGURE NO. :	REVISION :
AJ456101	1	C

- BH01 BOREHOLE (PDP SOAKAGE INVESTIGATION, APR 2014)
- EXISTING FEATURES
- FORMER FEATURES
- SITE BOUNDARY

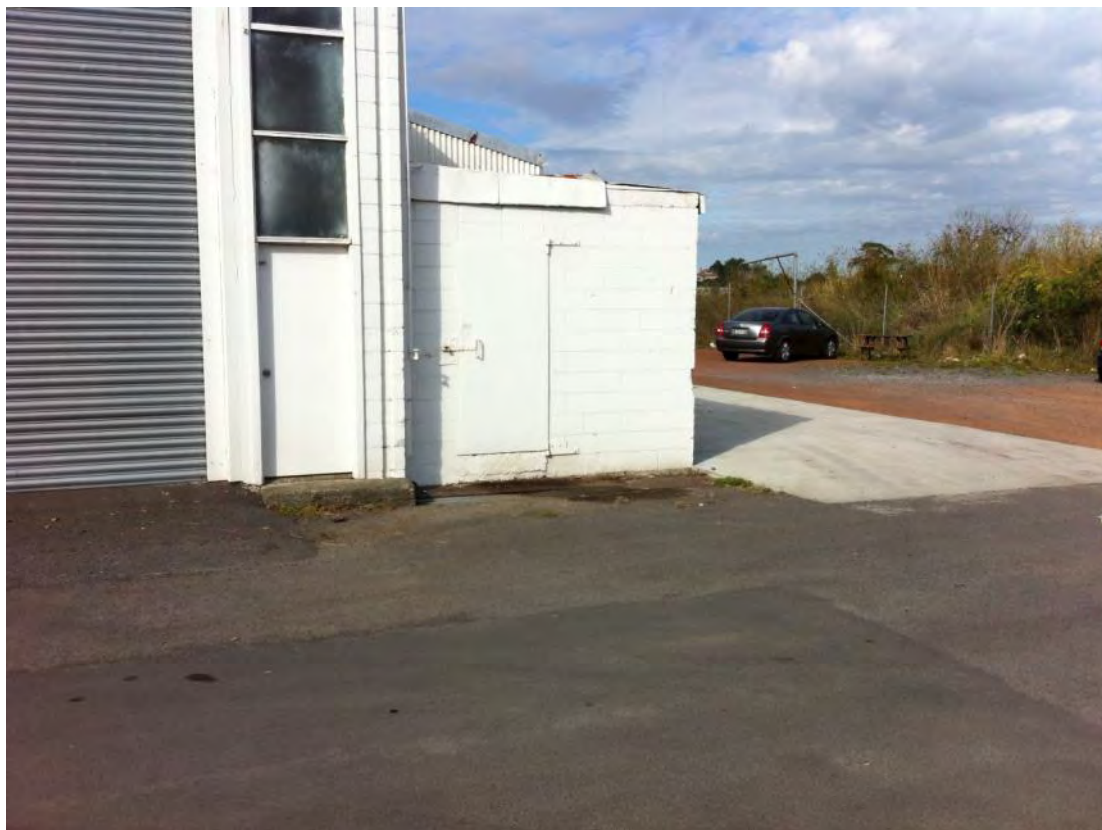
Photograph 9: Possible former dangerous goods store on the northwest corner of the main block of buildings.

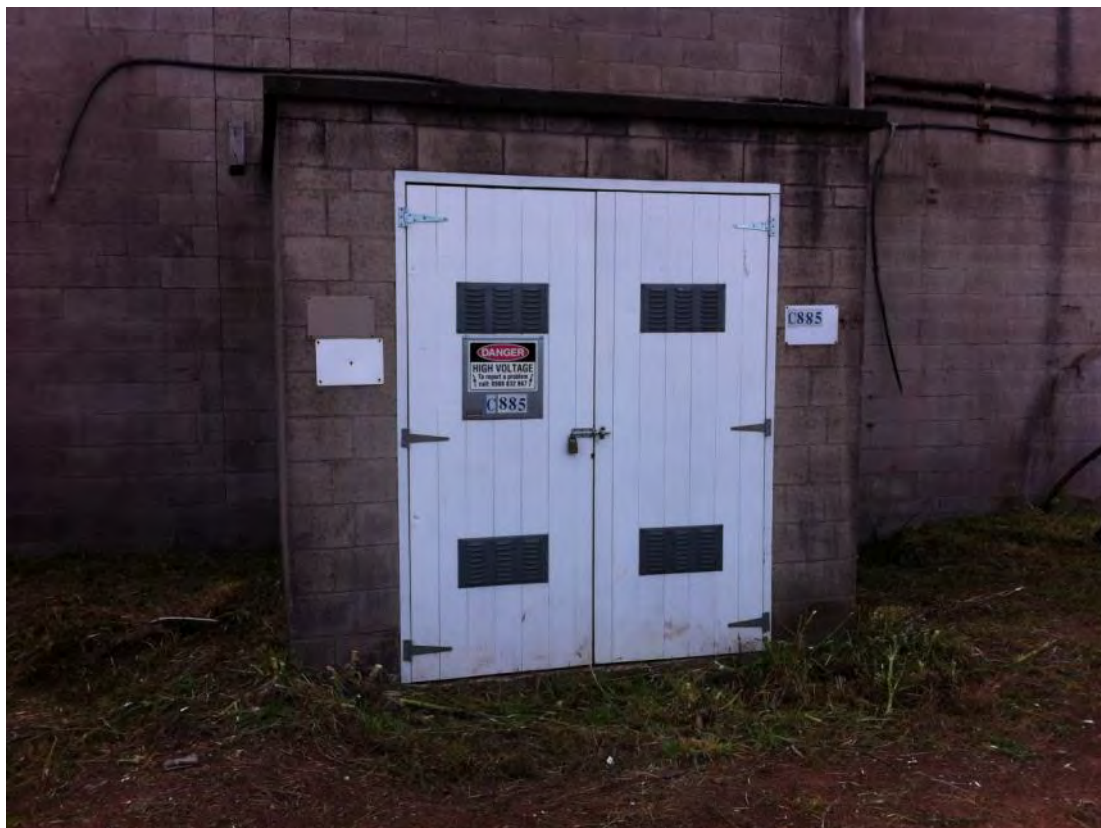
Photograph 13: Electrical transformer shed on the western side of the main block of buildings.

- ✧ Sampling of site soils in the immediate vicinity of the transformer kiosk is recommended to determine whether any actual contamination occurred from this equipment. Transformer oil should be tested for PCBs as part of the decommissioning of this equipment unless there is existing documentation to confirm that the transformer oil is free of PCBs;

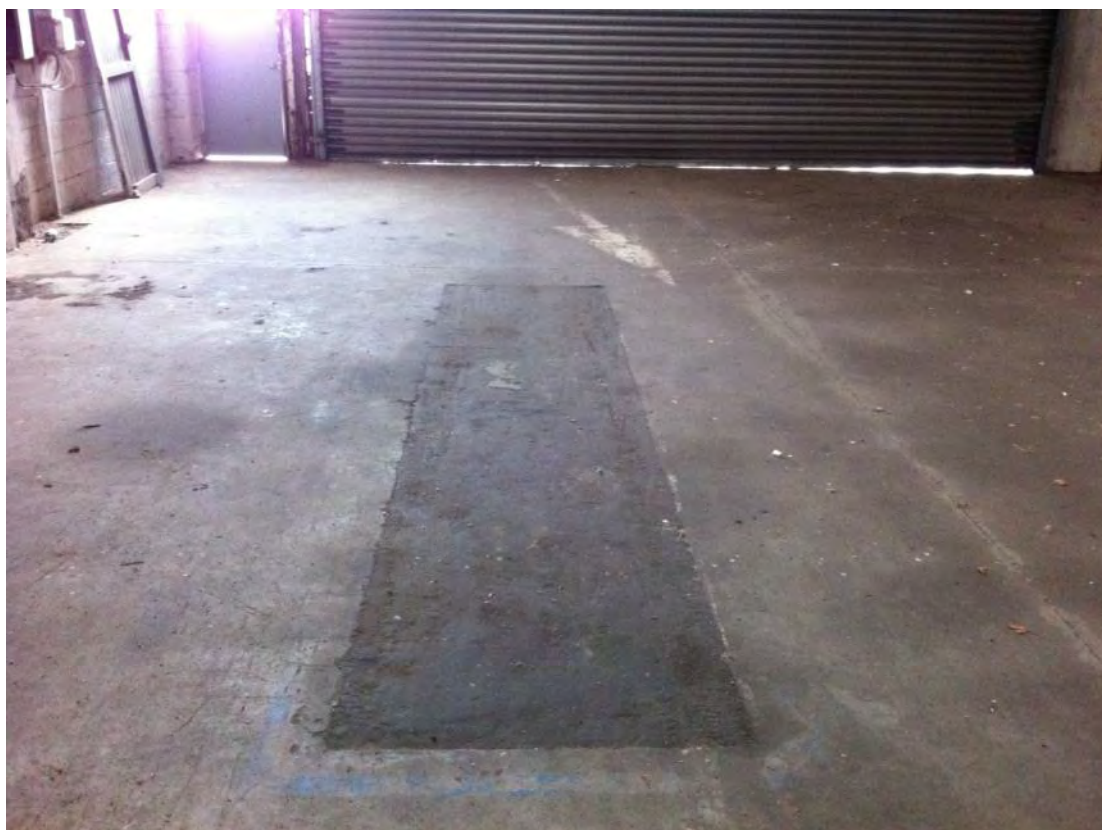
Photograph 16: Former vehicle service pit near the northern end of the western building currently vacant.

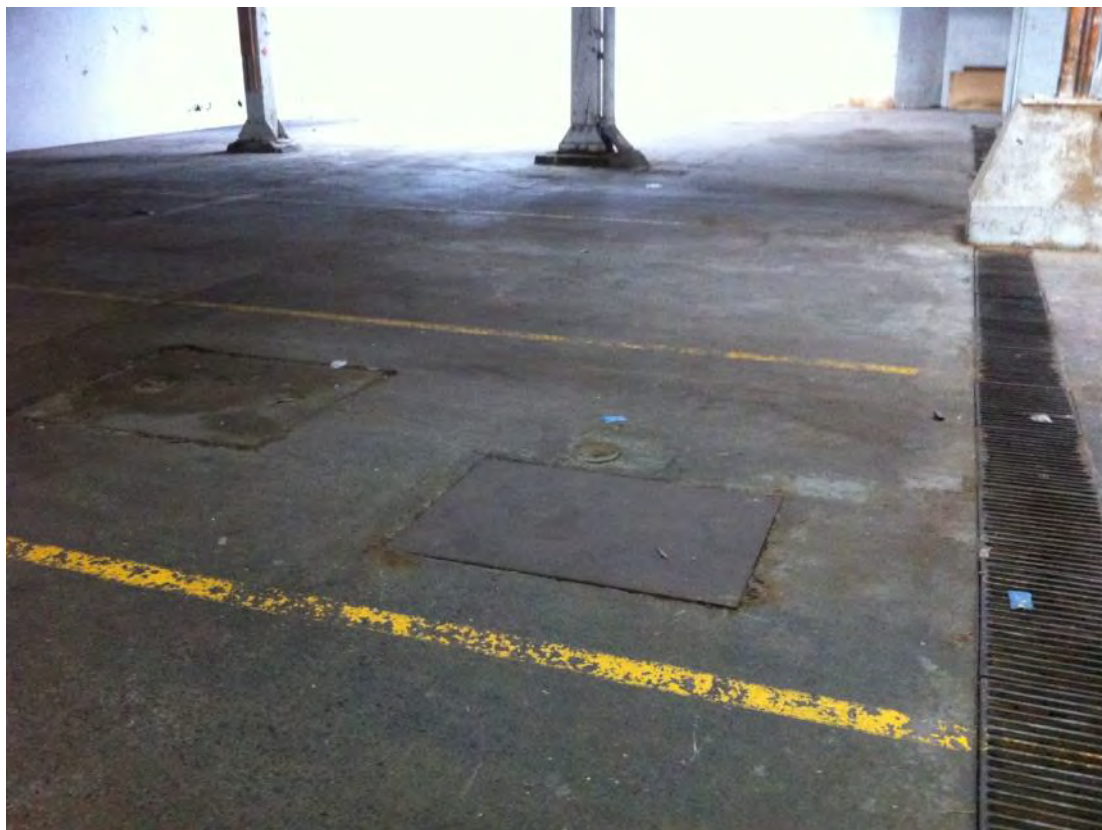
Photograph 17: Floor drains and metal covers over

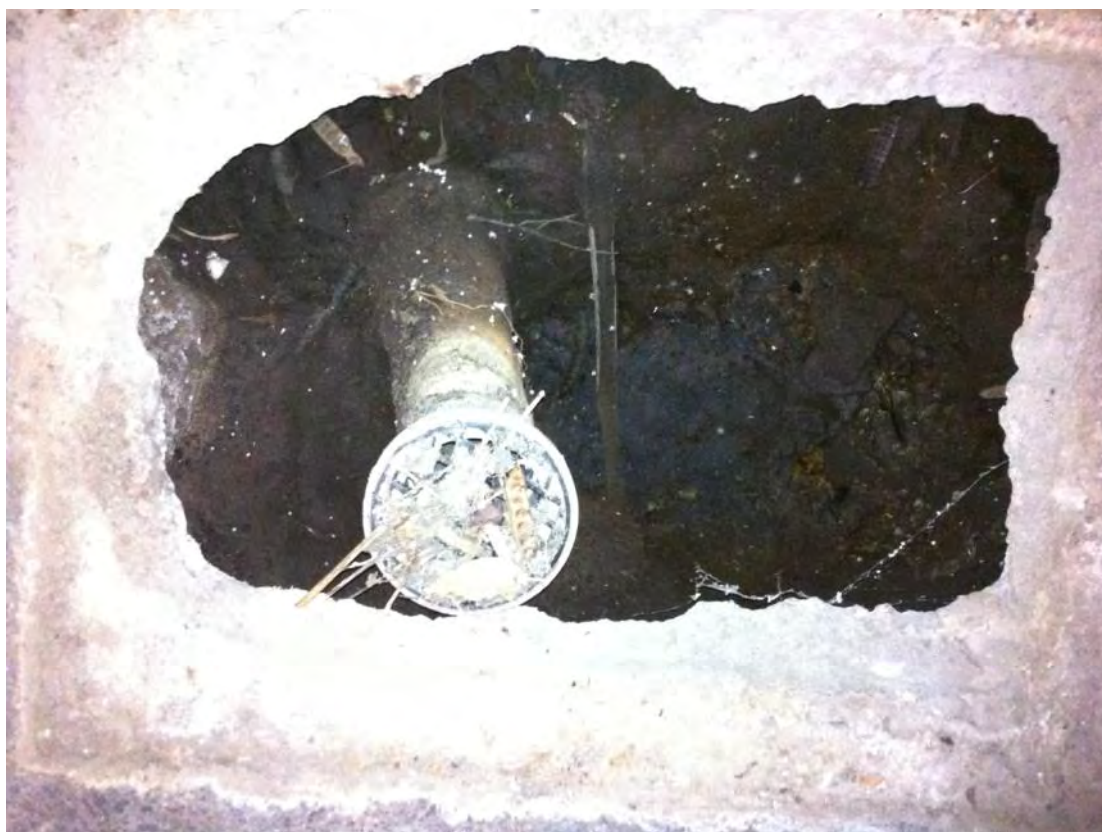
Photograph 18: Soakage pit inside the western building currently vacant.

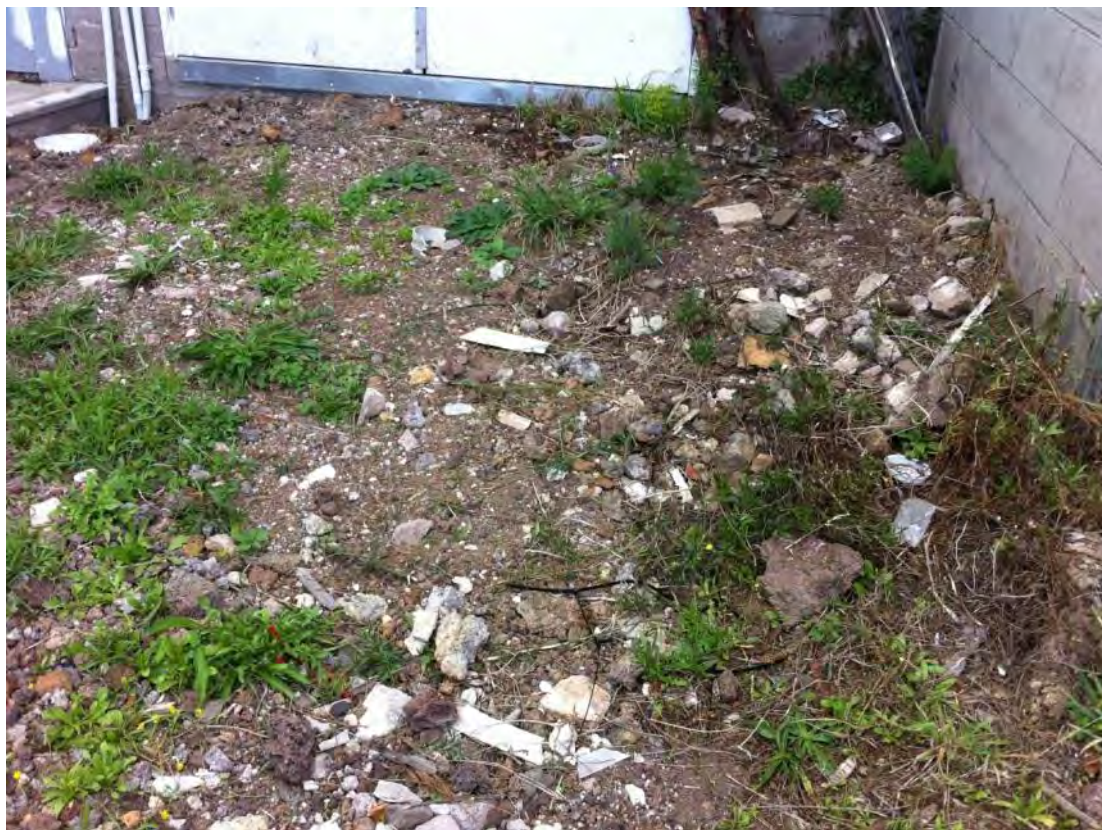
The building aspects found to contain ACM were wall cladding and roofing materials. These materials were present across the site buildings. The types of asbestos identified in these materials were chrysotile (white asbestos) and amosite (brown asbestos) (confirmed by qualitative laboratory testing of one representative sample of roofing material). As part of their inspection, CEDA assessed the extent of deterioration, and the potential to release fibres if disturbed, of the ACM observed. With the exception of the materials observed on the north walls, which were painted and assessed as having a very low potential to release fibres, the remaining materials were assessed as having a medium to high risk of releasing fibres if disturbed. However, air testing carried out in two locations by CEDA during the inspection indicated that fibre release was not occurring above the detection limit of the monitoring equipment (<0.01 fibres/mL).

Photograph 21: Suspected ACM fragments from degrading building cladding in southwest part of the commercial area next to the 2 Degrees electrical cabinet.

The CEDA report concluded that if left undisturbed, the ACM observed on site should not pose a risk of fibre release above Workplace Exposure Standards, and that the materials should remain stable until at least 2016. The report further stated that any work on the roof structure should be done by tradespersons with a suitable qualifications in dealing with ACM, and should conform to the guidelines set out in the Health and Safety in Employment (Asbestos) 1998 Act and the New Zealand Demolition and Asbestos Association New Zealand guidelines for the management and removal of asbestos (3rd Edition) (NZDAA, 2011).

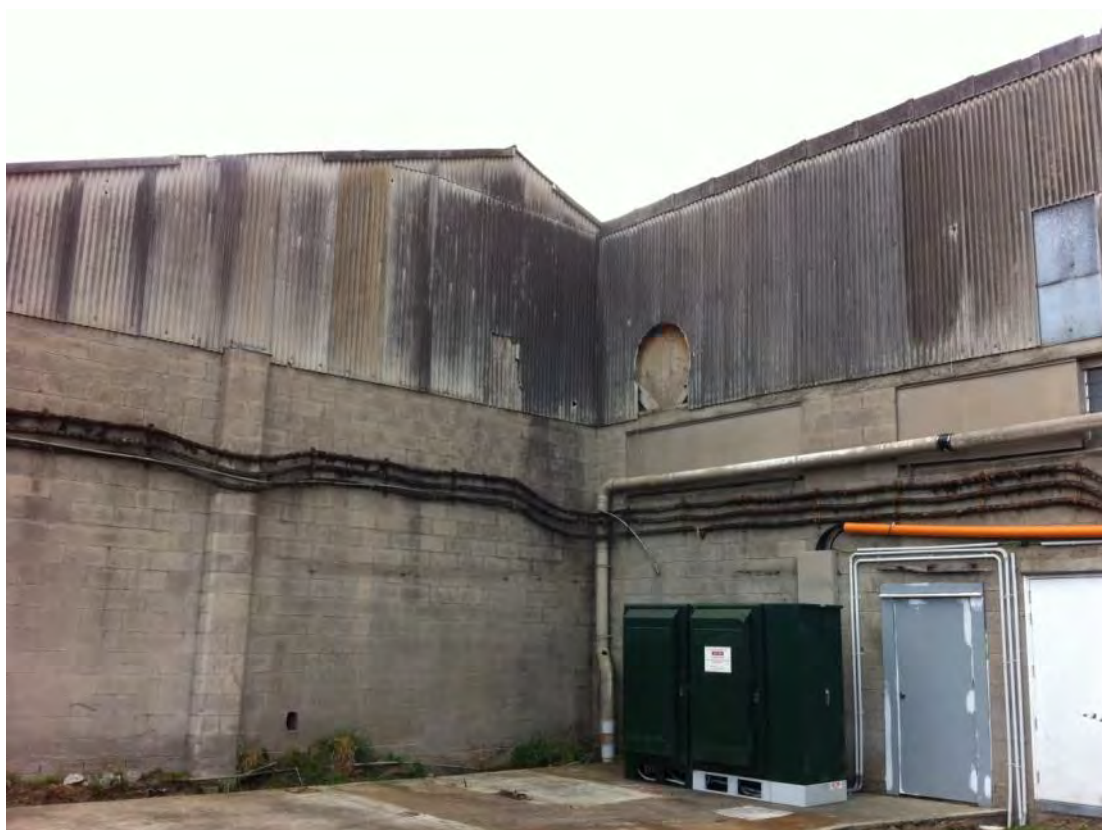
Photograph 22: Suspected ACM cladding on the southwest part of the main building complex.

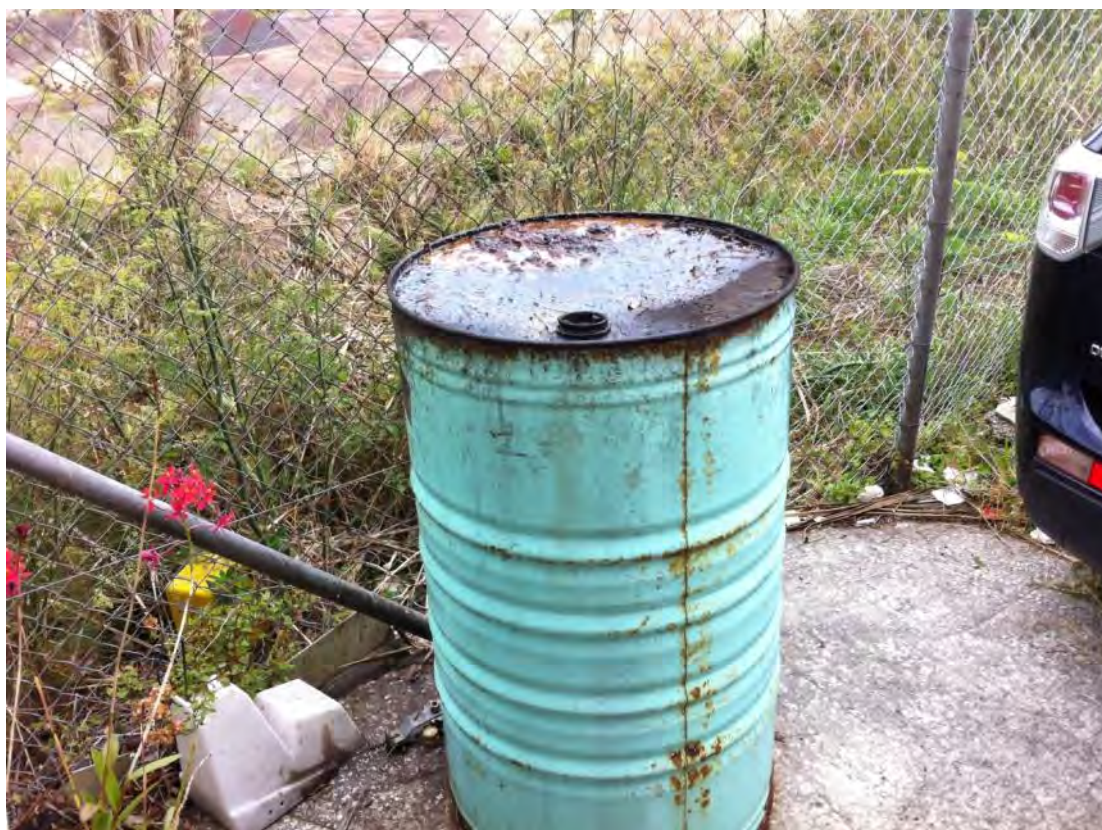
In the southwest part of the commercial area, next to the vacant building is a large concrete pad where dust extraction equipment was formerly located. 2 Degrees have recently relocated their electrical cabinet to this concrete pad from a small concrete plinth on the western boundary of the commercial area. In the southwest part of the commercial area, adjacent to the vacant building and old tower, there are fragments of suspected ACM which appears to have fallen from the degrading cladding on these structures. In the same area is an underground concrete chamber of unknown use that appears to be holding water. There is a manhole opening in the concrete lid and a thin steel cover that is badly rusted and unsecured. In the southwest corner of the commercial area there is a 210L drum (contents unknown).

Photograph 27: Drum behind the Eiffel café in the southwest part of the commercial area.

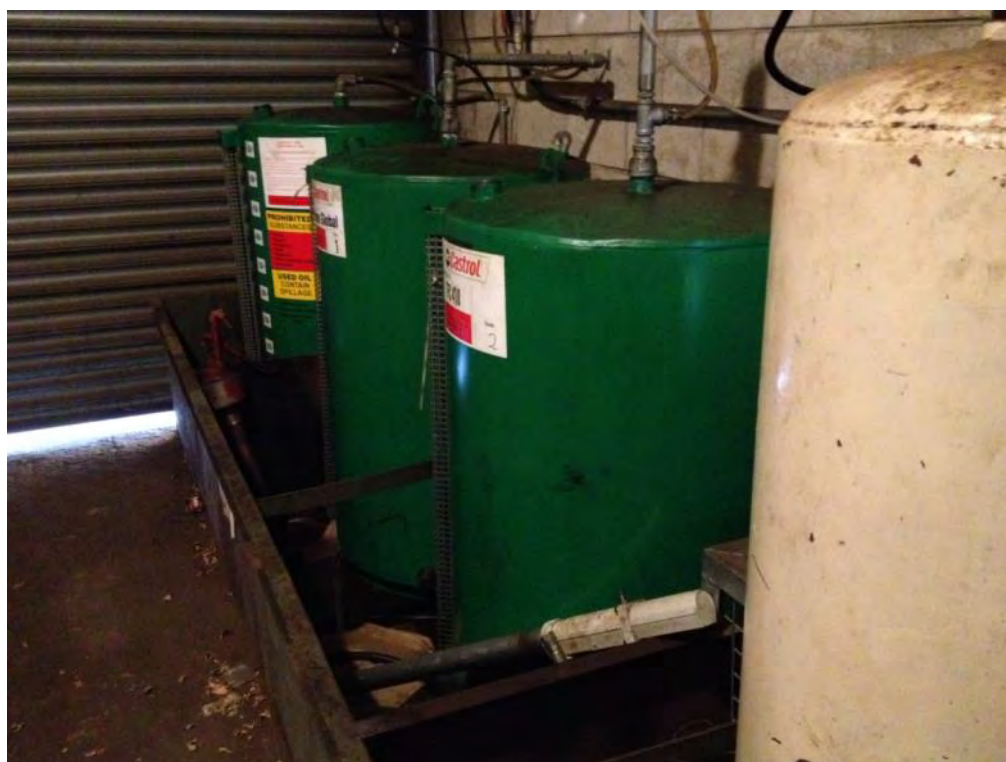
**Photograph 34: Inside the engineering workshop showing banded oil storage area
– both new and used hydraulic oils. Note: concrete floor.**

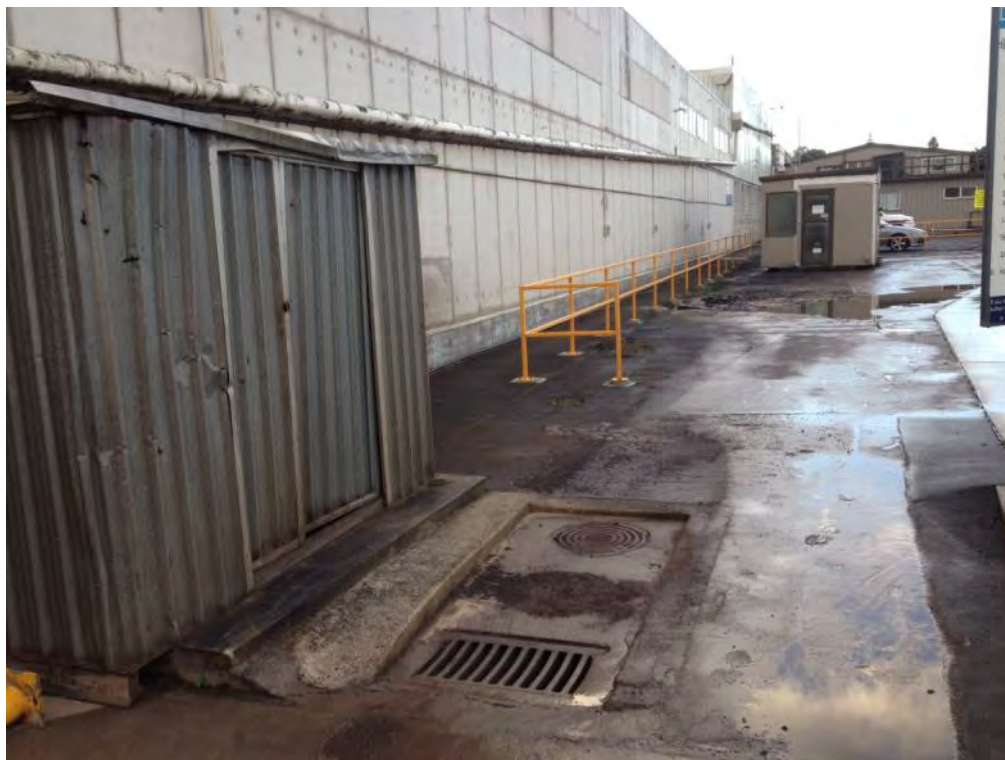
Photograph 41: Adjacent to the wheel wash and weighbridge area showing cesspit and interceptor; northern site boundary is indicated by the building on the left.

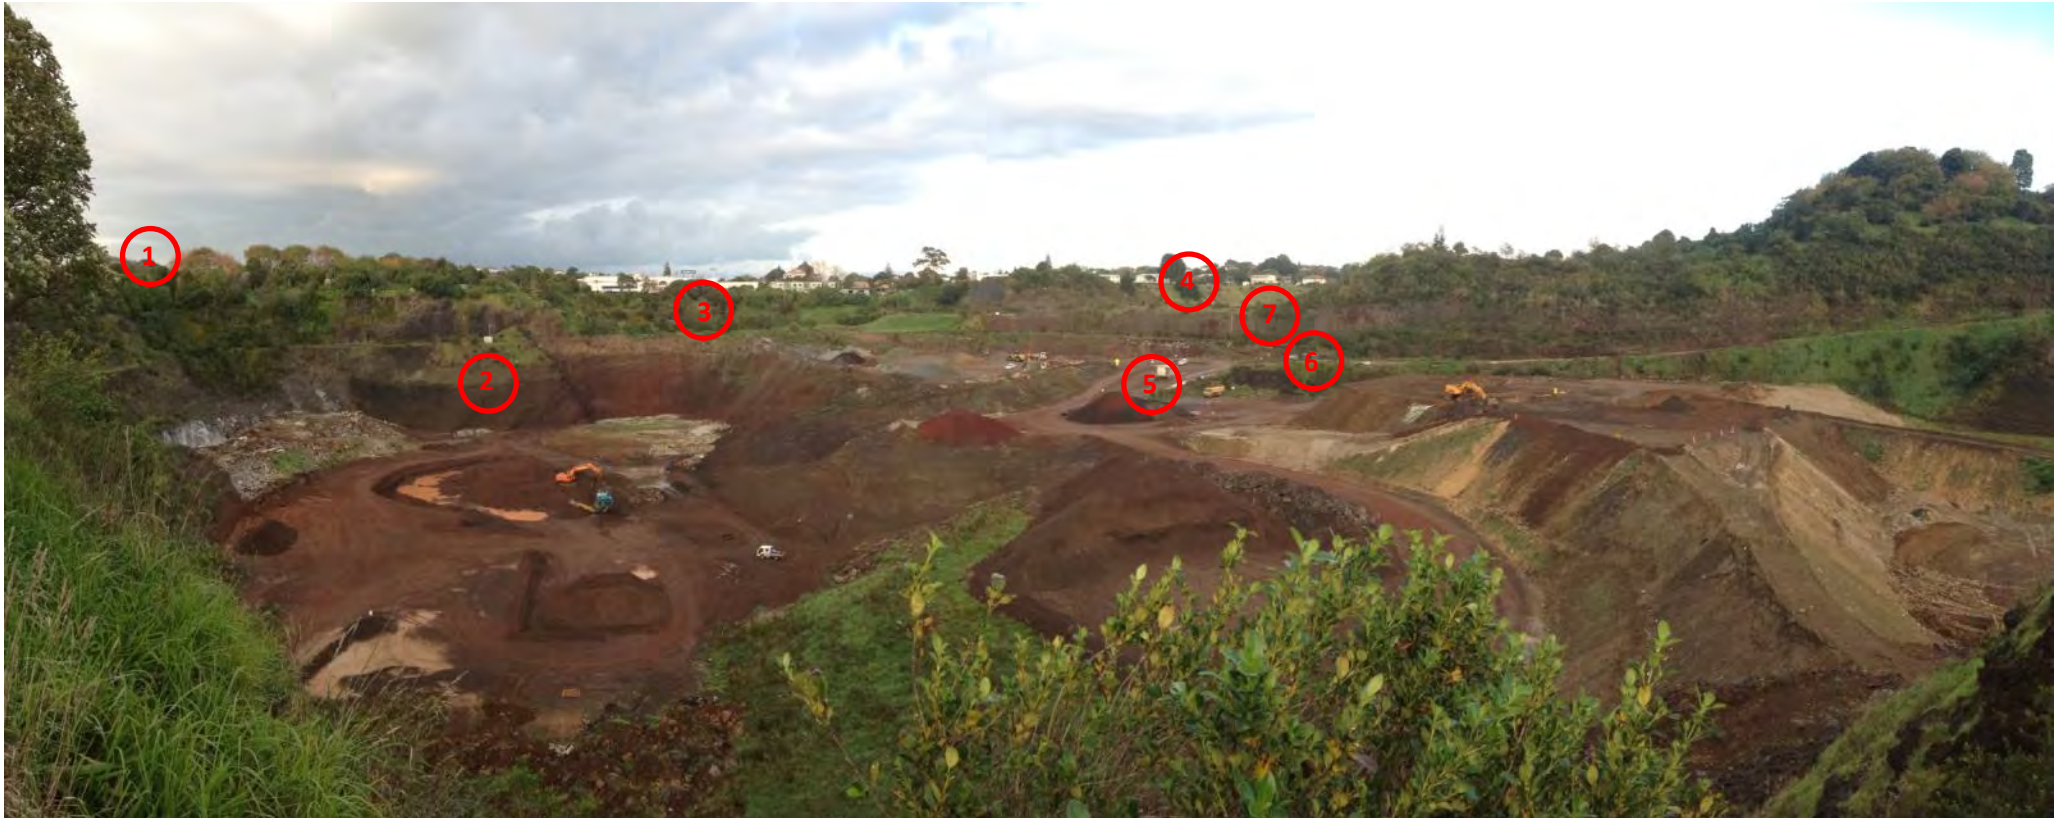
Photograph 43: Large-scale panoramic of the quarry as it is at the time of the site visit; photograph taken from the bund wall to the south of the main entrance area.

Features in this image include: the Watercare WTP (1); the quarry pump-shed (2); former extent of quarry in adjacent southern parcel (3); former extent of quarry in south-west parcel (4); portacom in the quarry floor (5); lower wheel wash area (6); and, power into the quarry floor from Fyvie Avenue (7)

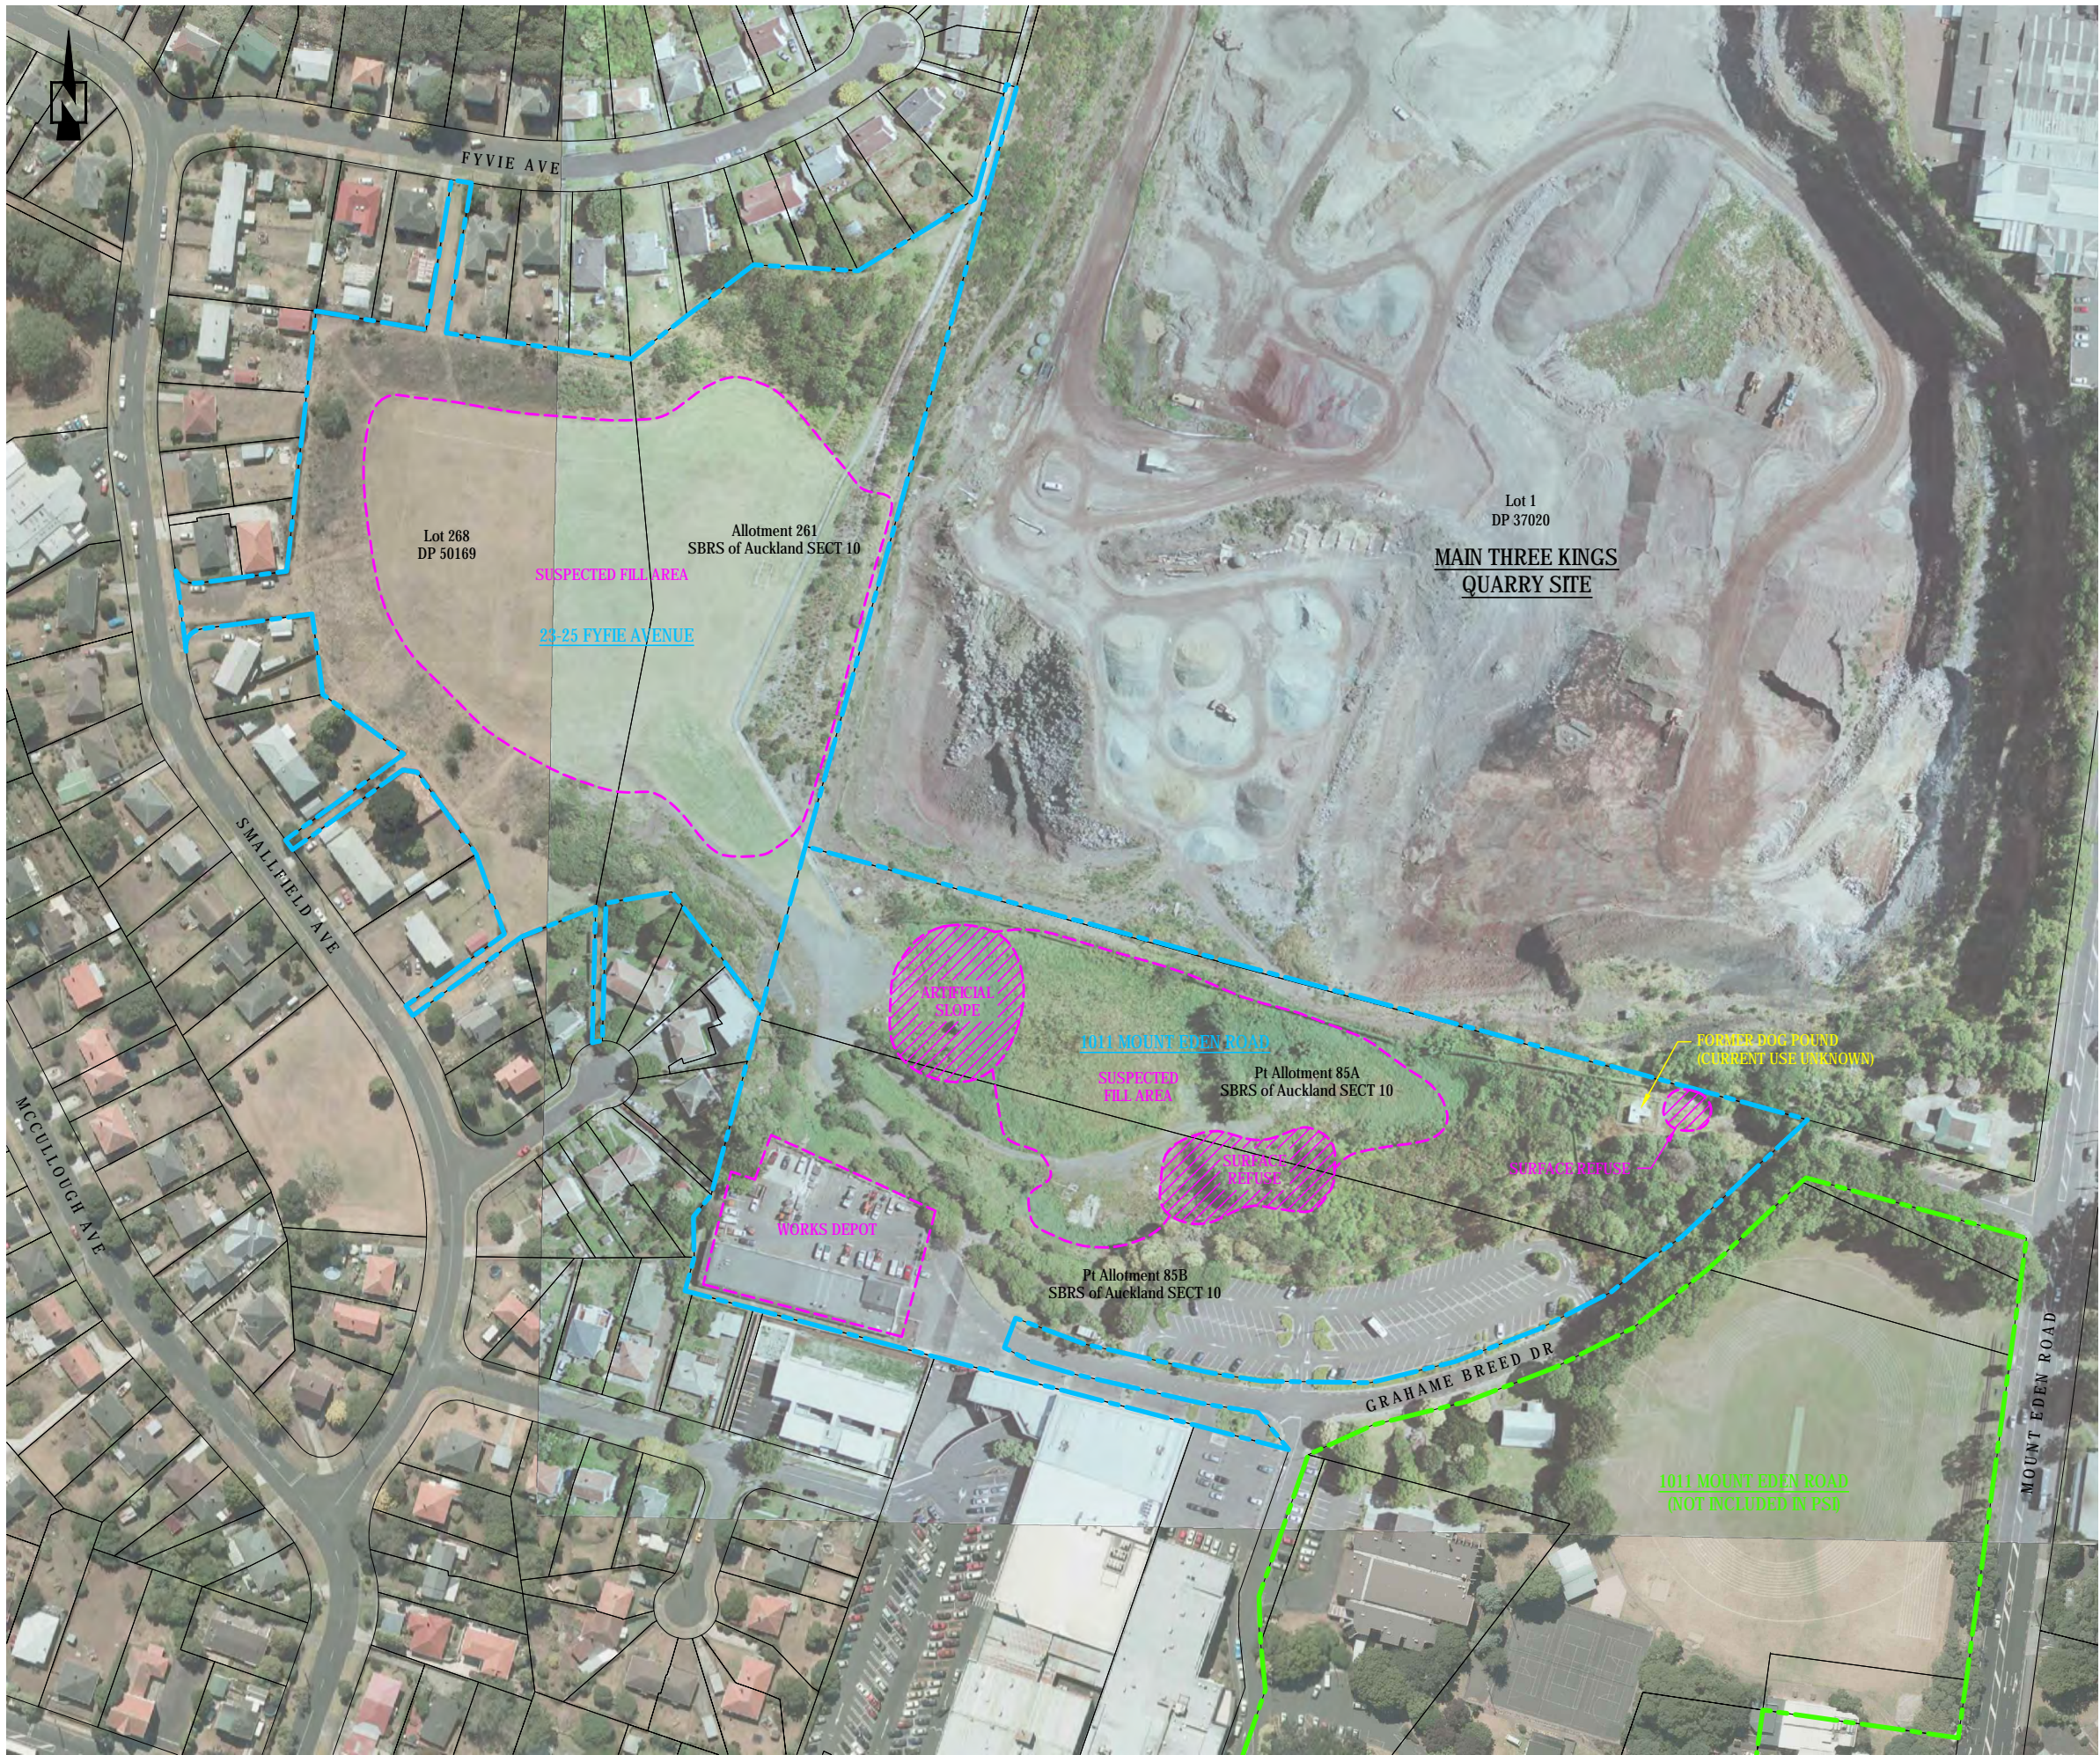
PROJECT NO. : AJ456103	FIGURE NO. : 1	REVISION : C
----------------------------------	--------------------------	------------------------

EXISTING FEATURES
	FORMER FEATURES
	INVESTIGATION AREA BOUNDARY

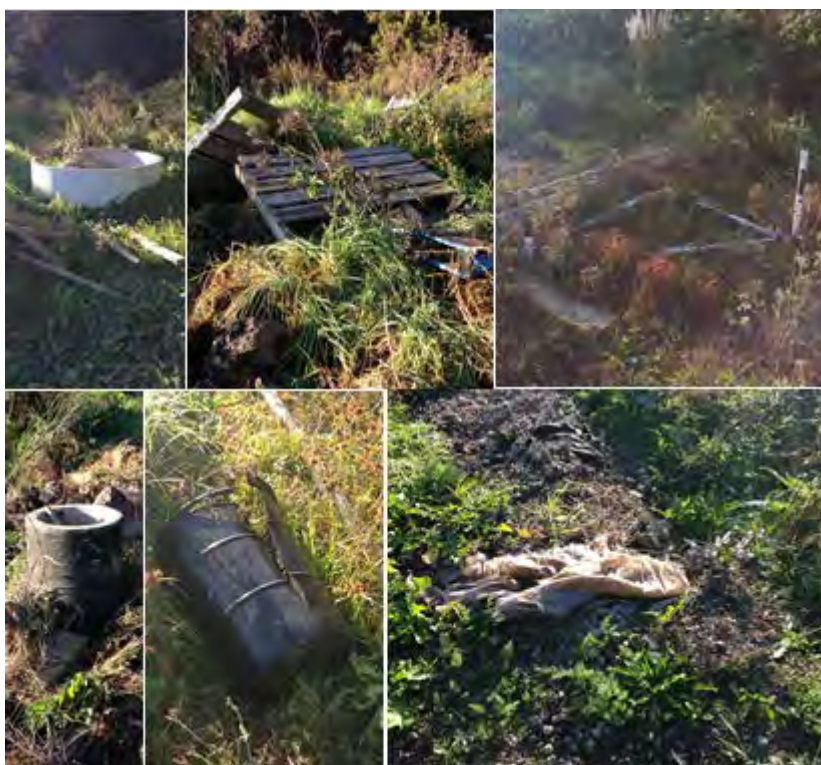
Photograph 5: Surface of former quarry pit to the south of the quarry parcel showing the different types of refuse material

The extent of the fill material was not documented at the time of the filling; and no analytical results are on file which characterise the nature of the fill material. There is potential that contaminated fill has been deposited onsite. There has reportedly been some 'waste' material dumped in the former quarry area at 1011 Mt Eden Road. Investigation prior to site redevelopment to determine nature and extent of fill materials is recommended;

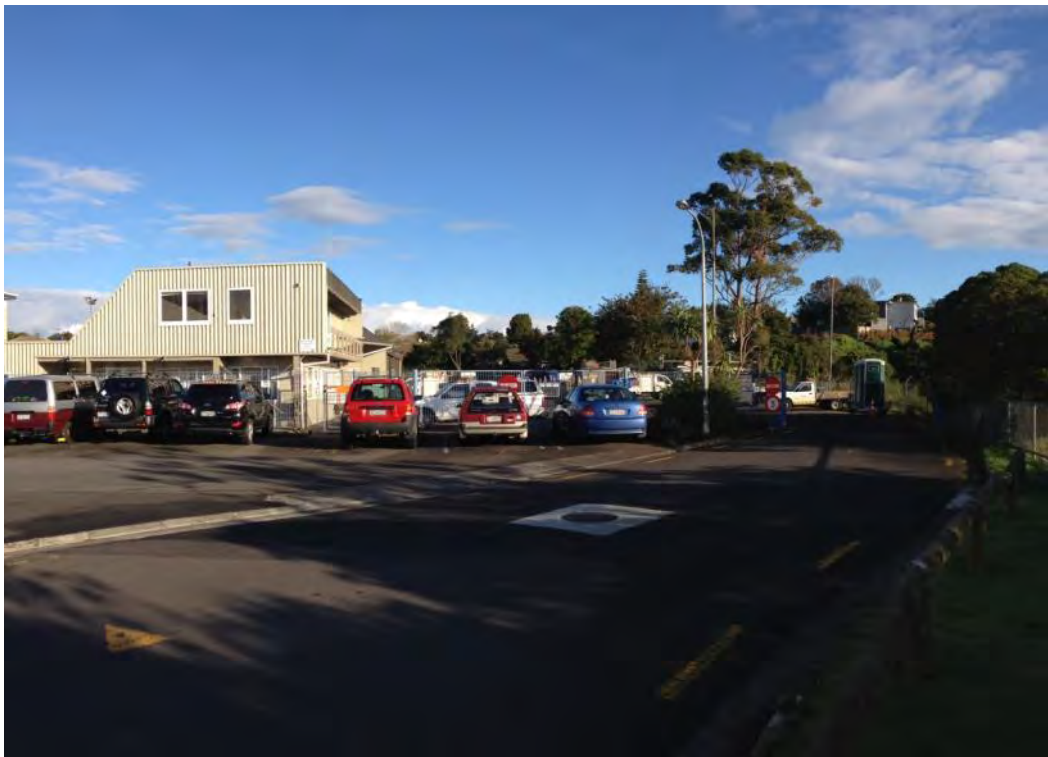
Photograph 8: Southern boundary of the 1011 Mt Eden Rd site facing west and showing the extent of the works depot compound.

- ✧ The nature of the materials used and stored onsite as part of the continued use of the area as a works depot (since 2005) suggests that investigation in this area should target hydrocarbons and potentially pesticide/herbicide contaminants. In more recent years (since the 1996 aerial image) any spills or leaks of such chemicals is expected to have run-off into the reticulated stormwater network, but potential for ground contamination exists where the area may not have been previously sealed.

- ✧ Further, the level surface of the works depot compound suggests some cut or fill earthworks where material may have been imported to site. There is potential that contaminated fill has been deposited onsite. A discussion with a long-standing employee of the works depot is recommended, in order to accurately determine the type of chemicals and fuels stored here both now, and in the past. If these discussions indicate that discharge of contaminants to ground may have occurred during the historical occupation of the area, then further investigation may be warranted;

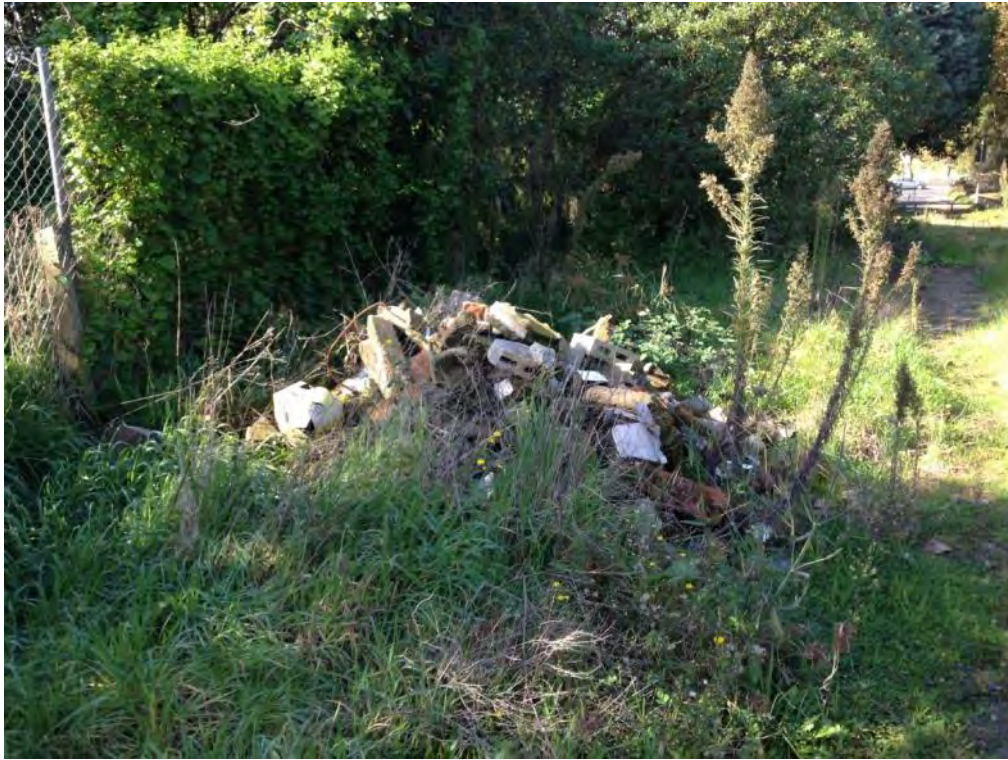
The former dog pound area is located to the north-east of the 1011 Mount Eden Road parcel. The area has gated vehicular access from Grahame Breed Drive. The compound is fenced. Some refuse material (bricks) was noted in this area; piled on the current ground level (see photos).

Photograph 11: Former dog pound area showing rubbish (bricks) pile

wood and bricks. This material is not expected to be of a hazardous nature, but may have leached contaminants onto the surrounding ground. Investigation is recommended;
