Flat Bush

Built Heritage Review

Reynolds
Associates

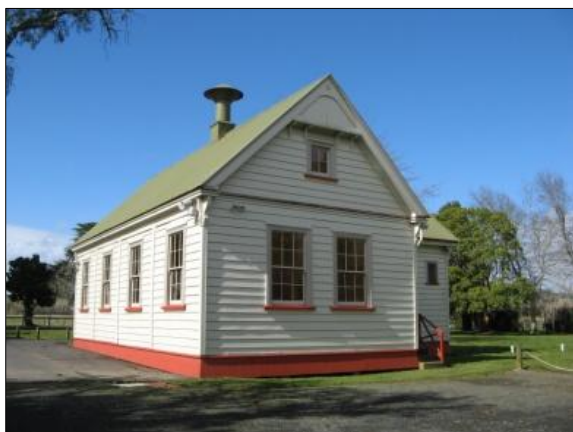
Fig 3: Flat Bush School built 1877 and moved to its present site from Baverstock Road in 1893.
Photo: Reynolds & Associates

The former Flat Bush School is currently scheduled (Group 1 exterior only), under criteria i, iii, iv, vi, vii, viii, ix, x, xiii, xiv, xvii, xix, xx.

The school is one of many standard plan buildings constructed by the Auckland Education Board immediately following the Education Act of 1877. Henry Alright was the Board's architect at the time and remained with the Board from 1877 to 1892 during the main period of school building expansion.⁹ Flat Bush school is a rare survival of that style from the time of the commencement of free, compulsory and secular education in New Zealand.

Few of these timber school buildings built to this plan remain in a good state of preservation. Many were replaced in the 1960s and 70s with standard "Nelson Plan" classrooms. What is remarkable in this case is the school's surviving 40 year's service as a hay-shed. A comparative and well-preserved example is the former Thames North (Tarurau School) which is also an HPT Category 1 registered historic place. The Mangere Central School, which preceded the Education Act by 7 years, and built to an earlier plan, is scheduled in Group 1 (exterior only).

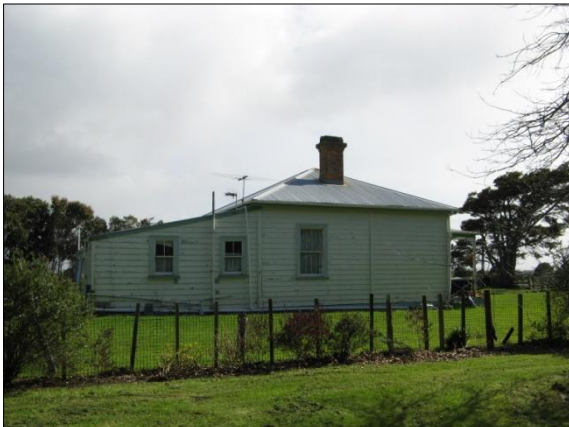
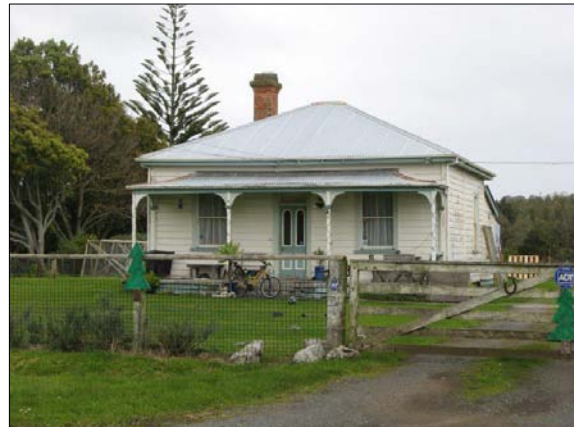
Figs 5 & 6: East and north elevations, Murphy Homestead/ Flat Bush School house in 2010. Photos: Reynolds & Associates

Murphy's Homestead, also known as the former Flat Bush School House, is scheduled in Group 2 (exterior only) under criteria i, iii, iv, viii, x, xi, xiii, xiv, xvii, xviii, xix, xx.

Well preserved, with a very intact interior it is a relatively rare example of a school teacher's house presumably built when the school was relocated here in 1893.

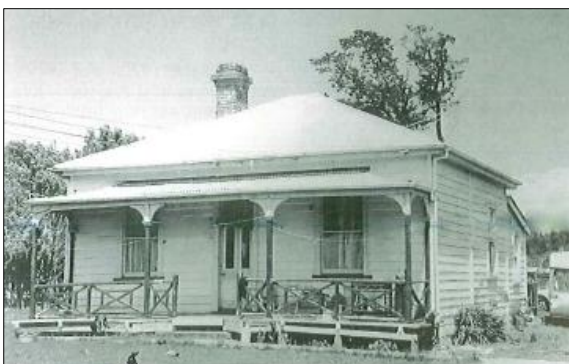
Fig 7: Murphy Homestead/ Flat Bush School house in 1997 when it still had its criss-cross verandah railing.
Photo: Papatoetoe Historical Society

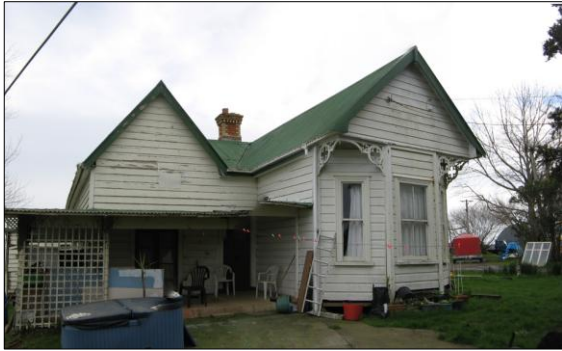
On the north elevation, the verandah roof has since been lowered, extended to the east and partly filled in with trellis on 2 sides. The French doors have been modernised and the front door has also been rebuilt with glazed panels inserted. The verandah floor has been replaced with a poured and plastered concrete slab.

Fig 8: North elevation August 2010
Photo: Reynolds & Associates

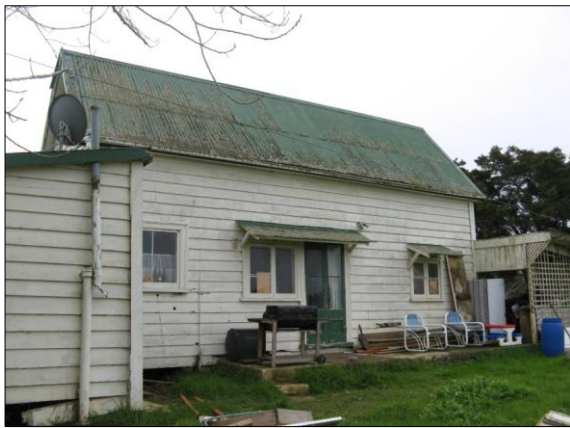
On the east elevation, two sets of C20th casement windows have been introduced into the wall, though an original French door and kitchen window, with early moulded architraves, remain.

Fig 10: East elevation
Photo: Reynolds & Associates

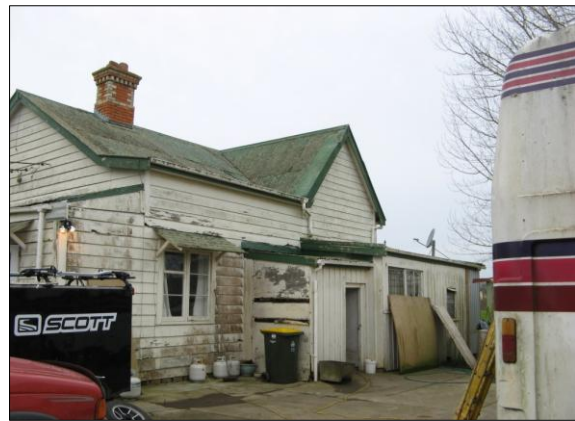
On the south elevation, the living room is now lit with modern casements and the bathroom/toilet area has a set of Cooper louvres and one window of fixed glass adjacent a fixed one 2-light sash.

Fig 11: South elevation
Photo: Reynolds & Associates

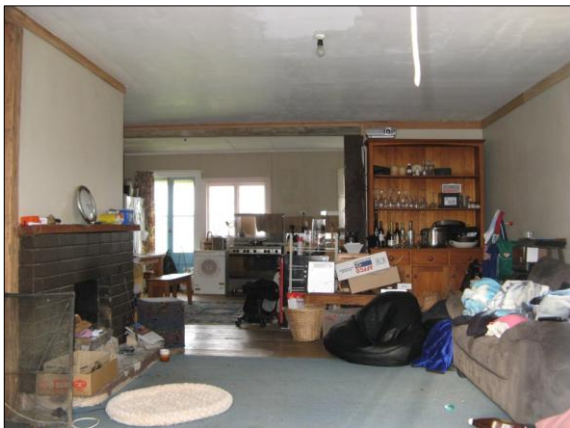
Fig 12: Rear living/dining area made up of three rooms across the back of the house combined.
Photo: Reynolds & Associates

The rear section of the house is now a single, roughly 'L' shaped room. The chimney to the front room (NW corner) has been removed and the bricks lie stacked in the implement shed.

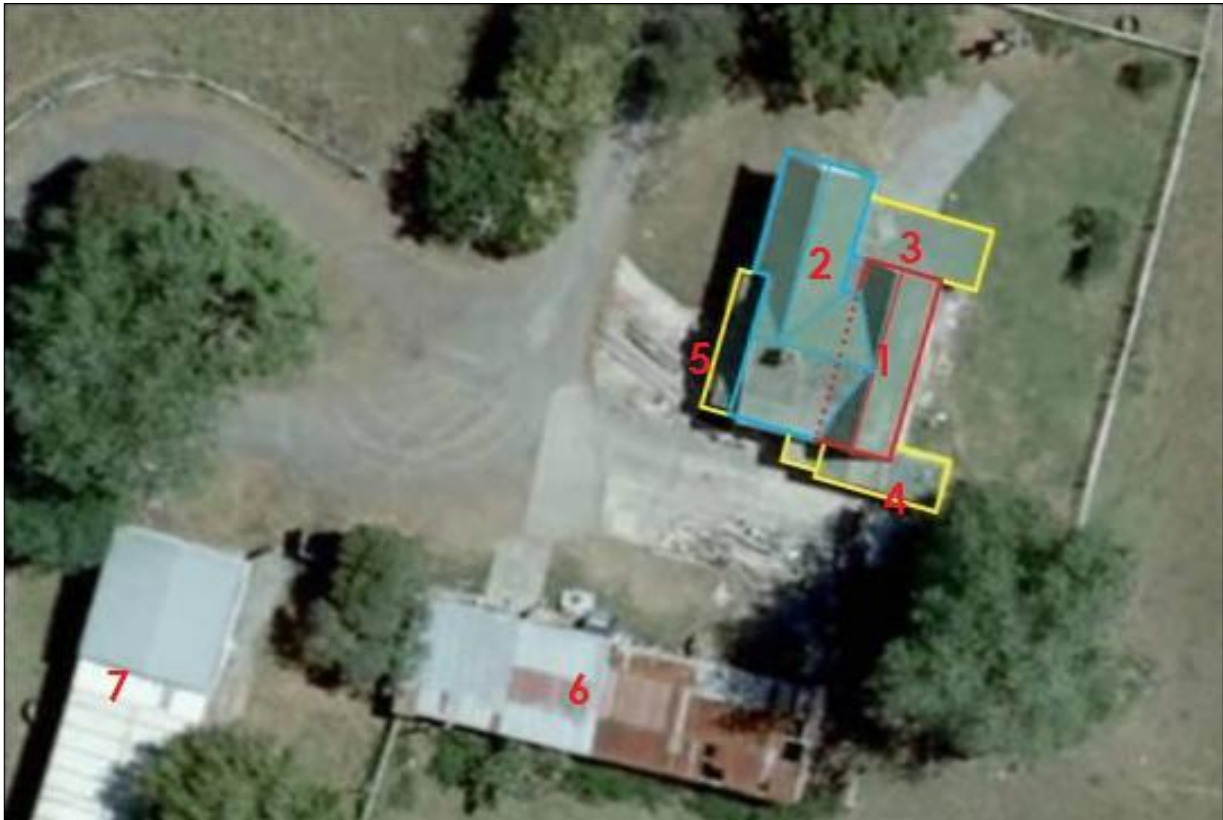
Fig 14: *Developmental stages of the cottage.*

1. Original cottage
2. Bay villa section and intersecting gable
3. 20th century lean-to addition extending past east facade
4. 20th century bathroom/toilet addition
5. 20th century remodelling of original west porch entry
6. Early 20th century implement shed
7. Late 20th century implement shed

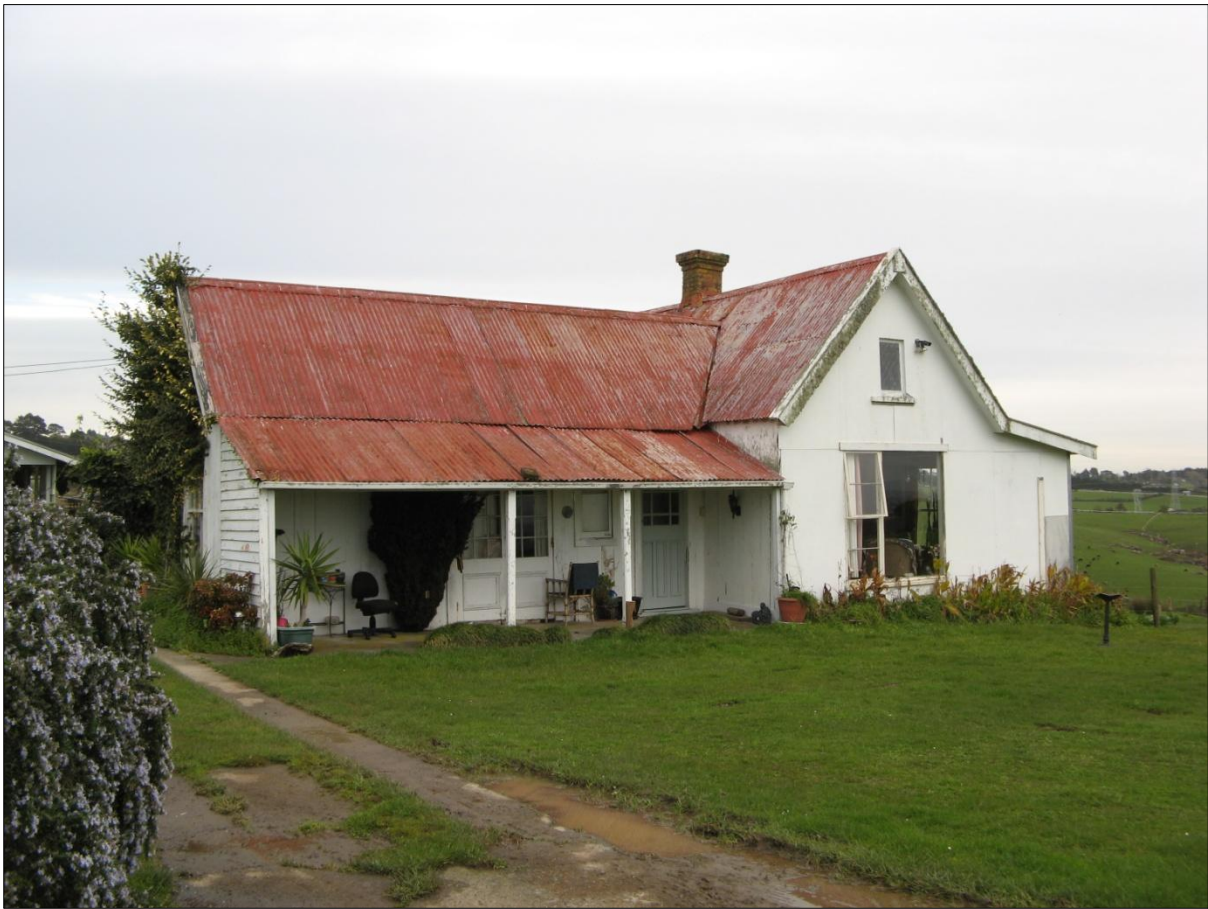
Fig 15: Major Bremner's cottage.

The core of the cottage is probably the wing to the west of the complex, overlooking Flat Bush. Intersecting with it is a second, probably later and slightly lower gable wing of similar construction.

The timber framed cottage, clad in approximately 9" x 1" (230 x 25 mm) dressed tongue and groove vertical boarding without battens, stands on timber piles and has a corrugated iron roof. Joinery is a mix of old and new. One gable end of each wing preserves one 6-light sash, the other having been replaced by a 2-light or single light sash. Windows in both gable ends of the west wing suggest either a loft or perhaps an original high open ceiling. Windows in the north and west elevations of the principal room are 2 light sliding sashes.

- That Major Bremner's cottage be considered for scheduling in Schedule 6A Buildings and Objects to be Protected in the District Plan.
- That the Scheduling include the cottage's interior subject to access and further assessment.

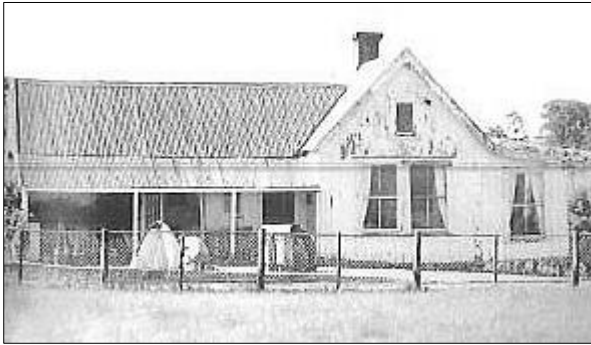
Fig 16 : North elevation Major Bremner's cottage photographed in 1997. Photo: Papatoetoe Historical Society.

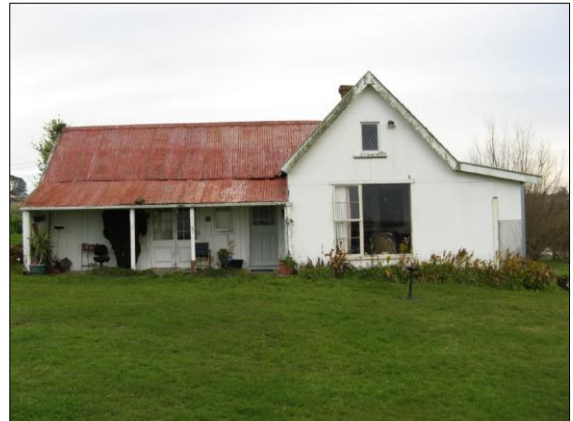
The pair of 2-light sliding sash windows in the north elevation has been replaced since 1997 by a large fixed central window with 2 top hung casements on the left side. This section of the north elevation has been re-clad in fibrolite, and this extends along part of the west elevation.

Fig 17: North elevation, 2010 showing altered windows and re-cladding. Photo: Reynolds & Associates

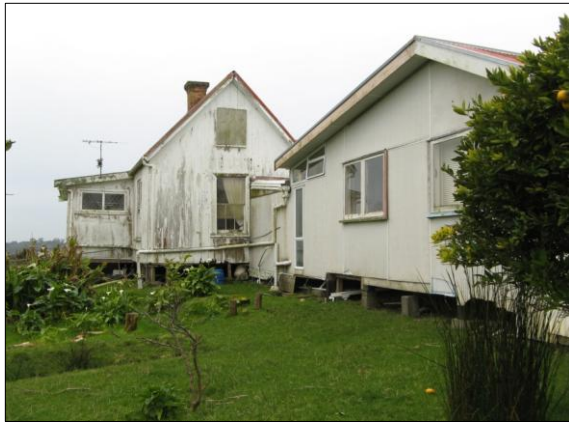
What appears to have been an early lean-to to the north wing has been extended to the south and now links with a C20th extension containing bedrooms.

Fig 18 : South elevation showing addition. Photo: Reynolds & Associates

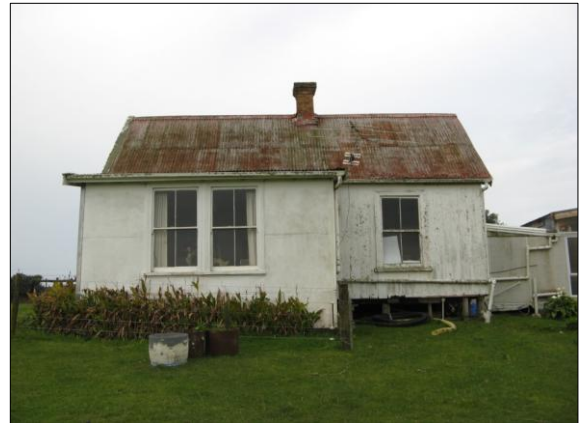
The living room extension on the west side, lit by a pair of 2-light sliding sash windows has the appearance and form of an earlier verandah which may have been later reduced and filled in to extend the principal living room.

Fig 19: West elevation part re-clad in fibrolite. The balance is clad in T&G. Photo: Reynolds & Associates

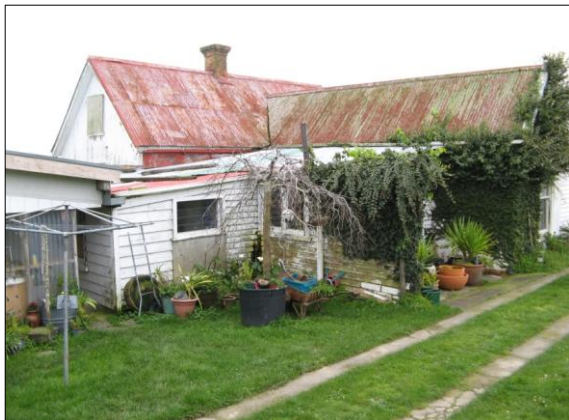
Fig 20: View from NE showing service lean-tos. Photo: Reynolds & Associates

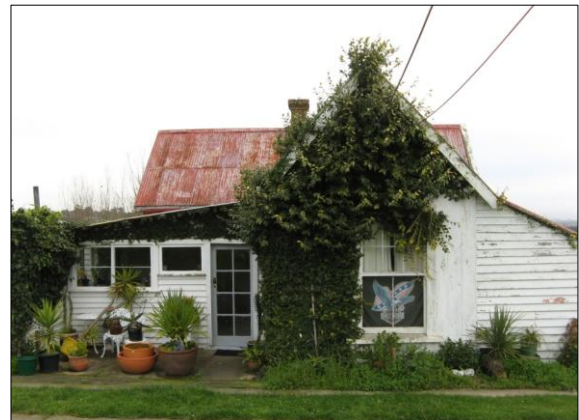
Fig 21: East elevation. Photo: Reynolds & Associates

The building is very low to the ground on the east side, and in need of repainting and re-piling. Several window sashes are severely weathered and require repair.

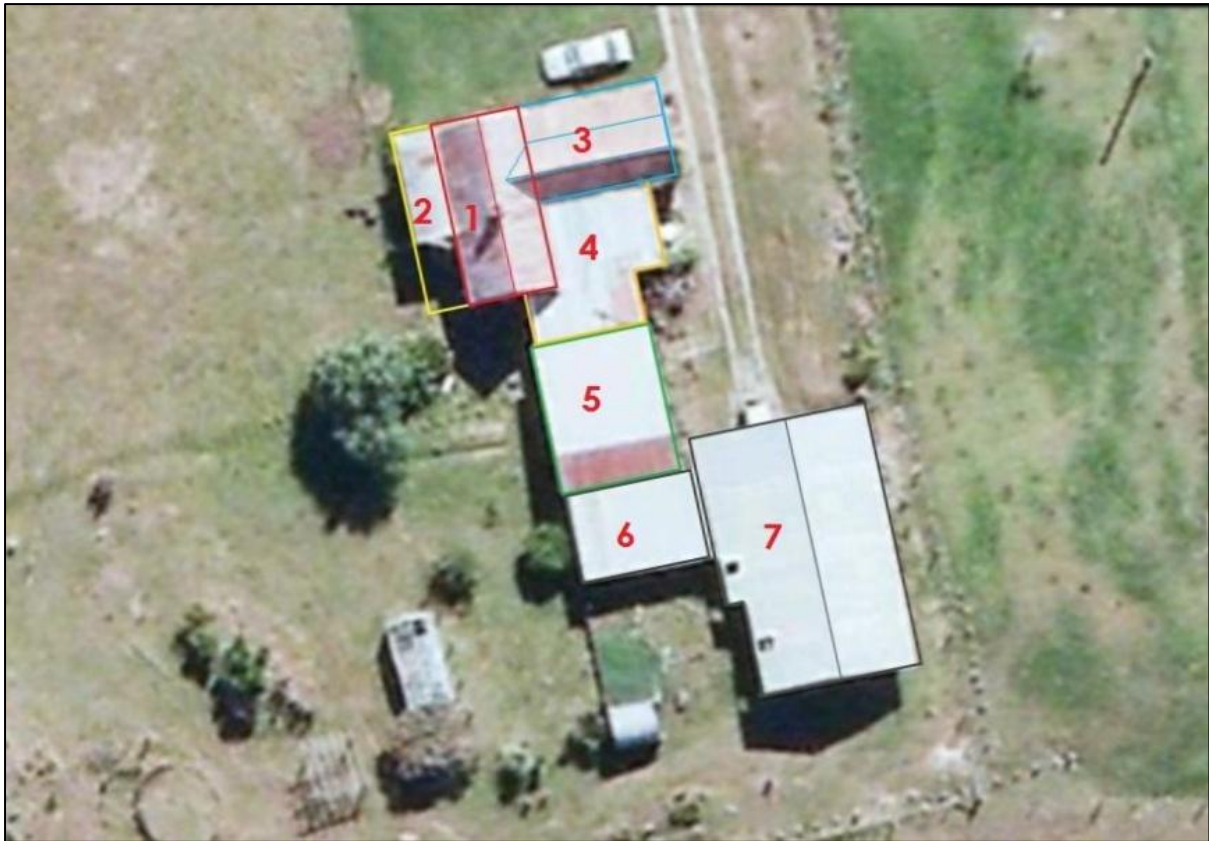
Fig 22 : Possible development of the cottage .

1. Original cottage
2. Possible original verandah, later reduced and closed in
3. Gabled addition with verandah to north
4. Lean-to addition housing kitchen
5. 20th century added living accommodation
6. 20th century carport
7. 20th century garage
