Ground Contamination Investigation
Flat Bush School Road, Flat Bush

Ministry of Education

October 2014

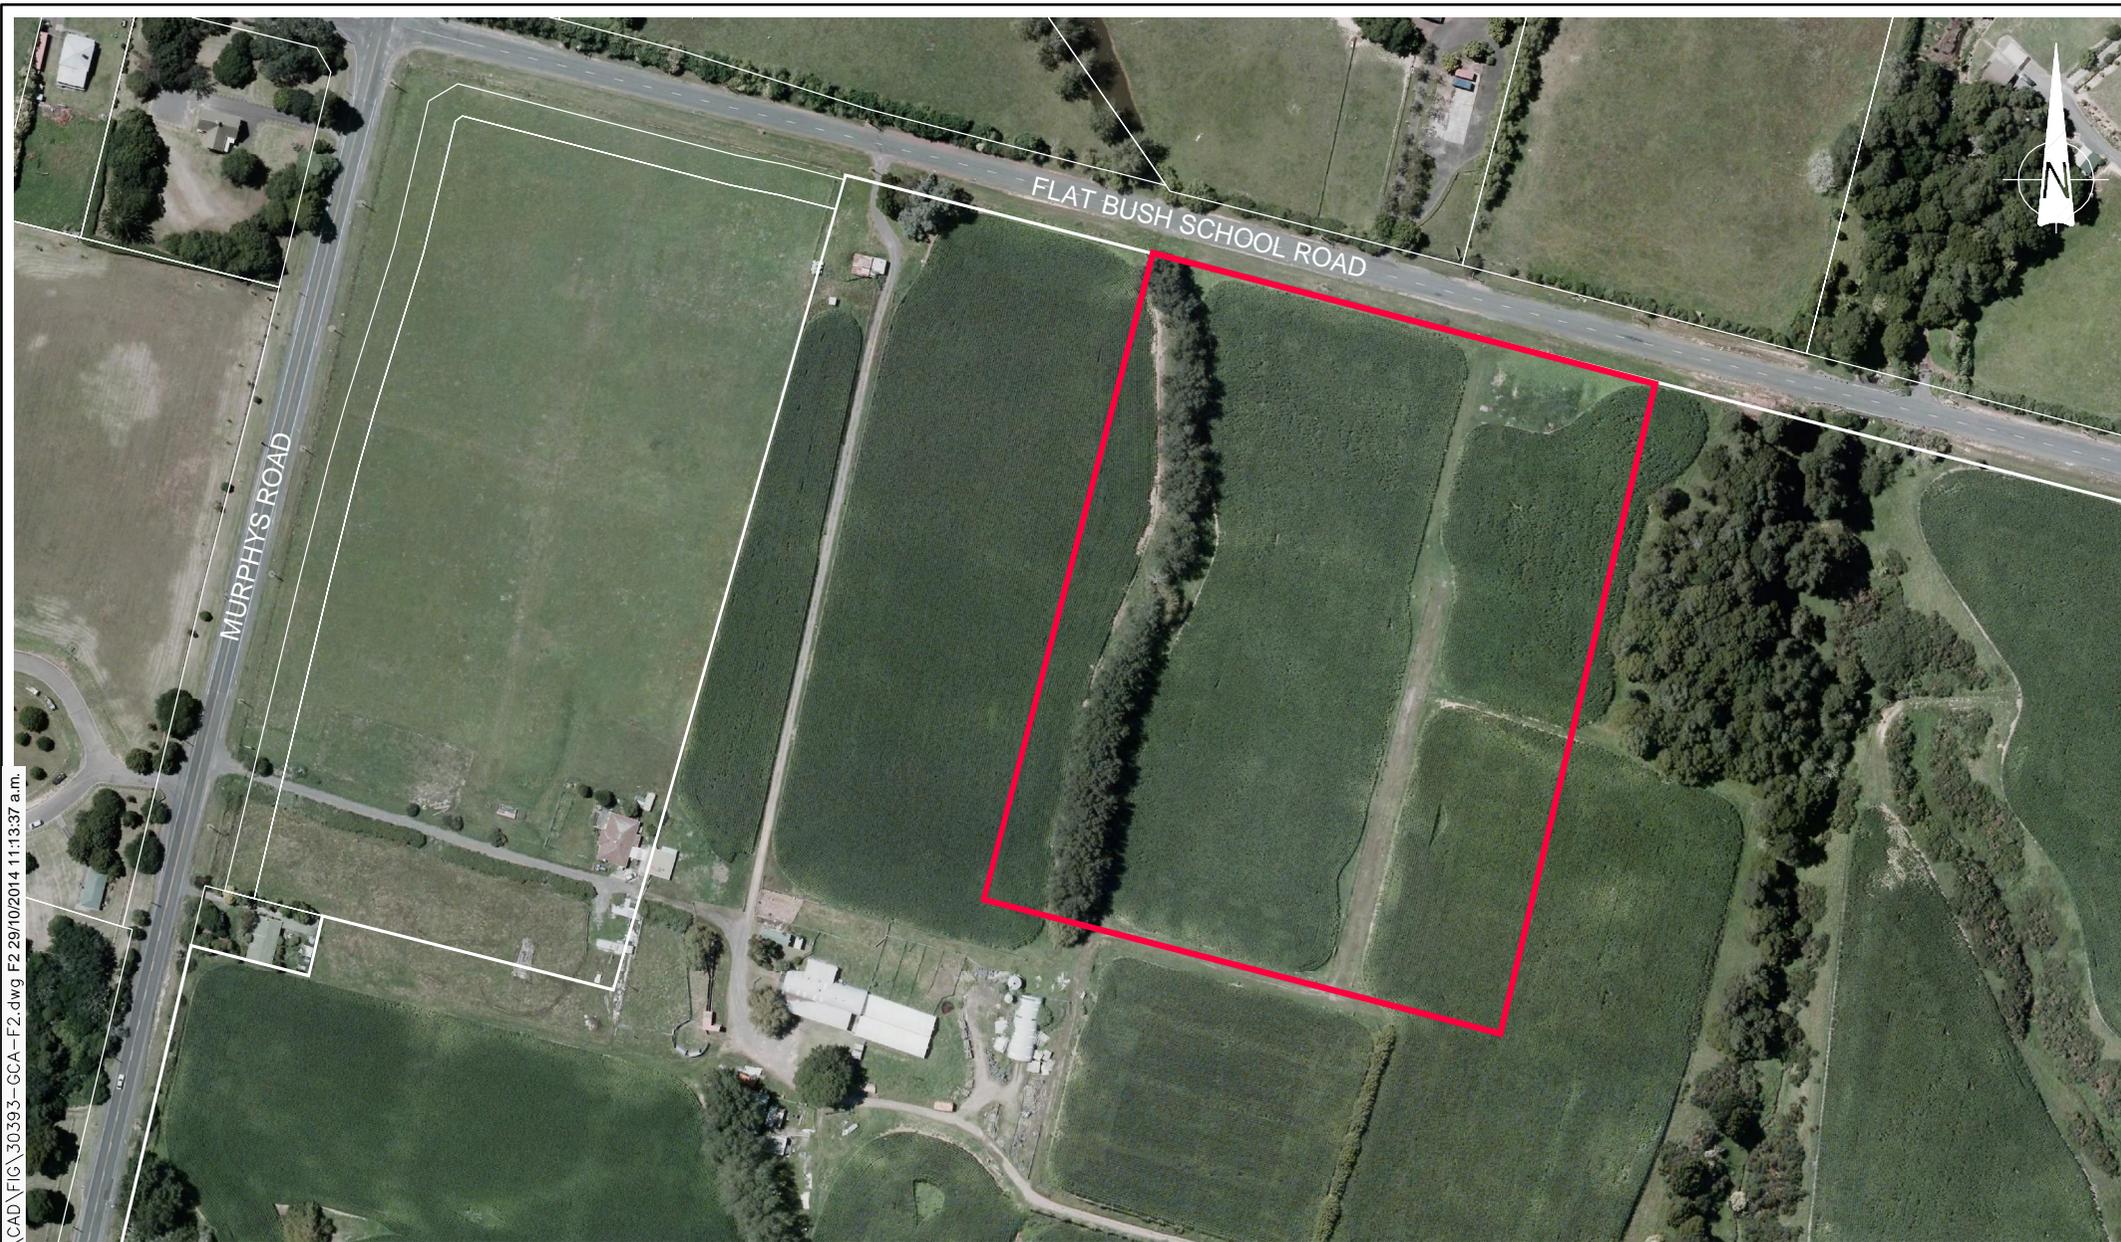
FIG. No. Figure 2

The activities, potential contaminants and an assessment of the likelihood, potential magnitude and possible extent of contamination are presented in Table 4.1 below. The inferred locations of these activities are presented on Figure 2, Appendix A.

The site is located on the southern side of Flat Bush School Road in Flat Bush, approximately 325 m east of the intersection with Murphys Road. It is legally described as PT Lot 2 DP 48950, Certificate of Title 69A/619. The site is approximately 3.71 ha in size, rectangular in shape and currently forms part of a larger agricultural property, addressed as 187 Flat Bush School Road. The site details are summarised in Table 2.1 and the site layout is shown in Figure 2 provided in Appendix A.

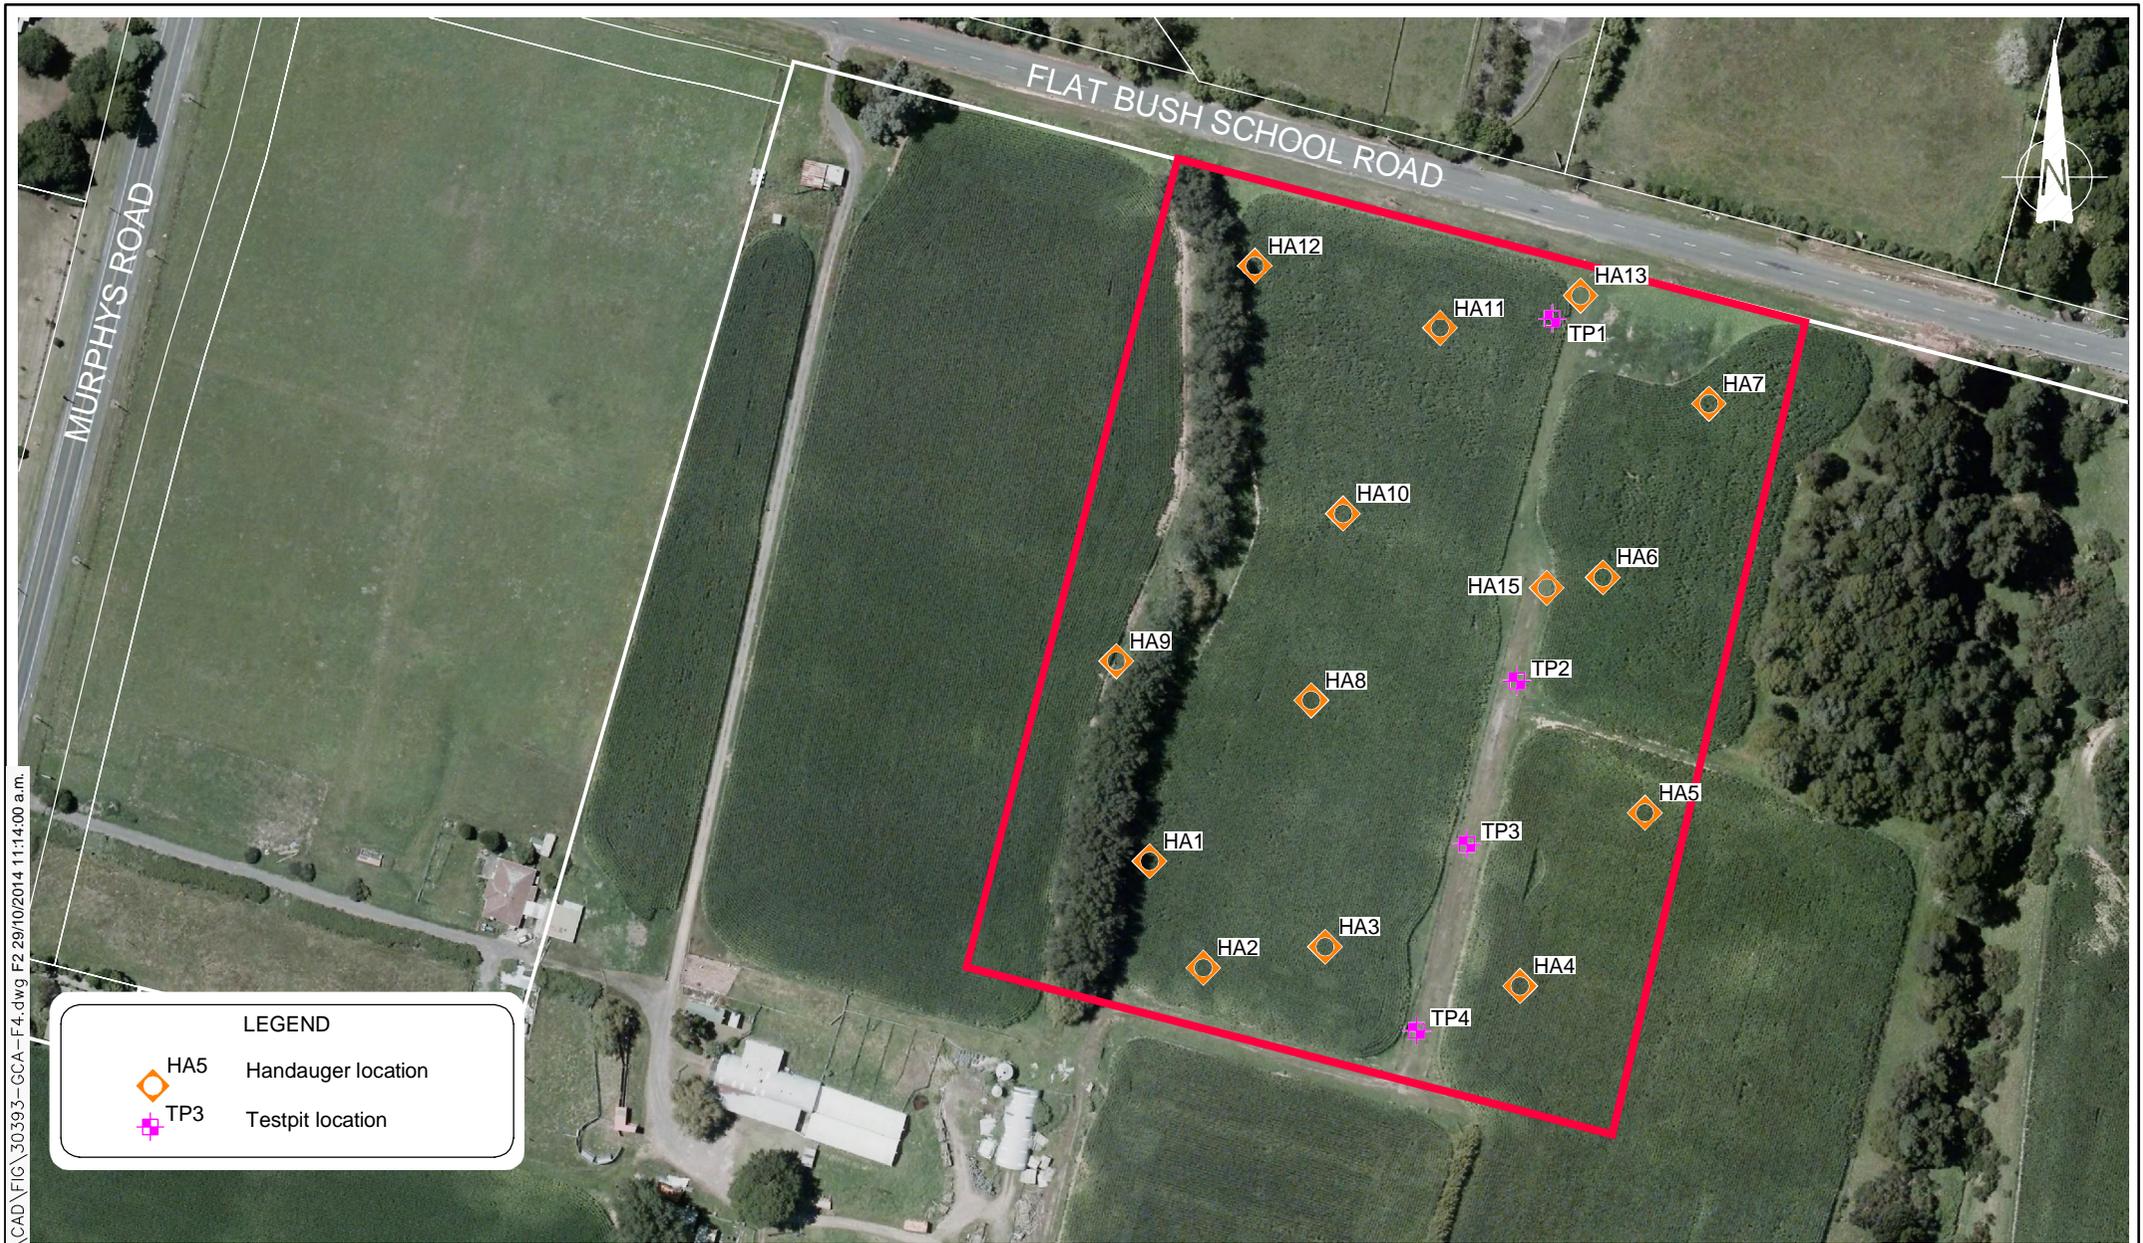
A T&T environmental scientist completed a site walkover inspection on 9 October 2014. Relevant observations made at the time of the inspection are summarised below. Key site features are shown on Figure 2, Appendix A and selected photographs are included in Appendix C.

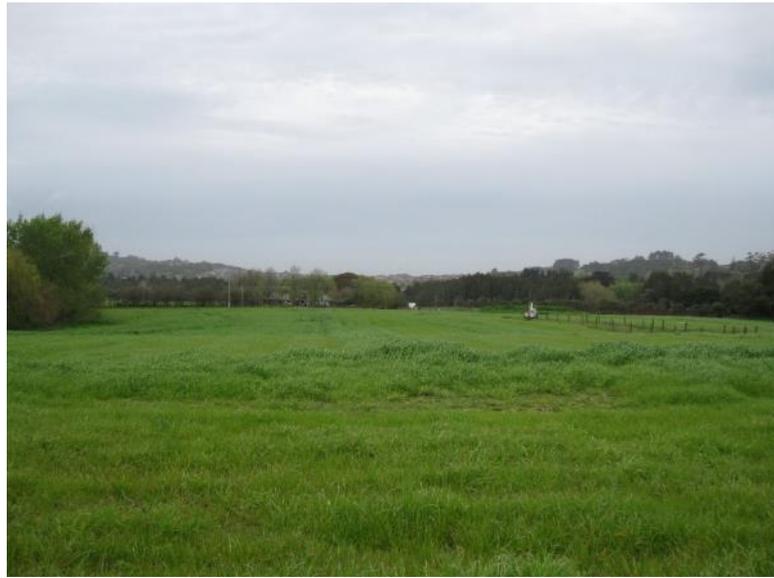
Photograph 2

Site; looking south-west from stockpile. Showing farm track (centre) and trees along stream (left).

- The site has an undulating topography and overall slopes down to the north towards Flat Bush School Road (Photographs 1 and 2, Appendix C);
- A large soil stockpile (approximately 200 m³ to 300 m³) is present in the northern portion of the site, adjacent to Flat Bush School Road (Photograph 3, Appendix C). This stockpile contained soils consistent with natural materials identified on site and is therefore assumed to have been sourced from the site (e.g. during construction of farm tracks, etc.);

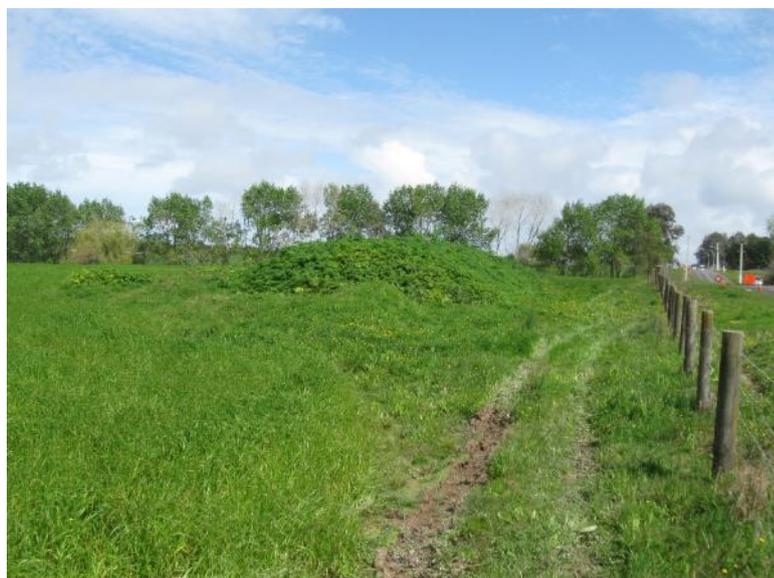
Photograph 4

Farm track (covered in grass), looking north.

- The site is predominantly covered in a pastoral grass crop which was seeded earlier in the year and was overdue for harvesting. The farm tracks are also covered in grass and weeds (Photograph 4, Appendix C);

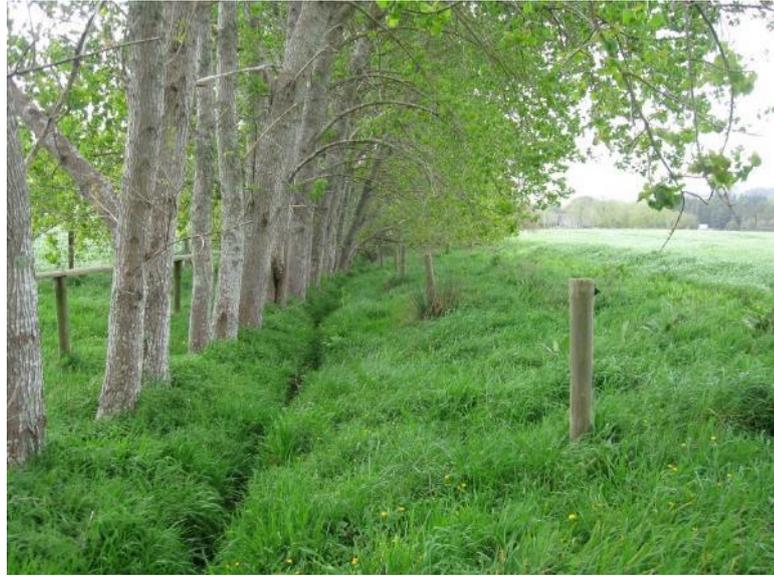
Photograph 8

Evidence of weed spraying along northern boundary of site. Looking west along Flat Bush School Road.

- Vegetation on site (including grass, trees, and weeds) appeared to be in good health. Evidence of weed spraying was observed at occasional places around the perimeter of the site (Photograph 8, Appendix C);
