Arboricultural Assessment - Northern Interceptor Project: Notices of Requirement

8 August 2016

Client:	Watercare
Project:	Northern Interceptor
GSNZ Ref.:	M13787/2
Proposed:	Construction, operation and maintenance of Watercare's proposed Northern Interceptor

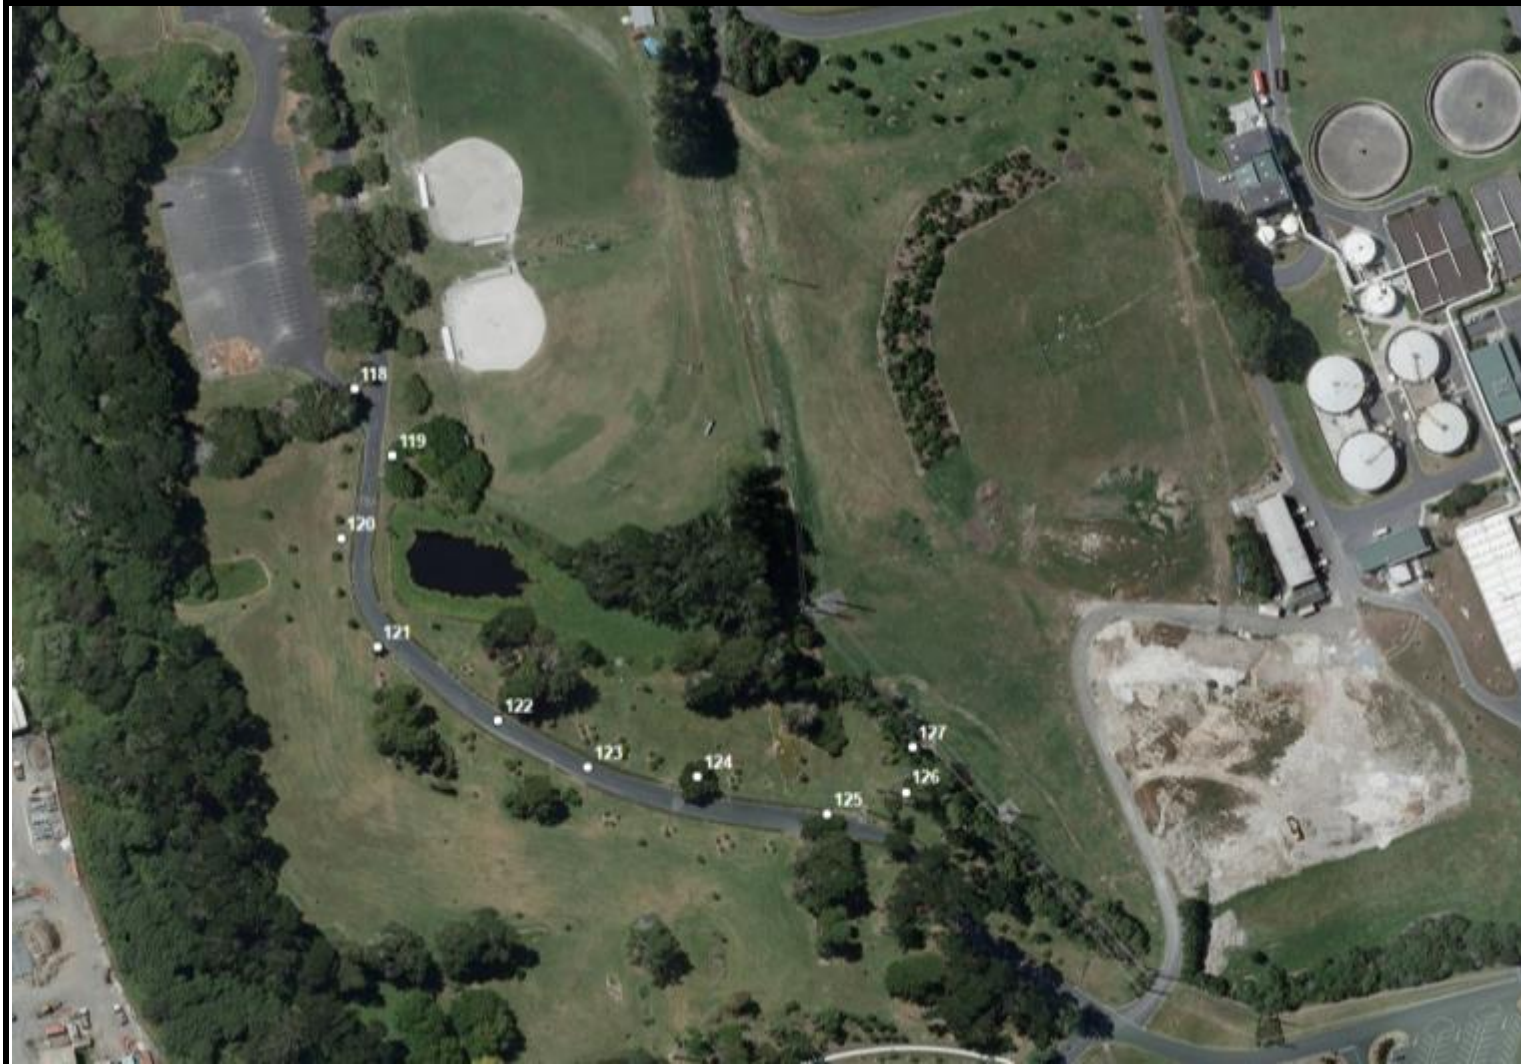
Bush Road to Rosedale WWTP

125	Monterey cypress (<i>Cupressus macrocarpa</i>)	Mature	Multiple trees forming shelter belt.
126	Monterey pine (<i>Pinus radiata</i>)	Mature	Multiple large mature trees scattered within proposed work zone. Some low hanging branches.
127	Mixed native: ti kouka (<i>Cordyline australis</i>), karo (<i>Pittosporum crassifolium</i>), tarata (<i>Pittosporum eugenoides</i>), karaka (<i>Corynocarpus laevigatus</i>), puriri (<i>Vitex lucens</i>), totara (<i>Podocarpus totara</i>), puka (<i>Meryta sinclairii</i>), ngaio (<i>Myoporum laetum</i>), kahikatea (<i>Dacrycarpus dacrydioides</i>)	Early-mature	Various native trees growing within the Rosedale Waste Water Treatment Plant forming shelter belt.
