Barriers to fish passage in the Hunua Ranges and Waharau Regional Parks : a comprehensive survey

June 2004 TP236

Prepared by:
Grant E Barnes

ARC Technical Publication 236 (TP 236)
Auckland Regional Council
Auckland

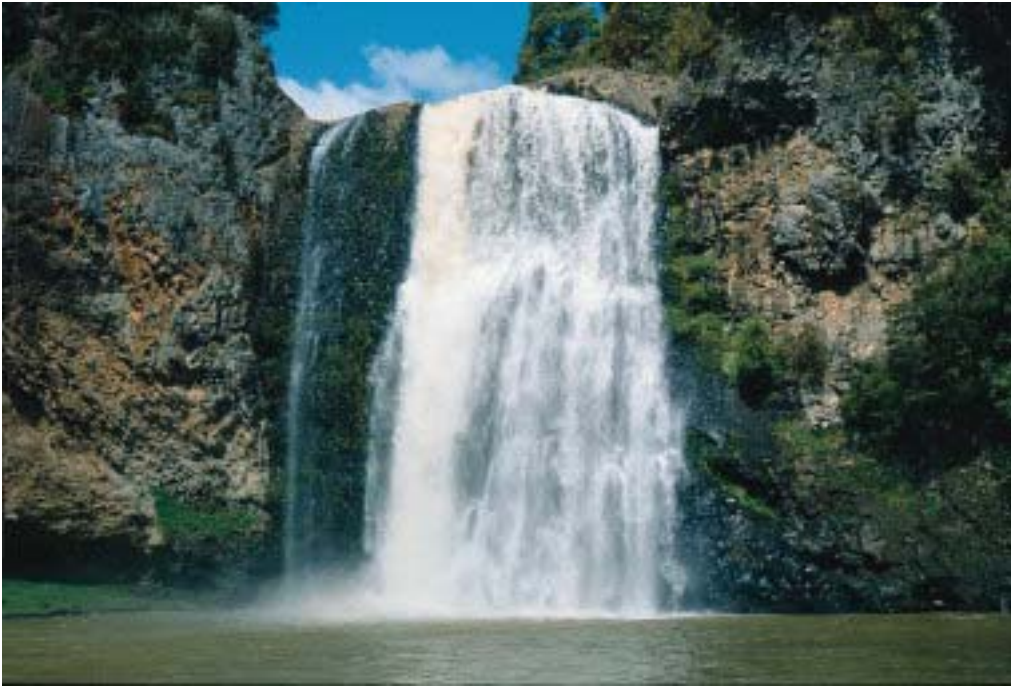
A high diversity of fish species have been found within the Mangatawhiri and Wairoa Rivers, despite the Hunua Falls (~30 m) located on the latter (Figure 2) (Bioresearches 1988; NIWA 1993; Joy and Death 2003; Slaven 1990). Galaxiids are well represented in both rivers, though largely absent from the Mangatangi catchment upstream of the waterflow gauging weir (Rowe and Chisnall 1993). The threatened shortjaw kokopu has been found in two tributaries of the Mangatawhiri River, below the Upper Mangatawhiri Dam (G. Barnes pers obs.). Longfinned and shortfinned eels, and Crans

Figure 2: Hunua Falls (~30 m) located downstream of the Cosseys and Wairoa water supply dams on the Wairoa River, Hunua

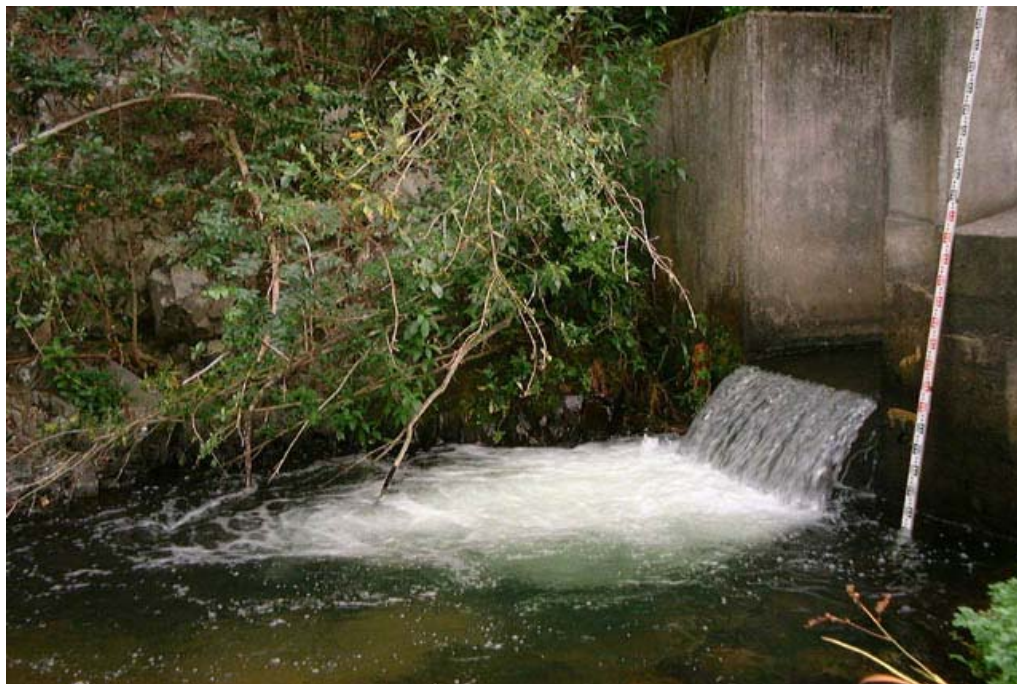
Three flow gauging weirs, located on the Wairoa and Mangatawhiri rivers and the Mangatangi Stream, are operated by Watercare Services Limited and provide hydrological information for each respective waterway relating to their operations. Only the structure located on the Mangatangi Stream was considered to be a significant barrier to fish passage (Figure 4)

Figure 4: Water gauging flume located on the Mangatangi Stream, approximately 2 kilometres downstream of the Mangatangi Dam.

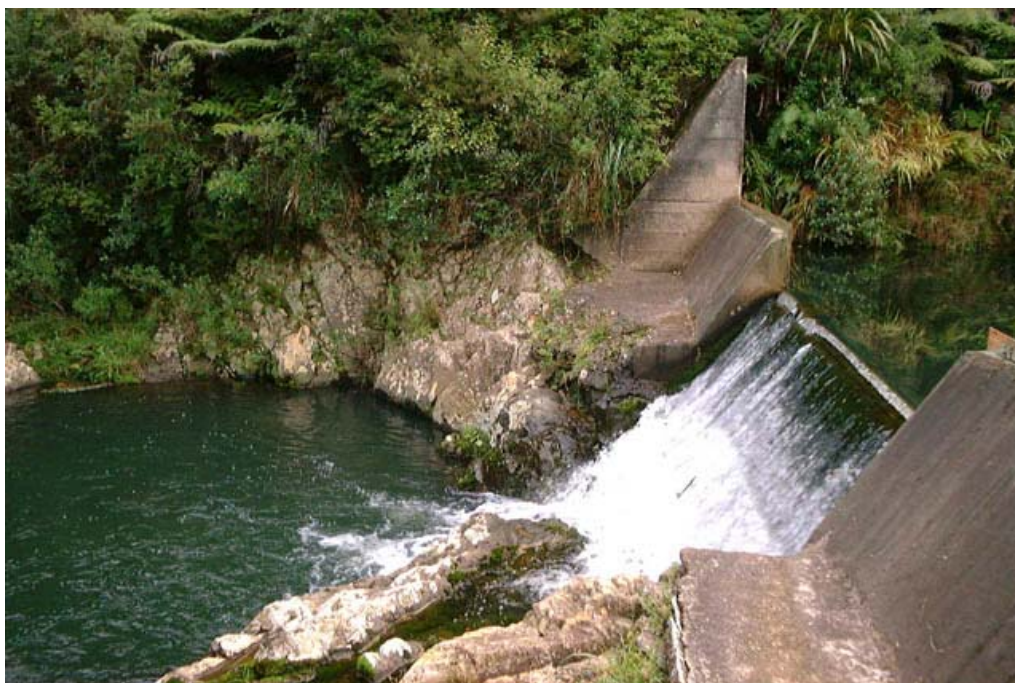
The Mangatawhiri weir is a barrier to swimming species, however surveys of fish communities by NIWA in 1993 downstream of the structure indicated that natural physical barriers within the Mangatawhiri gorge (rapids and waterfalls), result in a different fish in the upstream and downstream river system (Figure 5) (Tonkin and Taylor 1999).

Figure 5: Watercare Services Limited water flow gauging located on the Mangatawhiri River. Photograph taken on the true left bank.

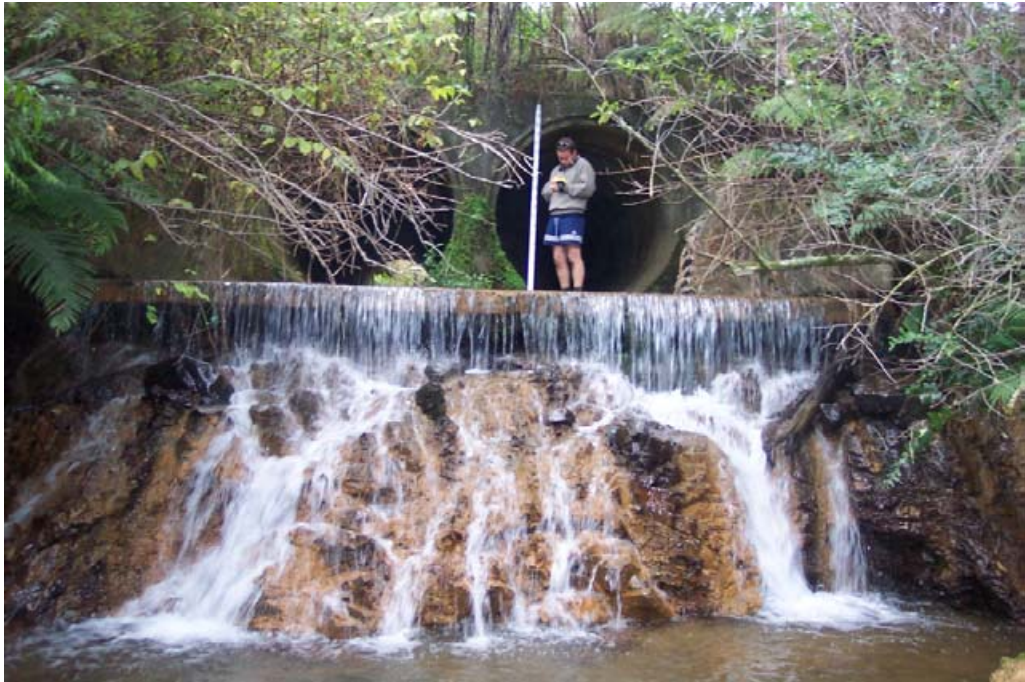
This study confirmed the presence of three potential fish passage barriers on the main stem of the Milne Stream (upstream of the Mangatawhiri gauging weir), of which one was a significant barrier to fish passage (Figure 6). Conversely, no barriers to fish passage were identified on the Acheson Stream. Despite the 2004 fish survey recording the same species diversity (longfinned eel, koaro, banded kokopu, shortjaw

Figure 6: Perched twin culvert the Milne Stream below the Mangatangi Hill Road.
