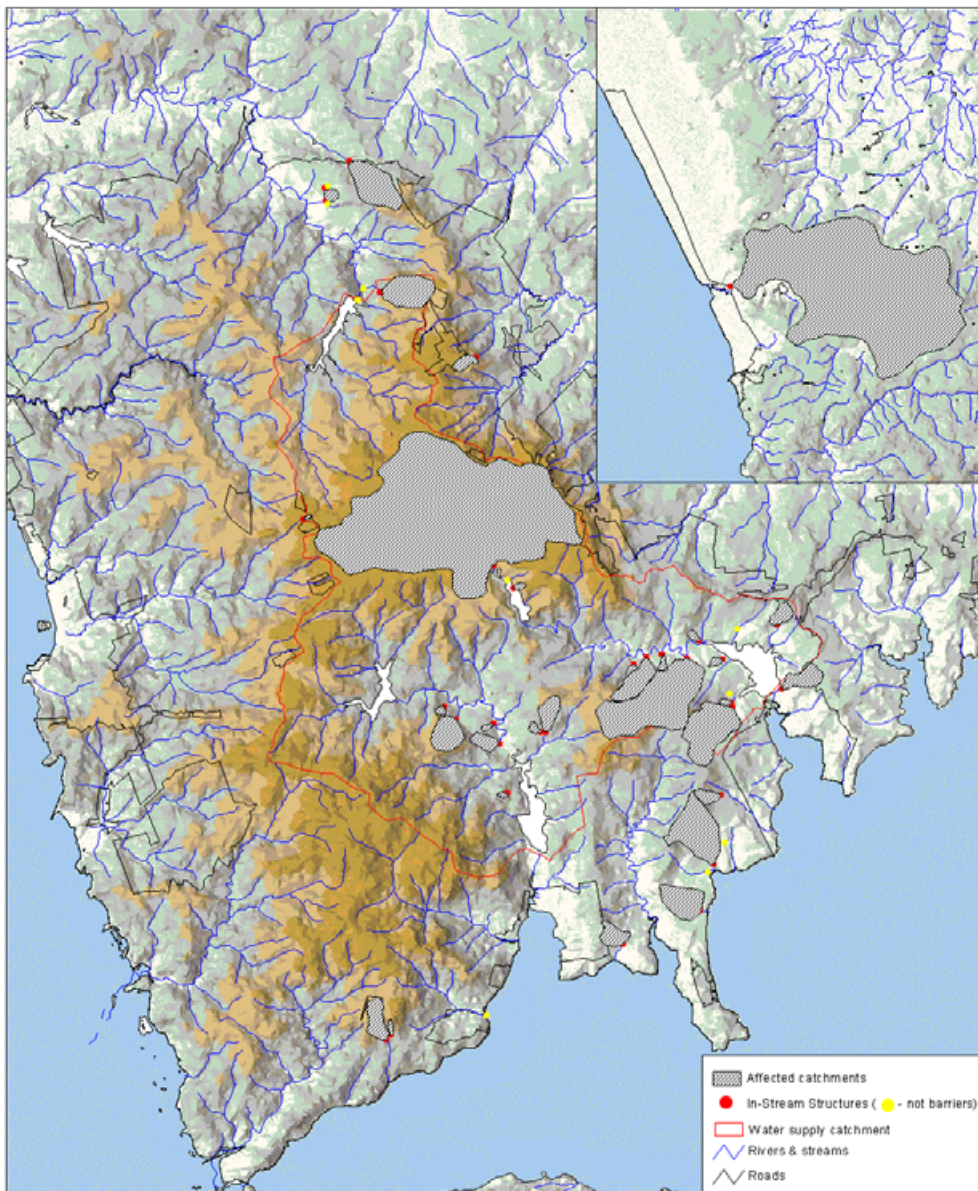
**Figure 3: Location of catchments affected by downstream structures assessed as barriers to fish passage during most hydrologic conditions.**
