## 4.2 Other Waitakere Ranges Regional Park Sites

## 4.3 Muriwai Regional Park

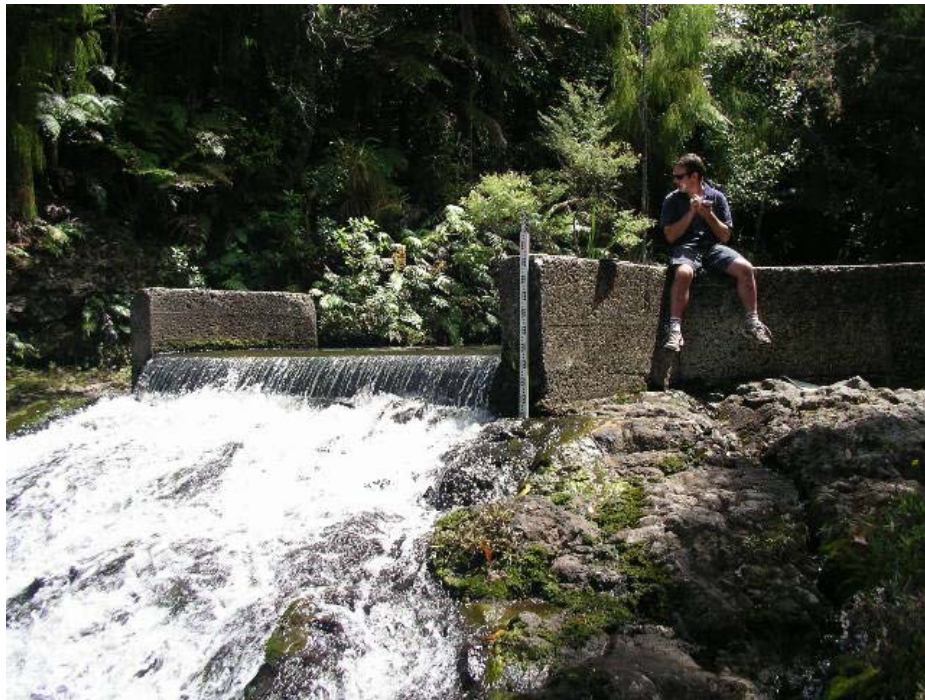
Figure 4: Watercare Services Ltd water gauging flume located on the Nihotupu Stream, approximately 200 m upstream of the Upper Nihotupu Reservoir.

The highest priority for fish passage restoration are the barriers located on streams within the Huia and Nihotupu catchments with substantial upstream native fish habitat. The Nihotupu gauging flume warrants immediate attention because the large area of catchment affected upstream. Similarly, the structures located at the base of the Waitakere Reservoir and the obsolete gauging weir on Island Stream should be removed.

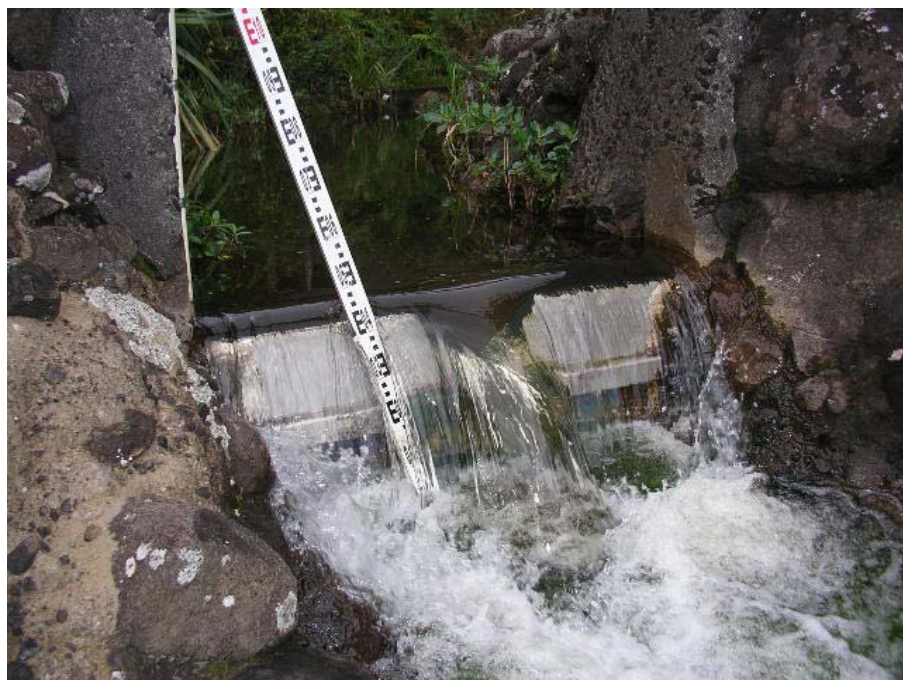
Figure 5: Obsolete water flow-gauging weir located on the Waitakere River above the Waitakere falls, but below the dam.

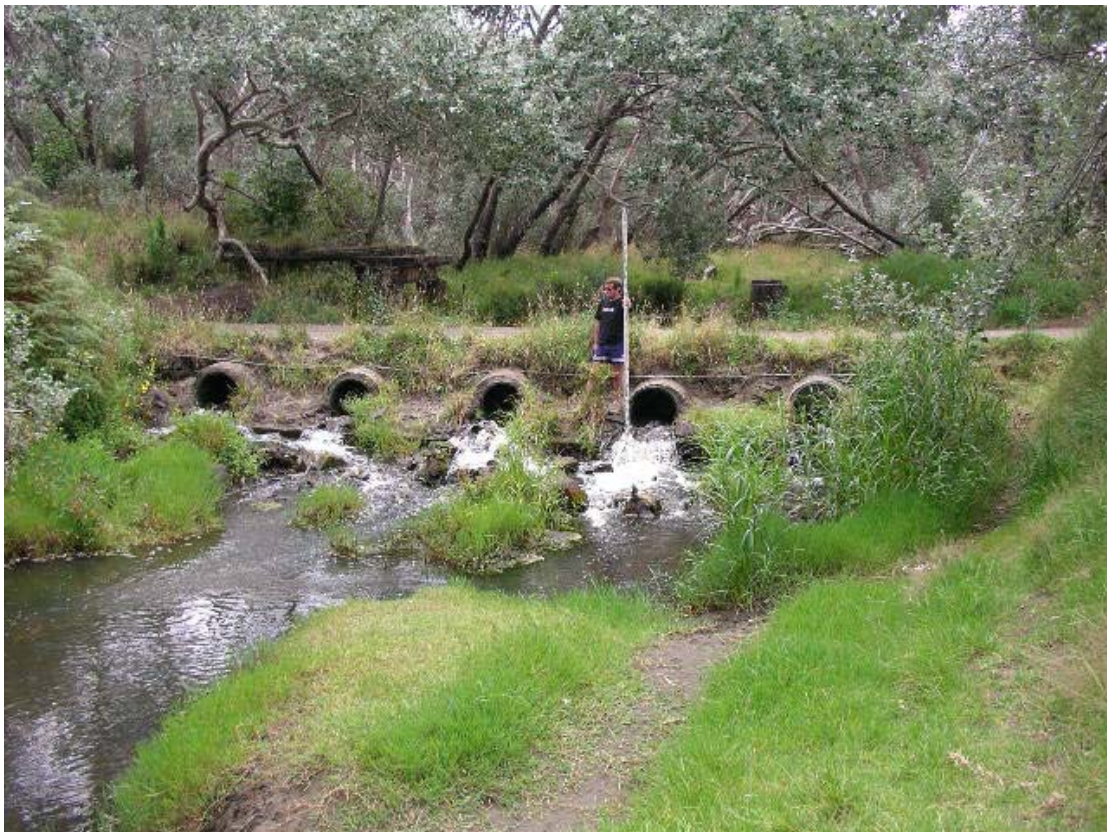
One structure was evaluated; a ford located on the Okiritoto Stream. The ford consists of five 0.6 m diameter culverts in parallel and provides access to forestry operations beyond the Okiritoto Stream (Figure 6).

The structure was assessed as a barrier to fish passage under most flow conditions despite an ARC fish survey in 1998 capturing non-climbing species (redfinned bully, inanga and common smelt) above the structure. During the present survey several culvert outlets were perched and water velocity through all barrels exceeded 1.5 metres per second, well in excess of the recommended  $0.3 \text{ m}^3 \cdot \text{s}^{-1}$  (ARC 2000).

Figure 6: Five barrel ford located on the Okiritoto Stream within the Muriwai Regional Park

The single barrier within the Muriwai Regional Park could be fixed relatively easily and would restore fish passage to the lower and middle reaches of the Okiritoto Stream. Modification to the structure to reduce barrel velocities and the repair of outlet conditions is recommended.

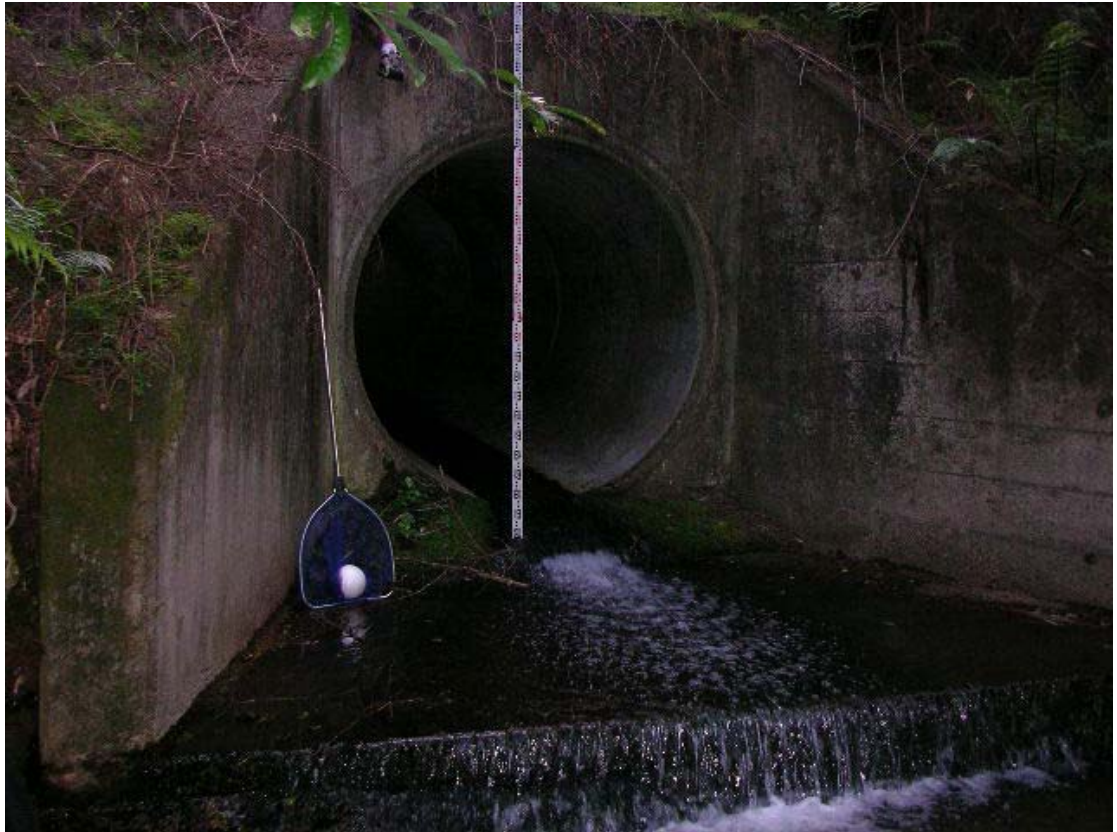
**Figure 6: Perched culvert on the Island Stream below the Nihotupu Dam Road. Note both culvert outlet and apron are perched.**
