Papakura Stream Assessment and Management Study

October TR 2008/014

Auckland Regional Council
Technical Report No.014 October 2008
ISSN 1179-0504 (Print)
ISSN 1179-0512 (Online)
ISBN 978-1-877483-55-4

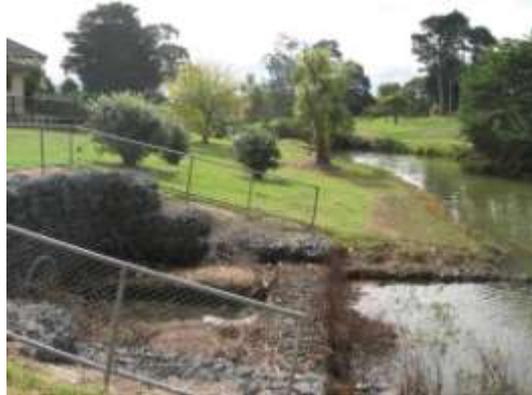
Existing stormwater outlet downstream of Gairloch Road

Potential locations for treatment wetland systems include a lineal area between the stormwater outlets upstream and downstream of Gairloch Road (see Photo 1), and opportunities to direct upper catchment pipe networks to an open expanse beside YKK NZ Limited building, where there is evidence of an existing overland flowpath or ephemeral spring (see Photo 2).

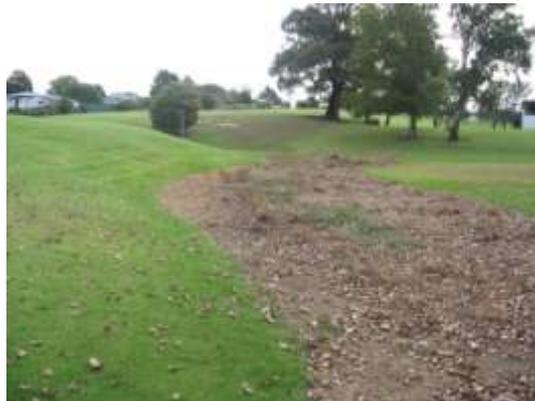
Photo 2.

Opportunities for treatment wetlands below the YKK NZ Ltd Building

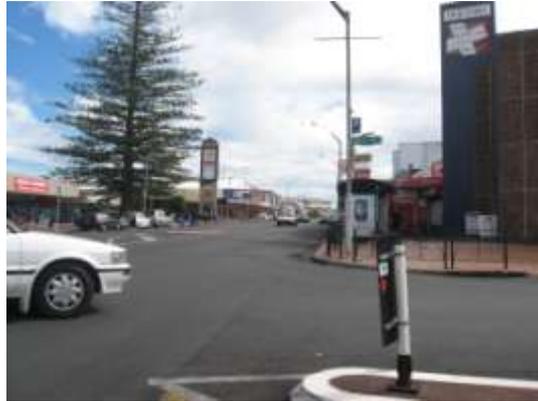
Photo 3.

Manurewa Town Centre.

The Neild Road sub-catchment (Figure 24) begins in lower density residential areas on the Papakura ridgeline, extending through the Manurewa town centre (see Photo 3), crossing Great South Road and the Northern Trunk Line, through dense residential areas of the Papakura lowland environments, to commercial properties adjacent to the Papakura Stream.

An LID retrofit of the Manurewa Town Centre streetscapes has the potential to improve traffic calming, and enhance urban design and landscape amenity values (see photo 3). This would also link with restoration proposals for tributary 'A' which flows in piped sections south of the Manurewa Town centre and across Alfriston Road.

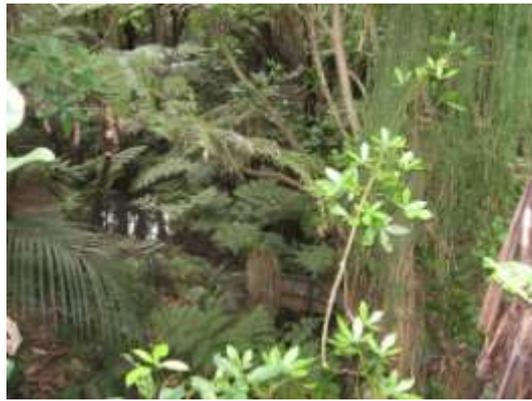
Photo 4.

Podocarp-Broadleaf forest remnants on private land in the upper tributaries.

The sub-catchment includes the Manukau Christian School and large areas of open space, including Beaumont Park, Gallaher Park, Tadmor Park and the Manurewa Native Bush Reserve. The bush reserve is contiguous with remnant vegetation in open upper tributaries (see photo 4), which supports mature native broadleaf-podocarp remnants, with substantive native understorey.

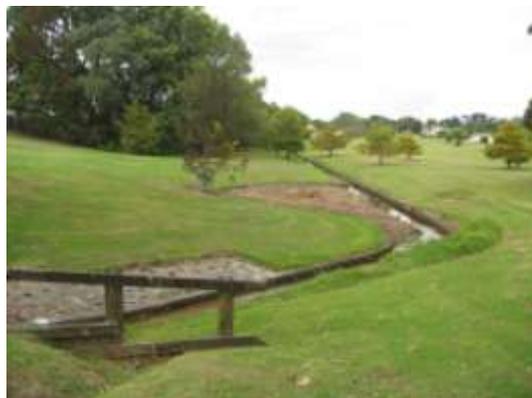
Photo 5.

Existing modified watercourse and treatment wetland through Beaumont Park

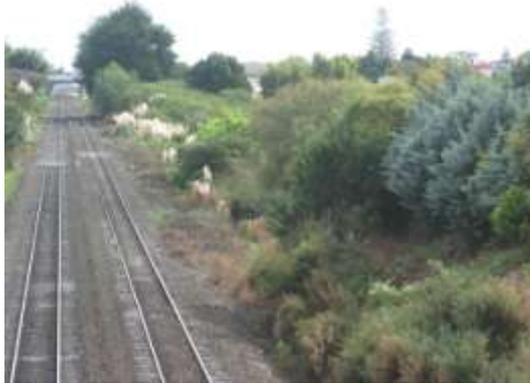
Railway embankments and associated right of ways support open channel in degraded forms.

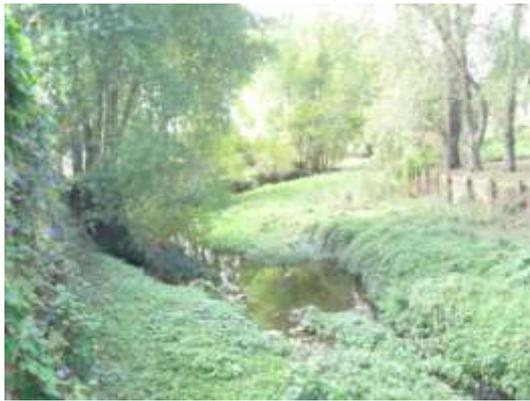
Photo 7.

A confined channel directs stream flows past commercial areas.

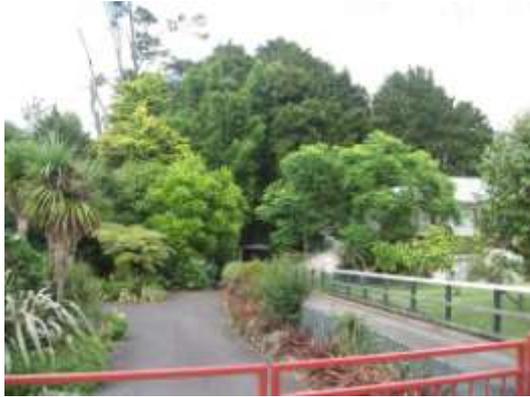
Photo 8.

Upper tributary to Greenmeadows with mature totara and mixed exotic vegetation.

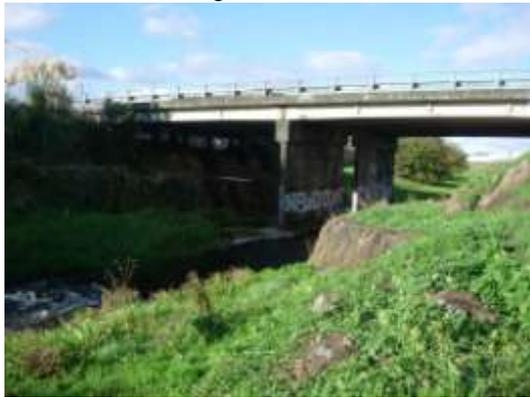
Photo 9.

The Papakura Stream and SH1 over-bridge with Greenmeadow outlet to the lower left.

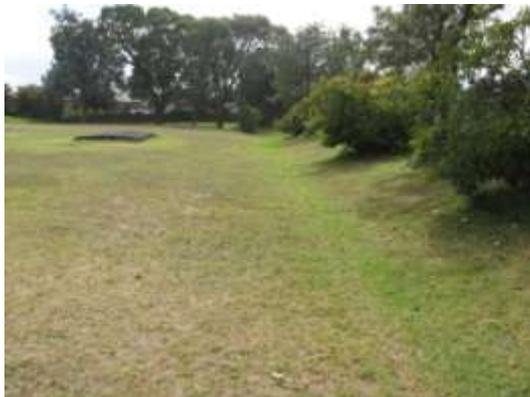
Photo 10.

The overland flowpath at Greenmeadows Intermediate

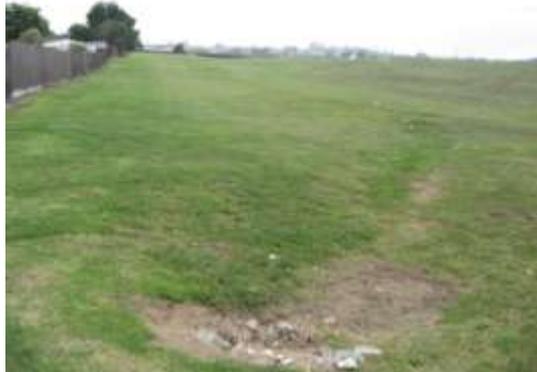
Randwick Park overland flowpath

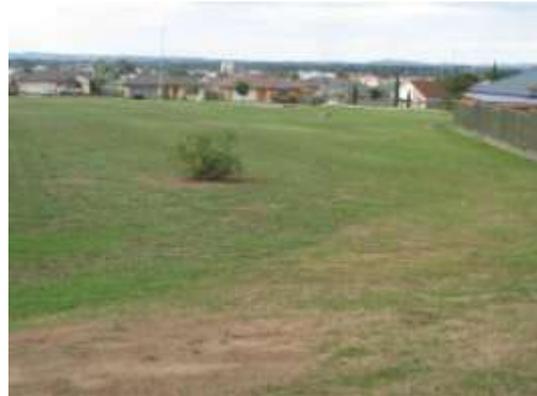
Photo 12.

An overland flowpath coincides with a residential reserve above Alfriston Road.

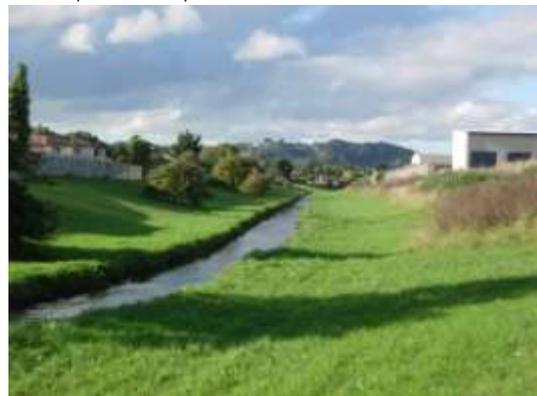
Photo 13.

The stream corridor with open flood plain, similar in character from Porchester Road to SH1.

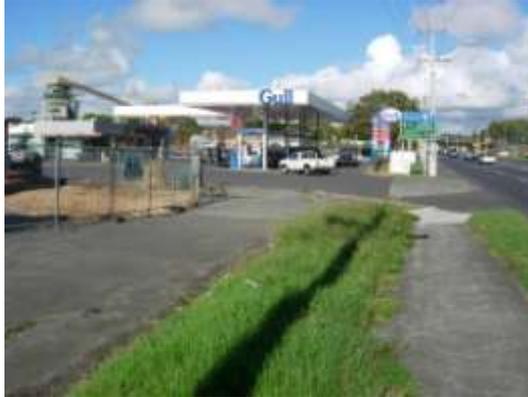
Photo 14.

Opportunities for LID retrofit and streetscape improvement along Great South Road.

Specific opportunities exist for LID treatments along Great South Road (see photo 14) and connecting with ascribed potential LID retrofits in the Lincoln sub-catchment. The Great South Road artery is wide and generally lacking in streetscape vegetation, with ample opportunities for an improved pedestrian experience associated with street trees and bioretention gardens.

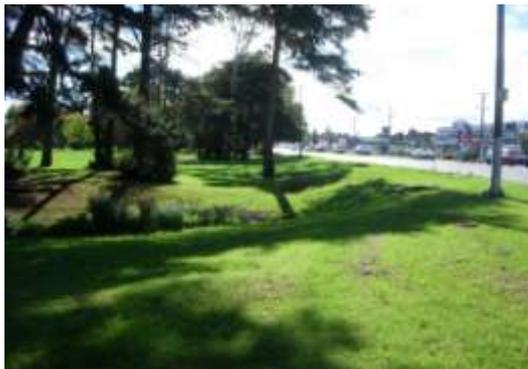
Photo 15.

The overland flowpath above a pipe system between Manukau Golf Course and Great South Road

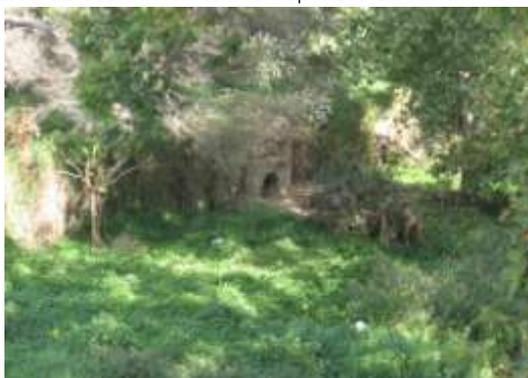
Photo 16.

Outlet of the Papakura sub-catchment to the Papakura Stream.

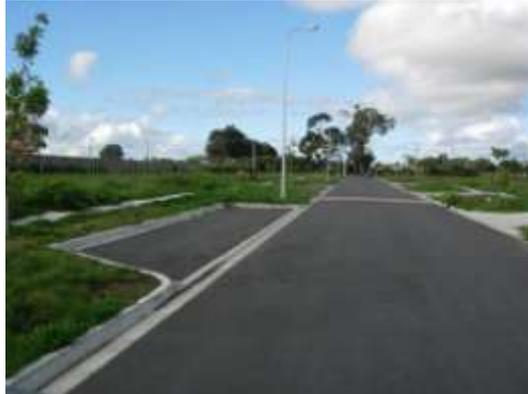
Photo 17.

New residential development adjacent to commercial land-use (no evident LID treatments).

The Takanini North sub-catchment (Figure 29) comprises the commercial and residential land to the west of the Northern Trunk Line. Much of the land remains undeveloped. Low impact treatments have been articulated in residential areas, such as swales and permeable paving, but these have been executed without a robust streetscape design. More recent development has omitted these features (see photo 17).

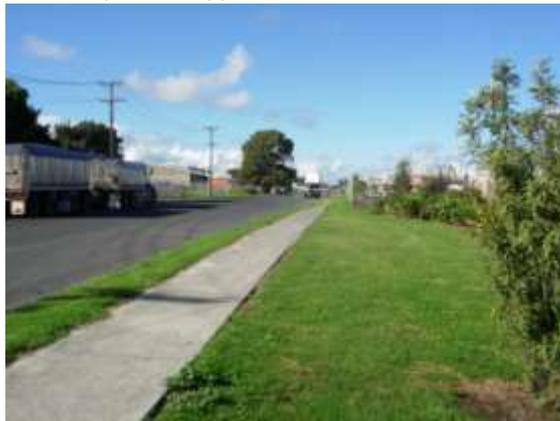
Photo 18.

Wide commercial streets represent opportunities for surface water conveyance

The catchment sits above the drained and consolidated Takanini peats and therefore surface water runoff occurs in significant quantities. A string of stormwater wetlands connect through the mid-catchment to provide for flood attenuation and primary treatment for both residential and commercial land-uses. There are opportunities to combine these centralised locations with open channel conveyance systems associated with wide commercial streets (see photo 18).

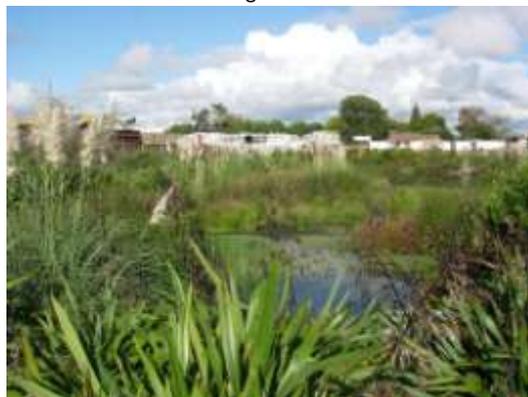
Photo 19.

Constructed stormwater wetland at Oakleigh Avenue borders commercial and residential areas.
