Assessment of the ecological condition of 32 lakes in the Auckland Region using LakeSPI

February 2009 TR 2009/011

NIWA Client Report: HAM2009-012
February 2009

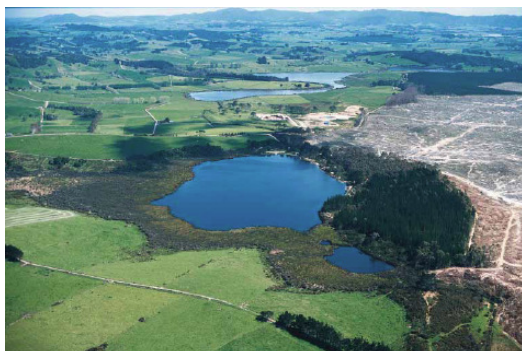
4.1.1 Lake Tomarata

Lake condition:	Excellent
Stability:	Improving
Lake Max Depth (m):	6
Lake type:	Dune

Currently the high LakeSPI Index of 78% (Table 2) reflects native plant dominance, the absence of invasive weeds, and the relatively deep extent of vegetation. Beds of native charophytes were recorded to depths of up to 4.3 m and were present at all survey sites around the lake. Marginal emergent vegetation was well developed except at those sites in the north-east where steep sand dunes extended into the lake.

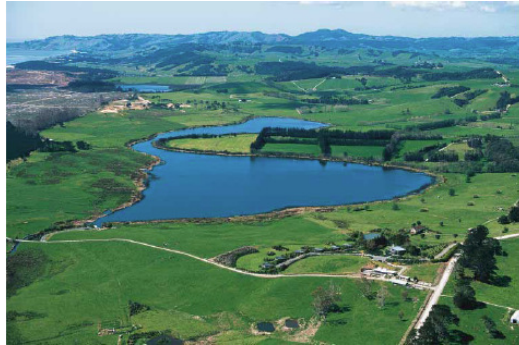
4.1.2 Lake Spectacle

Lake condition:	Non vegetated
Stability:	Stable
Lake Max Depth (m):	7
Lake type:	Dune

Lake Spectacle has not had submerged vegetation on the three occasions it has been surveyed (1988, 1999, 2008), and therefore has received a default LakeSPI Index of 0% (Table 3). In 1999, the lake was reported as having the worst water quality of seven Auckland Lakes assessed (Gibbs *et al.*, 1999) and submerged plants were effectively excluded by low water clarity (<1 m Secchi Disc depth) and floating sudds of marginal vegetation that extended out over 2 m in depth. Herbivorous rudd are known to have been present in this lake since 1979 (FBIS).

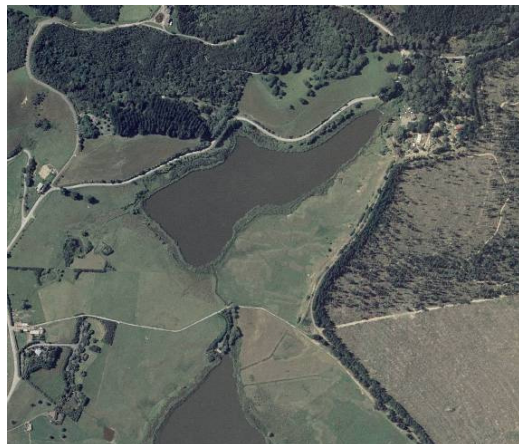
4.1.3 Lake Slipper

Lake condition:	Non vegetated
Stability:	Stable
Lake Max Depth (m):	5.3
Lake type:	Dune

Lake Slipper is connected to Lake Spectacle via a wide drainage channel. Both lakes are likely to have similar water quality issues and like Lake Spectacle, Lake Slipper has been devoid of submerged vegetation during 1988 and 2008 surveys. This has resulted in a LakeSPI Index of 0% (Table 4).

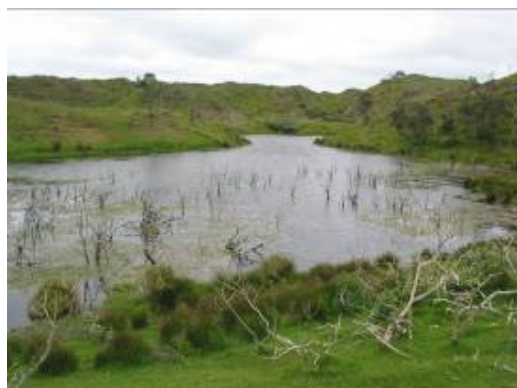
4.3.1 Lake Poutoa

Lake condition:	Excellent
Stability:	-
Lake Max Depth (m):	1.6
Lake type:	Dune

Lake Poutoa had a LakeSPI Index of 90% (Table 6), the highest LakeSPI Index identified for any of the Auckland lakes. This was a result of the proportional depth extent of native submerged vegetation in this very shallow lake, with little impact from invasive species. Charophyte meadows together with native pondweeds, grew from 0.8 to 1.5 m depth but were largely excluded from the shallow margins to 1 m depth by floating mats of the sprawling marginal weed *Ludwigia peploides* (Champion and de Winton 2005). The invasive species *Juncus bulbosus* was limited to the margins and had a minimum impact on the lake.

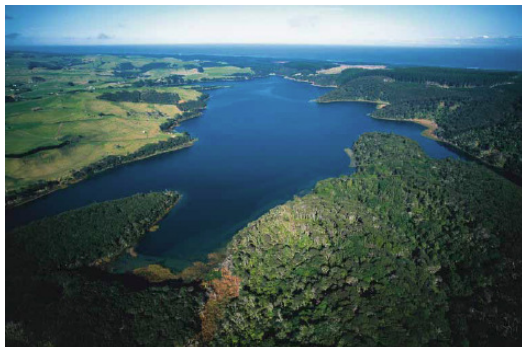
4.3.2 Lake Ototoa

Lake condition:	Excellent
------------------------	------------------

To date the lake has had an excellent and stable ecological condition on account of its native plant communities and water quality conducive to vegetation development. LakeSPI Indices for Lake Ototoa remained high (70-74%) and changed little over the last 23 years (Table 7).

The invasive species hornwort (*Ceratophyllum demersum*) was found in the isolated north-west arm of the lake in 2007 but it was not recorded at survey sites and so was not reflected in the LakeSPI scores. Despite initiatives to contain and eradicate the hornwort infestation, it was confirmed from several sites within the main body of the lake in March 2009 (Mike McMurtry, ARC, pers comm.). Without further intervention, hornwort is expected to expand and replace the charophyte vegetation, and substantial reductions in future LakeSPI Indices are anticipated.

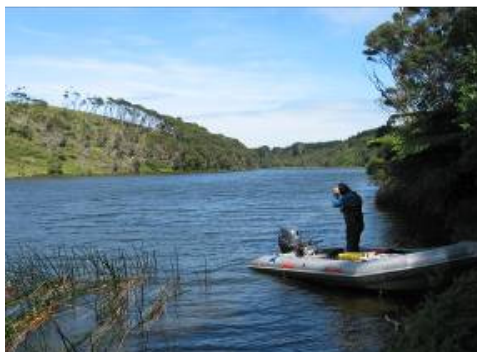
4.3.3 Lake Kuwakatai

Lake condition:	Poor
Stability:	Improving
Lake Max Depth (m):	15
Lake type:	Dune

Lake Kuwakatai has a low LakeSPI Index of 11% (Table 8) due to the high level of invasive impact (Invasive Index 99%) by the weed hornwort (*Ceratophyllum demersum*). Beds of hornwort extended from the lake edge to 8 m depth at complete cover, with lower covers recorded to 10.1 m depth (de Winton *et al.*, 2008). Beds grew up to 6.5 m height and were surface-reaching in shallow areas. Four other submerged plants were restricted in distribution to limited shallow areas. Emergent marginal plants were well developed along the northern and eastern shorelines, but scattered along the southern shoreline.

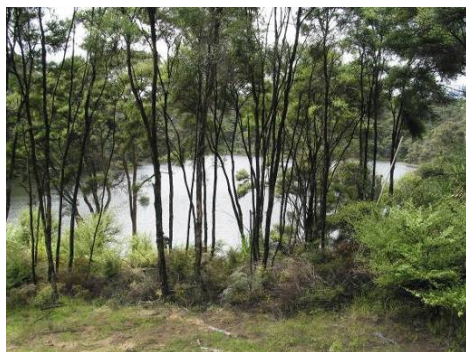
4.3.4 Te Kanae Lake

Lake condition: Poor

The lake at Te Kanae Road had a low LakeSPI Index (10%) and one of the highest Invasive Condition Indices (96%) reflecting the high invasive impact hornwort is having on the lake (Table 9). Hornwort formed beds up to 3 m in height that extended from the margin of emergent plants to a maximum of 6.6 m depth, and drifting shoots from these beds were noted on the lake bed to depths exceeding 12 m. The only other submerged plants seen were a native milfoil and fragments of the invasive weed *Utricularia gibba* at one site only.

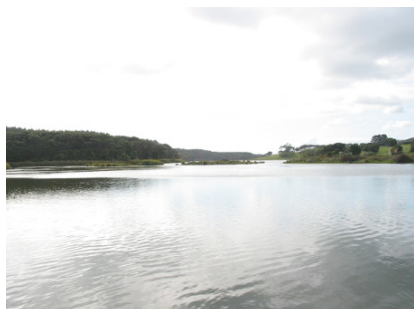
4.3.5 Lake Kereta

Lake condition:	Poor
Stability:	Declining
Lake Max Depth (m):	2.3
Lake type:	Dune

The very low LakeSPI Index of 8% (Table 10) results from the high level of invasion by hornwort (Invasive Condition Index of 94%). The entire lake bed to 2.3 m depth was covered by hornwort with only occasional holes or areas of lower cover. Beds averaged 0.5 to 2 m high and were surface reaching in shallow areas. Emergent marginal plants generally fringed the lake to 0.3 m depth and a few plants of a native milfoil and charophyte species were limited to a shallow sand bank within the lake. Scums from an algal bloom had accumulated along the central western shore.

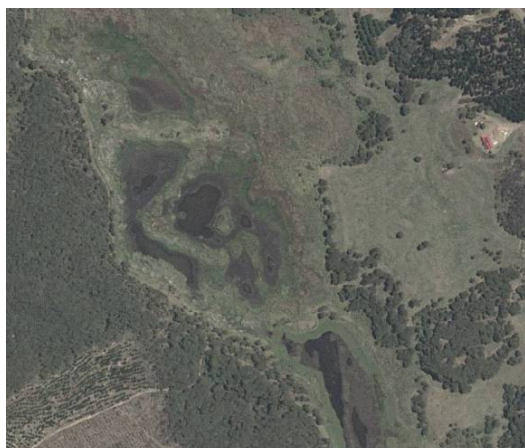
4.3.6 Lake Karaka

Lake condition:	Non vegetated
Stability:	-
Lake Max Depth (m):	1.3
Lake type:	Dune

Submerged plants did not exceed a 10% cover in Lake Karaka resulting in a default LakeSPI Index of 0% (Table 11). Only occasional shoots of native pondweeds were recorded to 0.3 m, and extensive areas in shallow water were bare, although diverse and well developed emergent plants fringed the lake (Champion and de Winton 2005).

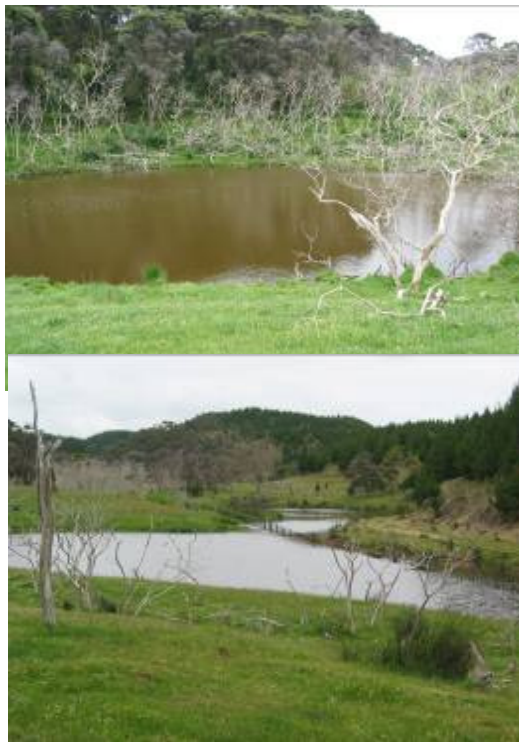
4.3.7 Lakes Ngakuru and Piripoua

Lake condition:	Not suitable for LakeSPI
Stability:	
Lake Max Depth (m):	<1.5
Lake type:	Dune

These lakes were represented by a series of shallow (usually <1.5 m) basins that had a mixture of marginal and submerged plants to <0.3 m depth. These included native milfoils and pondweeds at variable covers (Champion and de Winton 2005). Their shallow nature and the difficulty in distinguishing a true submerged plant community from marginal and ephemeral amphibious species means these lakes are not suitable for the LakeSPI method of assessing ecological condition.

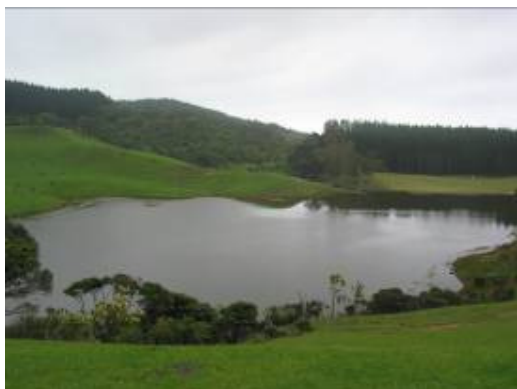
4.4.1 Lake Okaihau

Lake condition:	Poor
Stability:	-
Lake Max Depth (m):	9.5
Lake type:	Dune

The invasive weeds hornwort and *Egeria densa* have had a marked impact on Lake Okaihau resulting in a LakeSPI Index of 18% (Table 12). Hornwort was recorded at variable covers to a maximum depth of 3.9 m, and scattered shoots of *E. densa* were present to 2.2 m depth (Champion and de Winton 2005). Native vegetation character was limited to clumps of native milfoils to 1.8 m and low covers of a native turf plant at 0.2 m depth. Water lilies (*Nymphaea* sp.) were dominant in some shallow areas. Turbid water, and possibly the presence of rudd (adult fish recorded in 1974; Cadwallader 1978), may account for poor development of submerged vegetation.

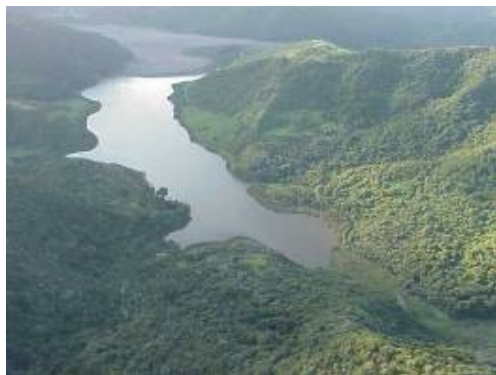
4.4.2 Lake Wainamu

Lake condition:	Poor
Stability:	Declining
Lake Max Depth (m):	15
Lake type:	Dune

Egeria densa formed a continuous band around the margin of this lake during the 2007 survey, resulting in a high Invasive Condition Index of 85% and LakeSPI Index of 16% (Table 13). High cover beds of *E. densa* formed from the edge of the emergents to 5 m depth, grew to a height of 4.2 m and were surface-reaching in places (de Winton *et al.*, 2007). Native charophytes formed patches between 2.5 and 3.5 m and the invasive weed *Utricularia gibba* formed entangling growths over plants to 2.3 m depth. Additional exotic species were *Myriophyllum aquaticum* and *Otelia ovalifolia* (de Winton *et al.*, 2007).

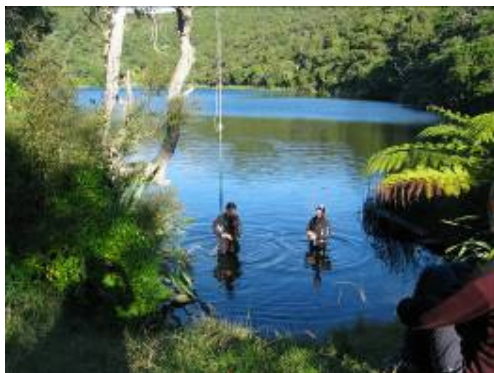
4.4.3 Lake Kawaupaku

Lake condition:	Poor
Stability:	Declining
Lake Max Depth (m):	22
Lake type:	Dune

LakeSPI indices for Lake Kawaupaku remained similar between the 2004 and 2007 surveys with LakeSPI Indices of 14% and 10% respectively (Table 14). During both of these surveys the Invasive Condition Indices have also remained high (81% and 89% respectively) due to the high level of invasive impact that *Egeria densa* is having on the lake. *E. densa* weed beds commonly grew from ≤ 1 m to 4 m depth, with lower weed covers found to 6 m depth. Flowering beds of surface reaching *E. densa* were also noted as common near the lake margins during the recent 2007 survey. The only other submerged plant species seen during the recent survey was one clump of a native charophyte species resulting in a low Native Condition Index of 3%. A dense algal bloom was also noted as present in surface layers of the water column during this survey (de Winton *et al.*, 2007).

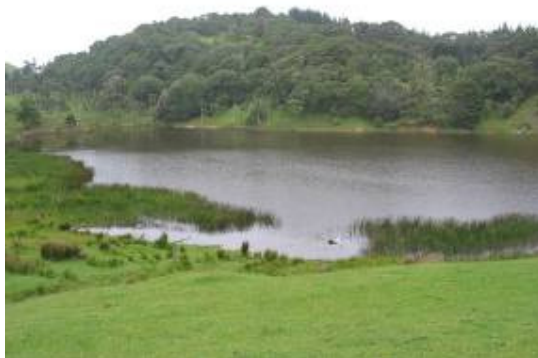
4.4.4 Lake Paekawau

Lake condition:	Non vegetated
Stability:	-
Lake Max Depth (m):	3+
Lake type:	Dune

No submerged vegetation was recorded giving a default LakeSPI score of 0% (Table 15), although native milfoils were a component of amphibious marginal vegetation at the extreme lake edge (Champion and de Winton 2005). Poor water clarity due to the dark-stained and turbid waters is likely responsible for the current absence of submerged vegetation. This lake was once infested by the floating weed *Salvinia molesta*, which was detected in 1988 and has since been eradicated (MAF unpublished records). At that time the lake have posed a poor habitat for submerged plants due to shading.

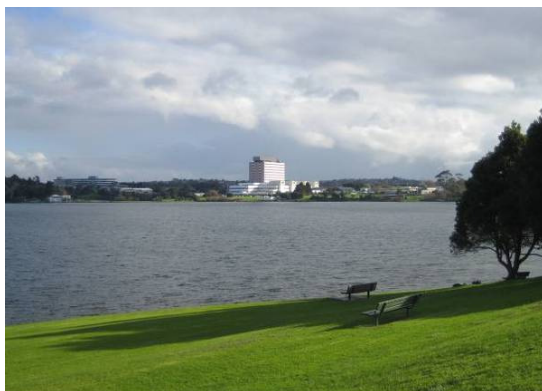
4.5.1 Lake Pupuke

Lake condition:	Good
Stability:	Improving
Lake Max Depth (m):	58
Lake type:	Volcanic

Lake Pupuke had a LakeSPI Index of 30% (Table 16) that was influenced by the large number of invasive weed species present, although native character was still discernable and the depth of vegetation extended to 11.4 m. Eelgrass (*Vallisneria spiralis*) was the dominant invasive weed forming a band of near complete cover from around 1 to 9.2 m depth. Limited charophyte meadows were present beyond the eelgrass beds to a maximum of 11.4 m depth, and native milfoils sometimes formed a band in shallow water to 3.5 m depth. Other invasive weeds included patches of high cover *Egeria densa* to 8.9 m, scattered plants to patches of *Lagarosiphon major* to 5.3 m depth, scattered plants of *Potamogeton crispus* to 4.9 m, and the rarely encountered *Elodea canadensis*.

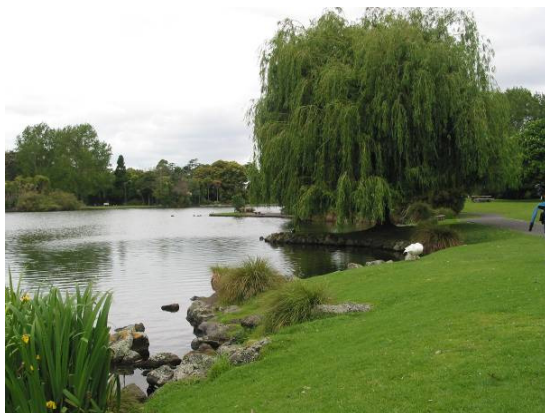
4.5.2 Western Springs Lake

Lake condition:	Non vegetated
Stability:	-
Lake Max Depth (m):	2.9
Lake type:	Volcanic

Western Springs scored a LakeSPI Index of 0% (Table 17) on account of the almost complete absence of submerged vegetation. Submerged plants were restricted to aquatic mosses, including the 'Nationally Endangered' species *Fissidens berteroi* (Hitchmough 2005), that were growing attached to volcanic rocks used in revetment walls and elsewhere within the lake. *F. berteroi* is locally recorded elsewhere in Auckland City from spring-fed waterways at Onehunga Springs, Meola Creek and Motions Creek which originates from Western Springs Lake (Bodmin and Wells 2009).

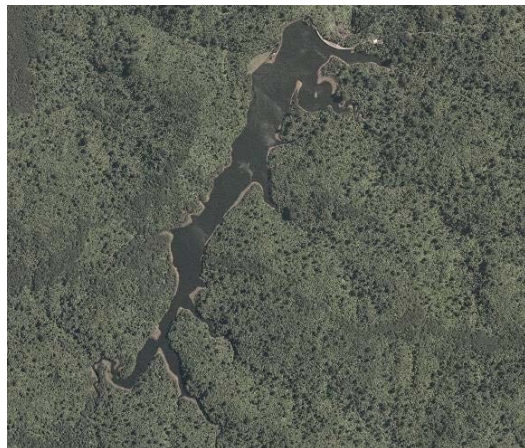
4.6.1 Waitakere Reservoir

Lake condition:	Good
Stability:	Stable
Lake Max Depth (m):	19.7
Lake type:	Reservoir

Waitakere Reservoir was the highest scoring of this group of reservoirs, with a LakeSPI Index of 51 % (Table 18) resulting from the presence of extensive charophyte meadows to 6.9 m depth, moderately impacted by a shallow band (<4 m) of the weed *Juncus bulbosus* (Invasive Condition Index of 39%). Patches of native milfoil were also common. Two other invasive weeds observed included one plant of *Ranunculus trichophyllus* and fragments of *Utricularia gibba* stranded on the dam structure outside of the survey sites. All three invasive species are spread by waterfowl. The high cover charophyte meadows began at between 2.5 and 3.8 m depth, within the range of water level fluctuation of 4.1 m and suggesting the 6-month period of stable water levels prior to the survey was sufficient for charophyte expansion.

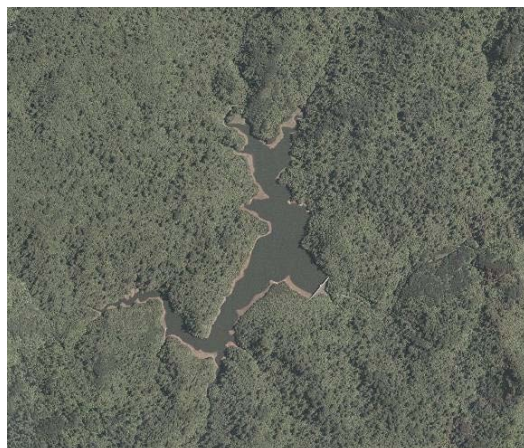
4.6.2 Upper Huia Reservoir

Lake condition:	Good
Stability:	Stable
Lake Max Depth (m):	33.1
Lake type:	Reservoir

The submerged vegetation was dominated by the weed *Juncus bulbosus*, resulting in a moderately high invasive Condition Index (53%) and modest LakeSPI Index of 36% (Table 19). Spread from seed by water fowl, *J. bulbosus* is less invasive than most other submerged weeds, but in the Upper Huia Reservoir it formed the highest covers of any plant species and was recorded to the maximum vegetation depth of 5.5 m. Native milfoils also commonly contributed to the vegetation, but no charophytes were recorded. All submerged vegetation was within the range of water level fluctuations experienced over the preceding year.

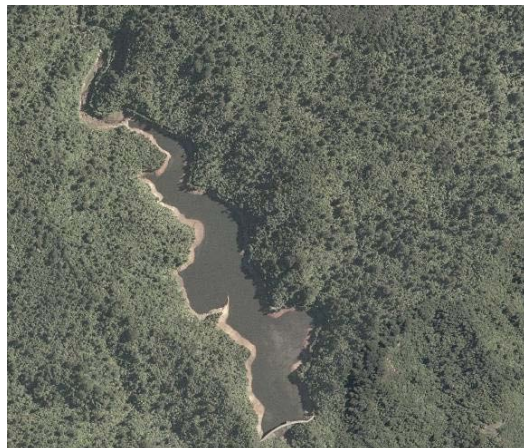
4.6.4 Upper Nihotupu Reservoir

Lake condition:	Non vegetated
Stability:	Stable
Lake Max Depth (m):	33.9
Lake type:	Reservoir

No submerged plants were recorded from the Upper Nihotupu Reservoir and it received a default LakeSPI Index of 0% (Table 21). The extreme water level fluctuations in this reservoir (11.5 m) are likely to exclude significant vegetation development. Likewise, no submerged species were recorded in 1982 (NIWA data).

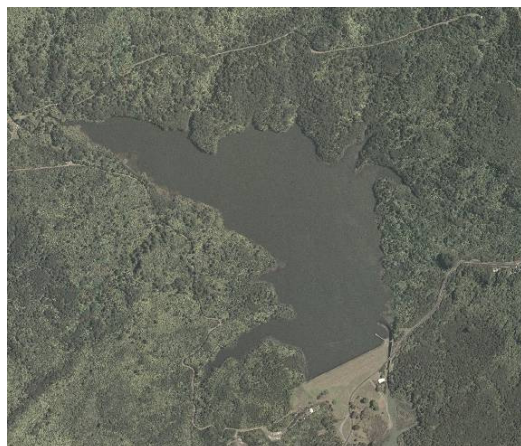
4.6.5 Lower Nihotupu Reservoir

Lake condition:	Unassessed
Stability:	-
Lake Max Depth (m):	18.4
Lake type:	Reservoir

A LakeSPI assessment could not be made in 2008 because of high water turbidity due to slip in a tributary catchment severely limited divers observations. We were able to confirm the presence of plants to 4 m depth, with apparent bare sediment at 5 m, the deepest extent investigated, however reliable LakeSPI indices could not be generated. Whilst recent water level fluctuations (4.9 m) were amongst the lowest in this group of lakes, additional light stress on plants from high turbidity raises doubts for the survival of deep submerged vegetation.

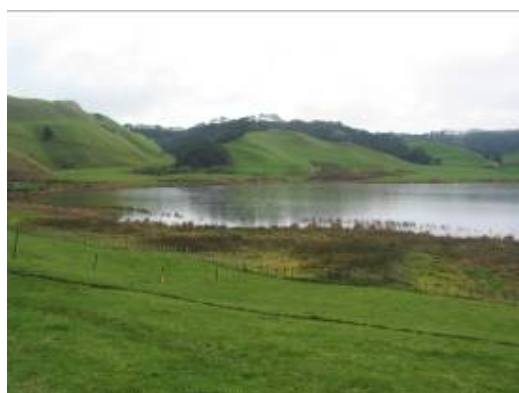
4.7.1 Lake Pokorua

Lake condition:	Excellent
Stability:	Improving
Lake Max Depth (m):	6
Lake type:	Dune

Lake Pokorua is one of the highest ranked of the Auckland lakes scoring a LakeSPI Index of 76% (Table 23). This is on account of the lake still maintaining a well developed native plant community with charophyte meadows recorded to a depth of 3.3 m and an open canopy of native pondweeds growing down to 3 m depth. *Egeria densa* was recorded at 75% cover to 3 m depth at one of the survey sites (Champion and de Winton 2005).

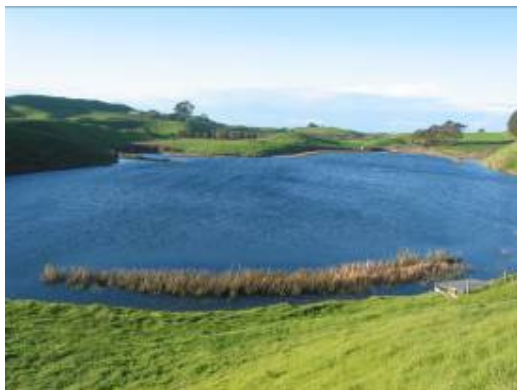
4.7.2 Lake Whatihua

Lake condition:	Good
Stability:	Improving
Lake Max Depth (m):	11
Lake type:	Dune

Lake Whatihua generated a modest LakeSPI Index of 33% which is a reflection of the significant native character of vegetation that remains in the lake even though *Egeria densa* is having a marked impact (Table 24). *E. densa* commonly formed complete cover weed beds up to 3 m tall from the edge of marginal reeds to 6.8 m depth (Champion and de Winton 2005). Another weed, *Elodea canadensis* made a minor contribution to the invasive character of the submerged vegetation. Despite these impacts the lake still had significant native character, with deeper meadows of charophytes recorded from 7 m to 7.2 m depth, and a diverse assemblage of plants in the shallow zone shoreward of the emergent reed beds. A total of ten native submerged species were recorded from this lake.

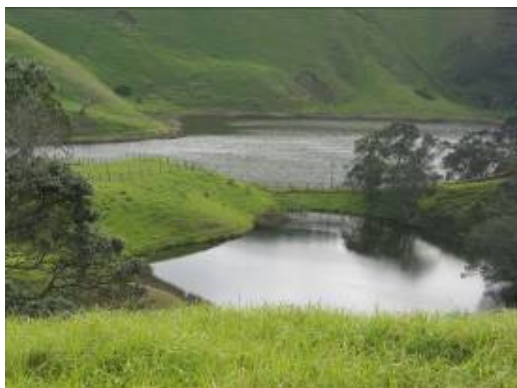
4.7.3 Lake Pehiakura (Small)

Lake condition:	Good
Stability:	-
Lake Max Depth (m):	5.3
Lake type:	Dune

A LakeSPI Index of 25% (Table 25) for the smaller of the two Pehiakura lakes resulted from the dense beds of invasive *E. densa* recorded between 1.3 to 5.3 m depth (Invasive Condition Index 85%). Some native character remained (Native Condition Index 25%), where good covers of native milfoils, turf plants (*Glossostigma* sp.) and a charophyte were found in depths <1.3 m between the clumps of emergent reeds (Champion and de Winton 2005).

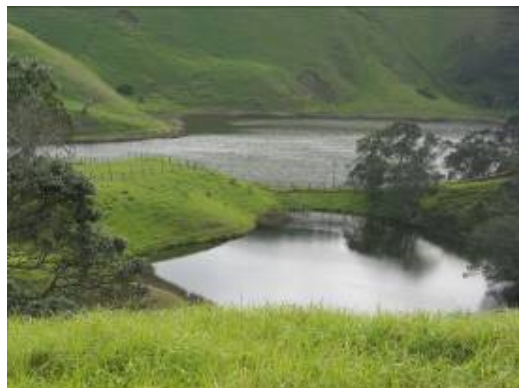
4.7.4 Lake Pehiakura (Big)

Lake condition:	Good
Stability:	-
Lake Max Depth (m):	5.6
Lake type:	Dune

The larger Pehiakura Lake had a LakeSPI Index of 15% (Table 26), lower than the smaller Pehiakura Lake, as *Egeria densa* was the only submerged plant recorded (Invasive Condition Index 89%). Large *E. densa* beds were recorded from 1.6 to 5.4 m depth while an almost continuous band of emergent plant species grew around the lake margin to a depth of 1.6 m (Champion and de Winton 2005).

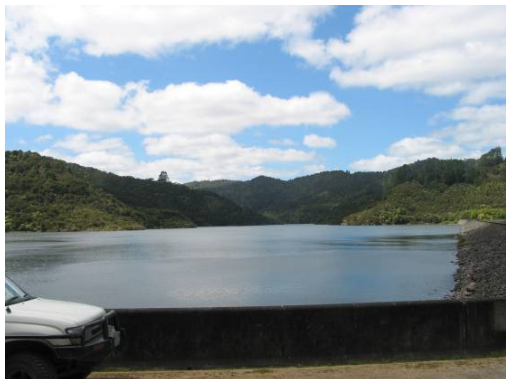
4.8.1 Mangatawhiri Reservoir

Lake condition:	Good
Stability:	Improving
Lake Max Depth (m):	35.6
Lake type:	Reservoir

The upper Mangatawhiri Reservoir had the highest LakeSPI ranking of the Hunua Reservoirs (76%) on account of the depth extent of native charophytes that formed high cover meadows down to 10.4 m depth (Table 27). The shallow edge of these meadows began at 6 m depth, corresponding with the water level rise of 6.3 m recorded prior to the survey. Native milfoils and pondweeds were a minor vegetation component found in shallower depths than the charophyte meadows and no invasive submerged weeds were recorded.

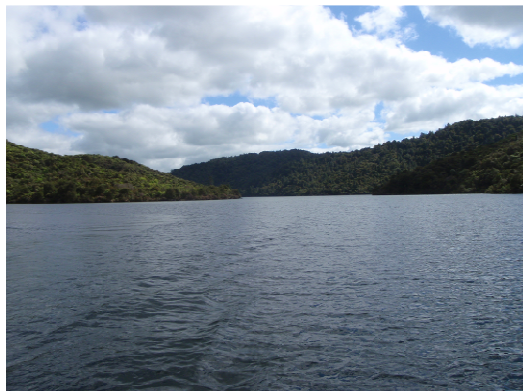
4.8.2 Wairoa Reservoir

Lake condition: Excellent

A high LakeSPI Index of 66% (Table 28) resulted from the presence of native plant communities growing down to a moderate depth in the absence of any invasive plant species. Beds of native charophytes began at 6.3 to 7.1 m and extended to 8.6 m depth, with occasional plants recorded as deep as 11.7 m. Native milfoils and pondweeds were sometimes present in mid-depths of 3 to 8.2 m and terrestrial vegetation was noted to 4.4 m depth. An increase in water level of 7.5 m prior to the survey would account for the transition from terrestrial to obligately submerged plants seen between 4.4 and around 7 m depth.

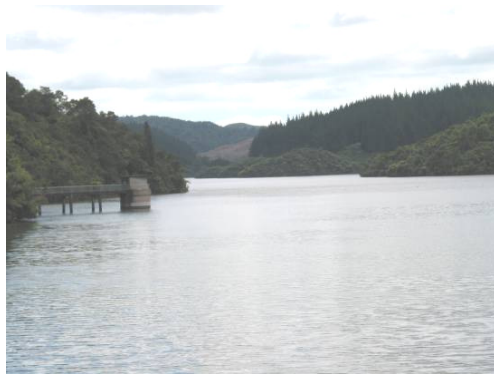
4.8.3 Cossey's Reservoir

Lake condition:	Good
Stability:	Declining
Lake Max Depth (m):	35.1
Lake type:	Reservoir

The LakeSPI Index of 49% (Table 29) reflected the largely native vegetation character in Cossey's Reservoir that, although it was low in cover and depth extent, had only minimal impact by invasive *Juncus bulbosus*. The sparse submerged vegetation comprised of native charophytes and milfoils while *J. bulbosus* was present at some of the sites. Submerged plants were recorded to 5.6 m depth although most growth was less than 3.3 m, and inundated terrestrial plants were noted to 2.6 m. The water level increase of 4.2 m prior to the 2008 survey was not clearly reflected in the depth distribution of the submerged vegetation.

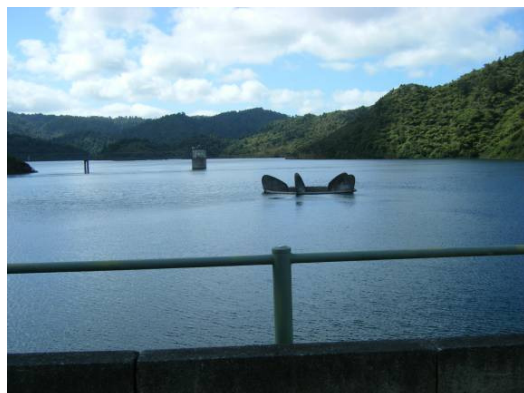
4.8.4 Mangatangi Reservoir

Lake condition:	Non vegetated
Stability:	Declined
Lake Max Depth (m):	54.6
Lake type:	Reservoir

Small patches of native charophytes were recorded between 13.1 and 15.4 m depth and native milfoils from 6 to 8.5 m. However, these plants were considered to be remnants of previous vegetation after inundation by a 14.1 m rise in water level prior to the 2008 survey, as it is doubtful these patches would survive the maintenance of high levels recorded over the subsequent three or more months (Figure 3). This together with the sparse nature of plant growth ($\geq 10\%$ cover at only one of three sites investigated) results in a LakeSPI Index of 0% (Table 30).

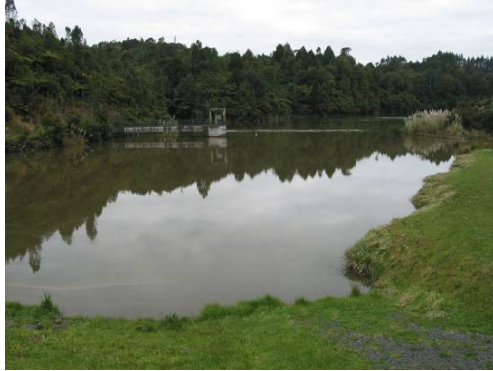
4.8.5 Hays Creek Reservoir

Lake condition:	Non vegetated
Stability:	-
Lake Max Depth (m):	20.7
Lake type:	Reservoir

Hays Creek Reservoir received a LakeSPI Index of 0% (Table 31) on account of the low presence of submerged vegetation. Only occasional charophyte plants were encountered at $\leq 10\%$ cover; below the threshold for generating LakeSPI scores. The low water clarity, with a turbid, 'milky' appearance, suggests light availability restricted submerged vegetation development. However, the presence of koi carp known from the reservoir is implicated both for impacts on water clarity (Rowe 2007) and direct impacts on submerged plants (e.g., Crivelli 1983). In contrast to the other Hunua Reservoirs, Hays Creek has a stable water level.

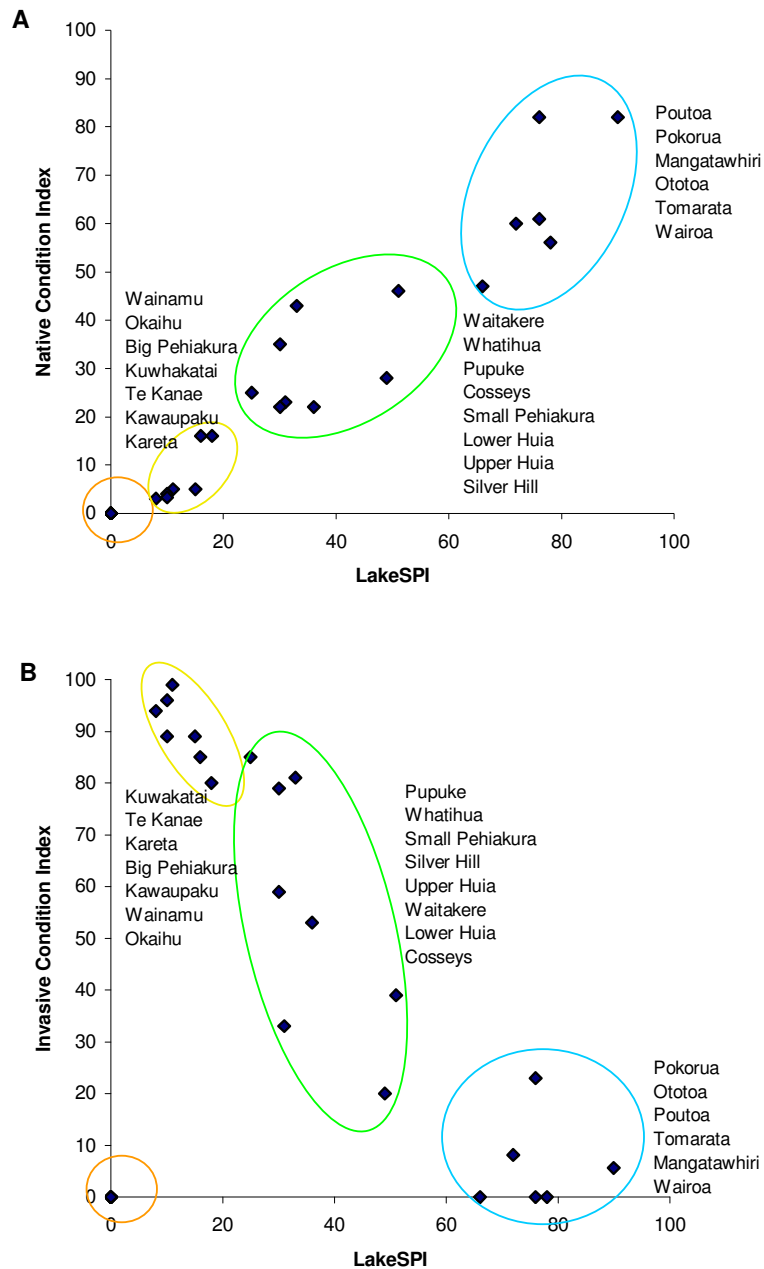
Relationship between LakeSPI index and **A)** Native Condition index and **B)** Invasive Condition index for lakes of the Auckland Region distinguishing four lake categories of *Excellent* (blue ring) *Good* (green ring), *Poor* (yellow ring) and *Non vegetated* (orange ring). Lake names listed in ascending order for Native or Invasive Condition.
