Use of Microbial Biofilms to Monitor the Efficacy of a Stormwater Treatment Train

September 2009 TR 2009/086

Auckland Regional Council
Technical Report No.086 September 2009
ISSN 1179-0504 (Print)
ISSN 1179-0512 (Online)
ISBN 978-1-877528-98-9

Lear, G., Ancion, P., Roberts, K. & G. D. Lewis. (2009). Use of Microbial Biofilms to Monitor the Efficacy of a Stormwater Treatment Train. Prepared by the University of Auckland for Auckland Regional Council. Auckland Regional Council Technical Report 2009/086.

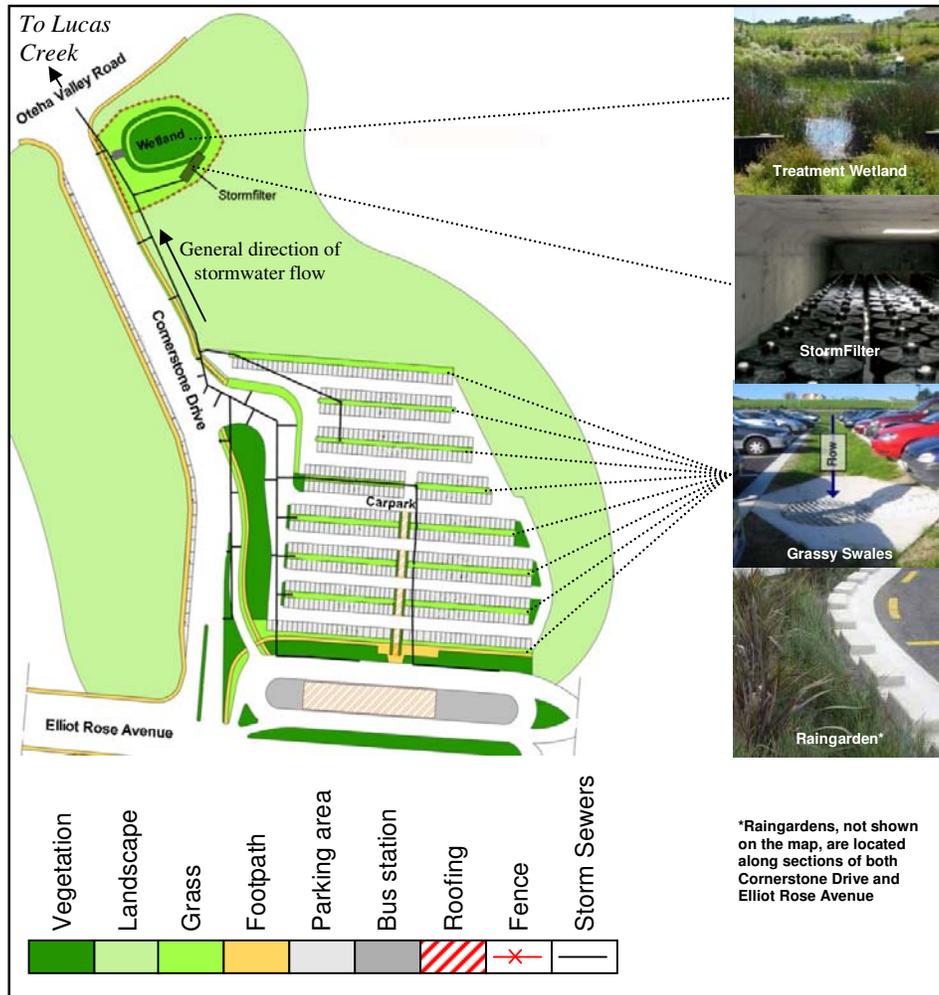
Figure 2.2:

Map of the Albany Busway site (3643'18 S, 17442'45 E) showing stormwater 'treatment train'. Adapted from a map produced by M. Ort, and re-produced with permission of Auckland Regional Council.

Source control practices are designed to prevent contaminants from entering the stormwater system. In addition to the use of environmentally conscientious practices (proper waste disposal and appropriate treatment of pollutant spills, etc.), 71 Enviropod™ filters have been installed within drains and catchpits throughout the car park, aimed at removing contaminants before they enter the stormwater pipe system. These filter systems consist of a galvanized steel supporting frame housing a removable polyester filterbag, which collect litter, organic debris and pollutants entering the drains, as the stormwater passes through. These filters are an effective, ARC-recognised, pre-treatment device for use in treatment trains, that allow contaminants and debris to be removed from the site for off-site treatment and disposal (for more information, refer to www.enviropod.com)

Raingardens are located along many of the roads leading into the Albany Busway including Elliot Rose Avenue and the southern end of Cornerstone Drive. These raingardens are designed to drain stormwater from the adjacent roads, into depressions planted with wetland vegetation. Typically, species native to the region are used (mainly grasses, sedges and *Cordyline australis*) as they are more tolerant of the local climatic conditions and are adapted to the prevalent soil and water conditions, negating the need for fertilizer additions. Raingardens reduce the concentrations of contaminants entering the watercourse downstream by enhancing absorption to the soil and encouraging the biological uptake and degradation of contaminants by both plants and associated microbial communities.

Grassy swales provide a similar service as the raingardens and are located throughout the car park, spanning a total length of 600 m. These grassed channels (~1.5 m wide) are also used to separate rows of car parking spaces (without restricting the views throughout the car park), whilst removing contaminants by natural infiltration, absorption and enhanced biological uptake.

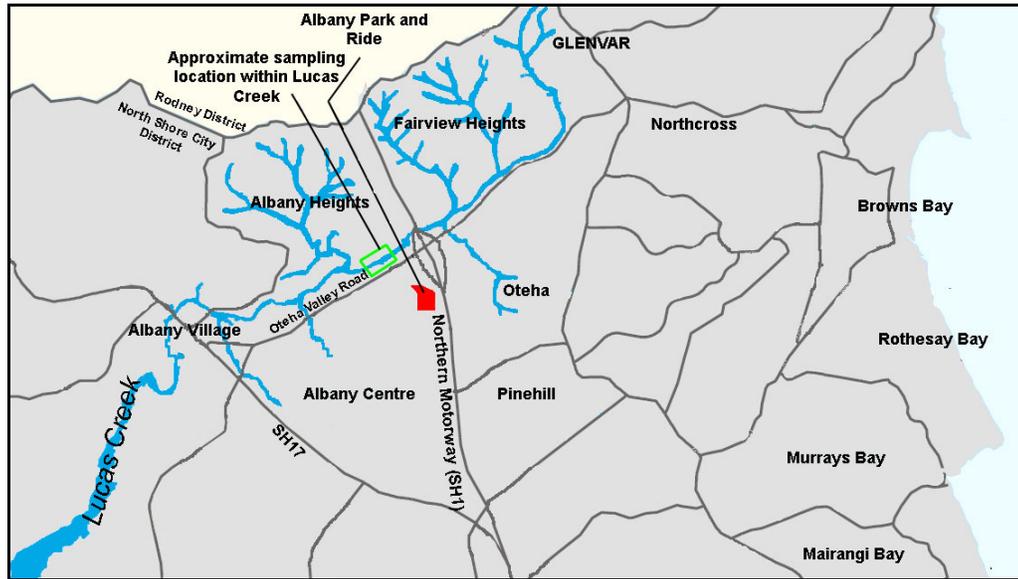
Figure 2.3:

Location of Lucas Creek and its tributaries, shown in blue (widths of the creek and tributaries are not to scale). The location of the Albany Bus Station car park is shown in red and the approximate location of the Lucas Creek sampling site shown in green. Major roads are shown in dark grey.

The major aim of the stormwater treatment train located at the Albany Park and Ride car park is to mitigate the impact of this development on the receiving waters of Lucas Creek (Figure 2.3). Lucas Creek is a soft-bottomed stream draining a catchment of approximately 600 hectares across its 16.3 km length. The large catchment area means that the lower part of the main channel is wider than generally found in North Shore streams (1-5 m).

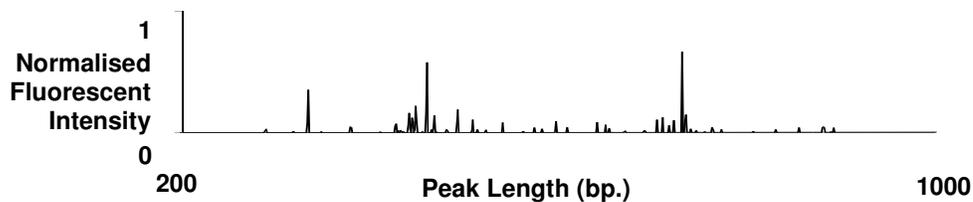
Figure 2.4:

ARISA profile of a stream biofilm bacterial community within Lucas Creek. Data are peak length of the 16S-23S intergenic regions of bacterial genome (x-axis; in nucleotide base pairs) within the total community, and normalised fluorescent intensity as recorded by a GeneScan automated DNA fragment analyser (y axis; see appendix 9.2). This method creates a 'fingerprint' of the structure of environmental bacterial communities in which each peak may be considered to represent a different bacterial taxon, and peak height represents the relative abundance of each taxon within the total community (note that these assumptions are not strictly true; for a useful review, refer to Bent *et al.* (2007)).

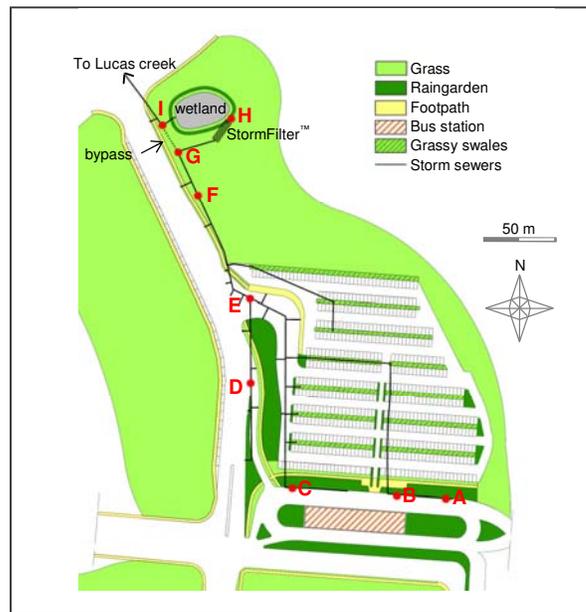
Figure 3.1:

Map of the Albany Busway site (36°43'18 S, 174°42'45 E) showing sampling locations (where manholes provided access to the stormwater drains). Adapted from a map produced by M. Ort for the Auckland Regional Council.

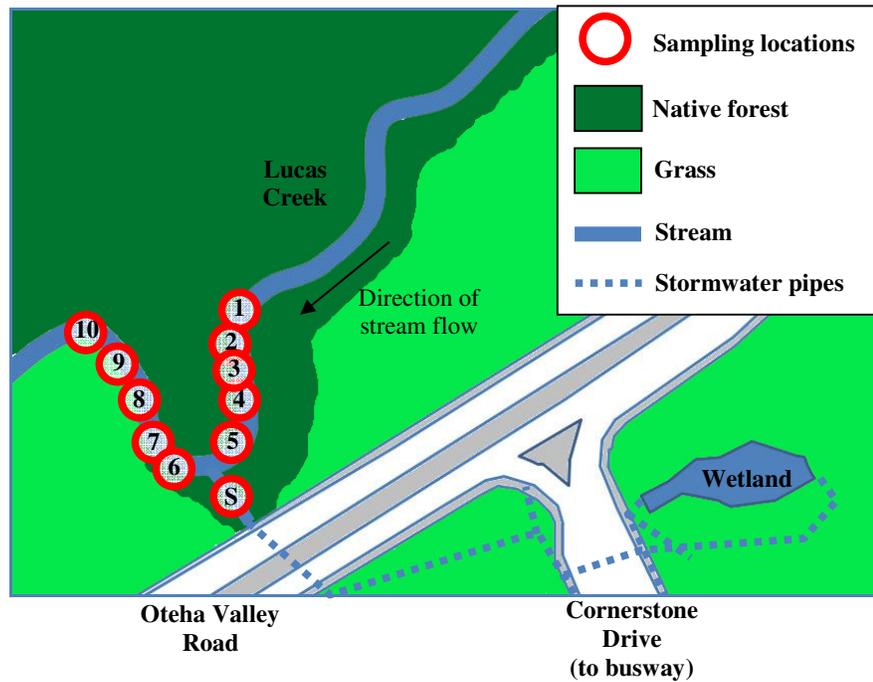
Figure 3.2:

Map showing sampling locations (1 to 10) within Lucas Creek (36°43'11" S, 174°42'34" E). Stormwater from the Albany Busway is channelled into Lucas Creek via a drain running under Oteha Valley Road (reaching sampling location 'S').

All of the stormwater drained from the Albany Busway is channelled (via the StormFilter and wetland) into Lucas Creek at the location shown (from a stormwater pipe originating downstream (left) of the wetland; Fig 3.2). Untreated stormwater draining Cornerstone Drive and Elliot Rose Road is also channelled into Lucas Creek at the same location (from the stormwater pipe to the left of Cornerstone Drive; Fig 3.2).

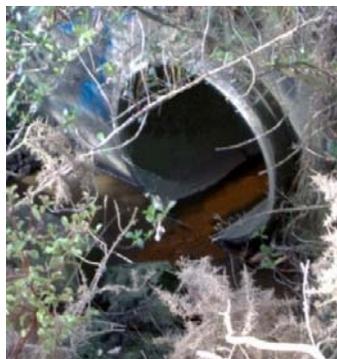
Figure 3.3:

Photograph showing sampling site 'S' within Lucas Creek, the outlet of a drain channelling stormwater from the Albany Busway, into Lucas Creek. Sediment immediately surrounding the outlet is 'red' in colour, presumably from deposited metal oxides.

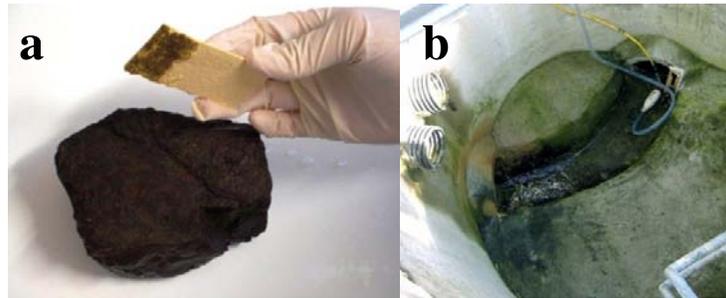
Figure 3.4.

A Speci-sponge™ is used to remove biofilm biomass. (a) For stream rocks, the entire surface area of each rock was swabbed using a different sponge. (b) For stormwater pipes, an area at the base of the stormwater pipe (~ 100 cm) was swabbed for each sample.

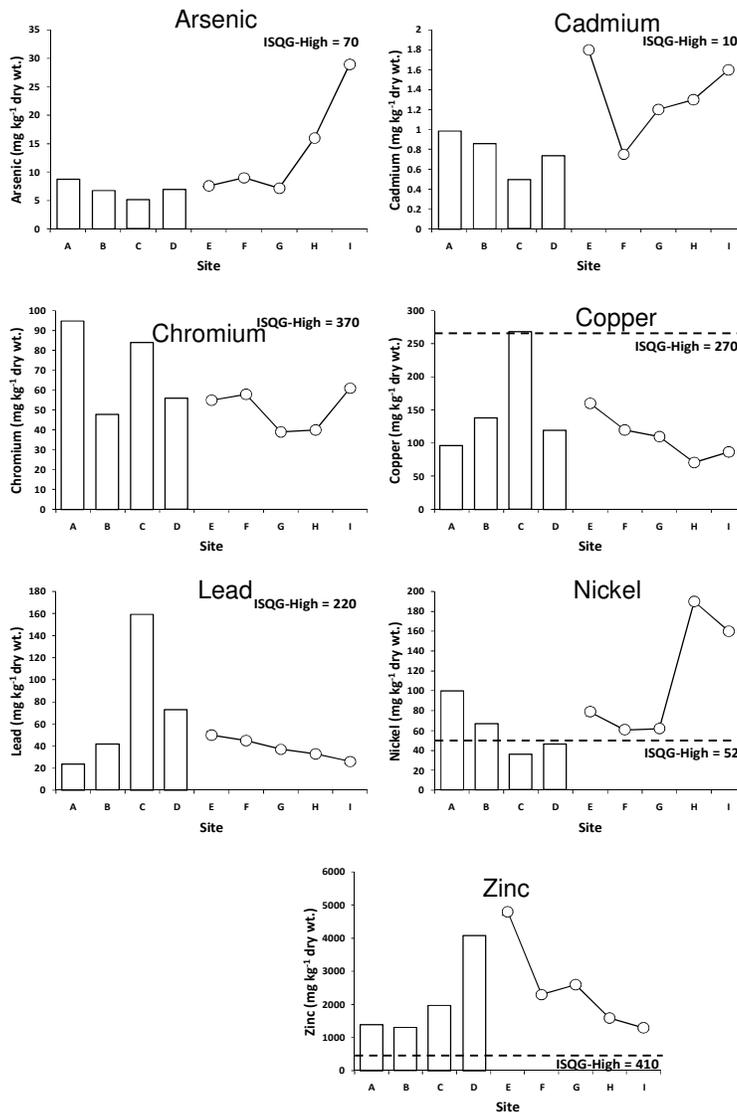
Figure 4.1:

Concentrations of As, Cd, Cr, Cu, Pb, Ni and Zn (mg kg⁻¹ dry wt. of biofilm) at different sampling locations within the Albany Busway Park and Ride treatment train. Data were collected from pooled samples, combining the biofilm biomass of three sponge samples, and not replicated. The dashed lines show the high interim sediment quality guideline (ISQG-High) values (ANZECC 2000) which indicate possible risk to environmental health. The data for sites E to I are plotted as a line as stormwater passes through each site, sequentially.

ISQG-values for sediment are provided throughout this study as there are currently no recommended trigger values for biofilm associated metals. Therefore, because a biofilm sample exceeds the guideline concentration for sediment may not mean that the community in the receiving waters are of significant risk of ecological impact. Nevertheless, it is worth noting that concentrations of zinc observed within these biofilm samples reach a maximum concentration more than 10 times higher than the ANZECC ISQG-High trigger value for sediment.

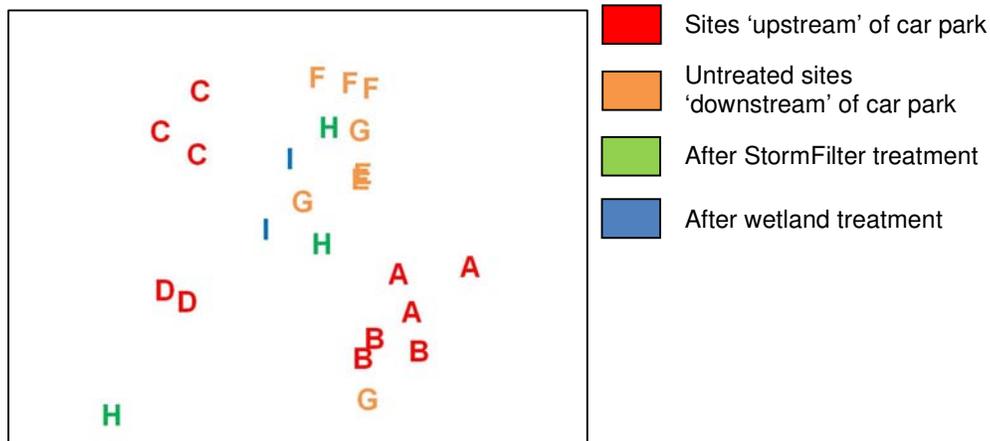
Figure 4.2:

Differences in bacterial community ARISA profiles from different sections of the Albany Busway treatment train sampled in January 2009. Plots are non-metric multidimensional scaling of bacterial ARISA data, derived from a Bray-Curtis matrix of samples. Letters refer to sampling sites detailed in Fig. 3.1. 2D stress = 0.16.

Multidimensional scaling (MDS) was done to visualise multivariate patterns in bacterial community structure based on the ARISA data generated from each biofilm sample (Fig. 4.2 & 4.3). Similar patterns in bacterial community structure were observed on both sampling occasions where significant differences were detected between sampling sites (PERMANOVA, $P < 0.0001$), but not within sampling sites (PERMANOVA, $P = 0.98$). For both sampling dates, similar bacterial community structures were detected for sites A and B, which were significantly different from sites C and D (PERMANOVA, $P < 0.0001$). The community within site E, located downstream of the car park area was significantly different from that of sites A, B, C and D (PERMANOVA, $P < 0.0001$). No significant differences were detected in bacterial community structure between sites E, F and G (downstream of the car park area), or between sites G and H (which are located at the inlet and outlet of the StormFilter device; PERMANOVA, $P < 0.0001$).

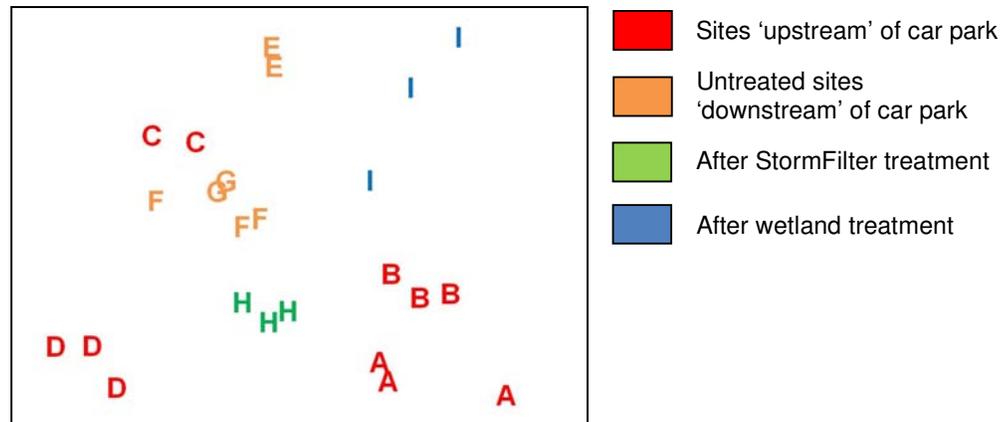
Figure 4.3:

Differences in bacterial community ARISA profiles from different sections of the Albany Busway treatment train sampled in March 2009. Plots are non-metric multidimensional scaling of bacterial ARISA data, derived from a Bray-Curtis matrix of samples. Letters refer to sampling sites detailed in Fig. 3.1. 2D stress = 0.20.

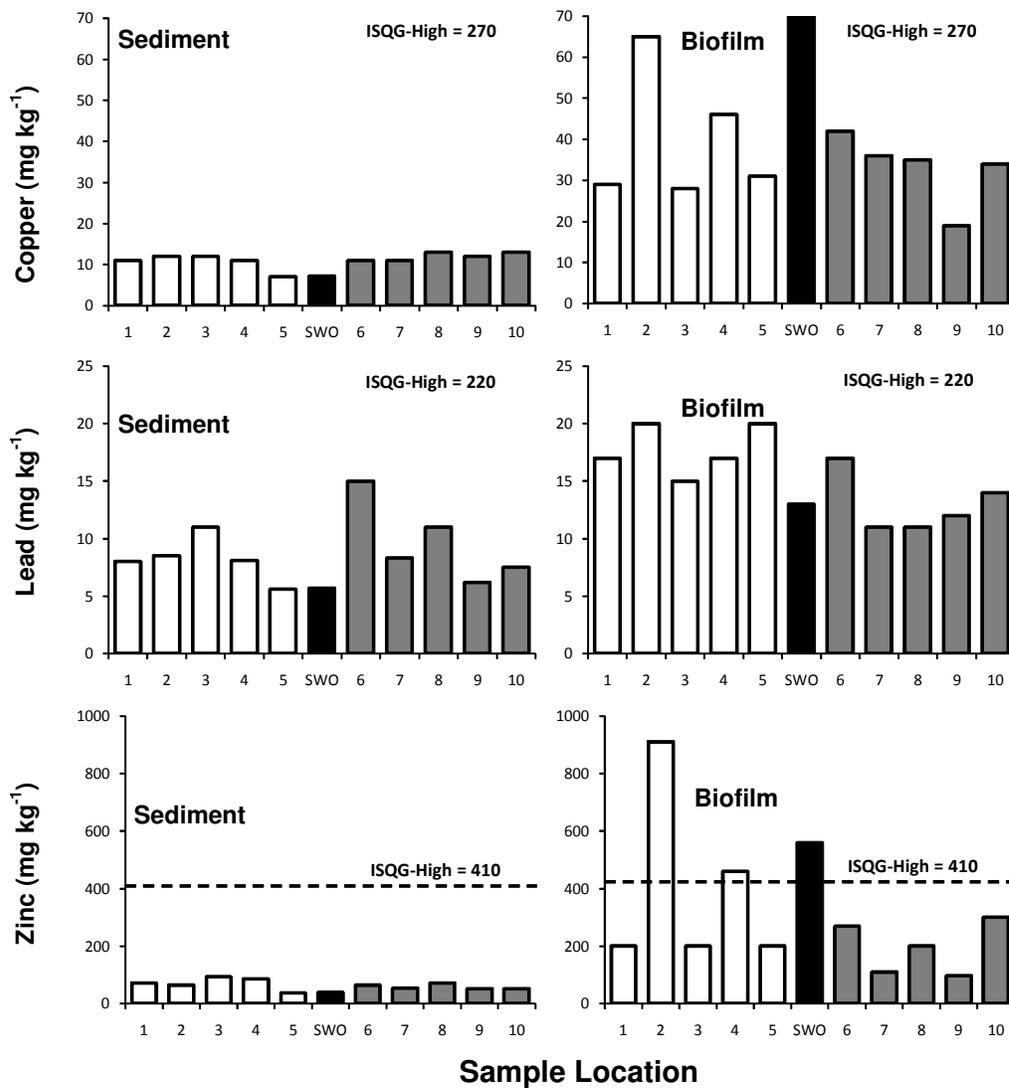
Figure 4.4.

Concentrations of Cu, Pb and Zn (mg kg dry wt.) in sediment (left) and biofilm (right) within: (□) Lucas Creek sites located upstream of the stormwater outlet; (■) Lucas Creek sites located downstream of the stormwater outlet; (■) the stormwater outlet. Data for each site were collected from pooled samples, combining either the biofilm biomass of three rocks or three 50 mL sediment samples and not replicated. Labels on the x-axis refer to sampling location within Lucas Creek, SWO is stormwater outlet. The dashed lines show the high interim sediment quality guideline (ISQG-High) values (ANZECC, 2000) which indicate possible risk to environmental health.

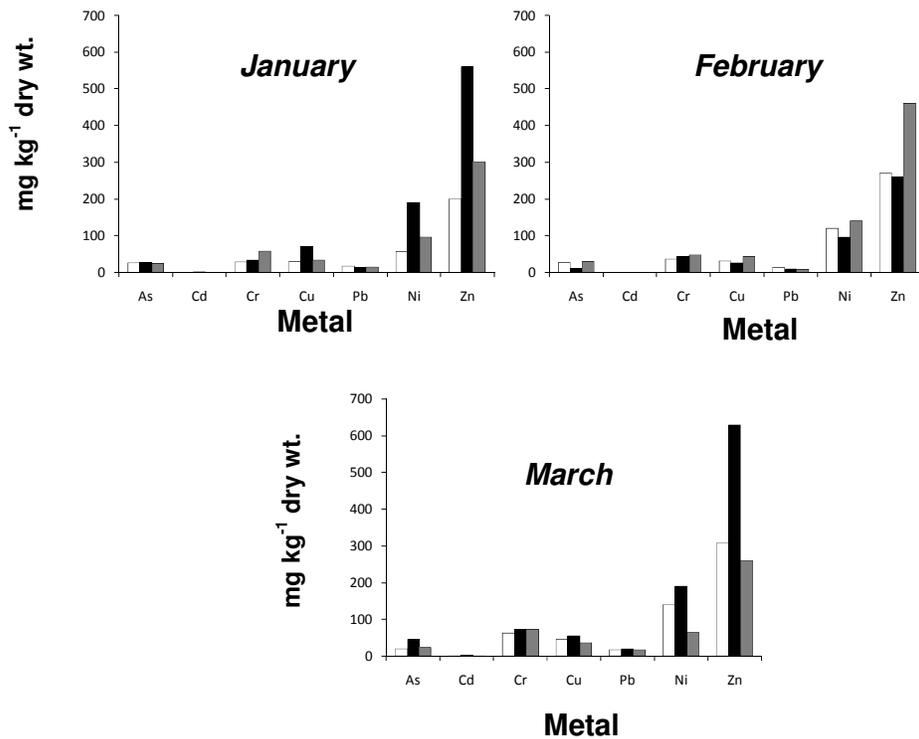
Figure 4.5.

Concentrations of As, Cd, Cr, Cu, Pb, Ni and Zn (mg kg⁻¹ dry wt. of biofilm) at different sampling dates within: (□) Lucas Creek sites located upstream of the stormwater outlet; (■) Lucas Creek sites located downstream of the stormwater outlet; (■) the stormwater outlet. Data for each site were collected from pooled samples, combining the biofilm biomass of three rocks and not replicated. ANZECC (2000) high interim sediment quality guidelines are 70 mg kg⁻¹ (dry wt.) arsenic; 10 mg kg⁻¹ (dry wt.) cadmium; 370 mg kg⁻¹ (dry wt.) chromium; 270 mg kg⁻¹ (dry wt.) copper; 220 mg kg⁻¹ (dry wt.) lead; 52 mg kg⁻¹ (dry wt.) nickel; 410 mg kg⁻¹ (dry wt.) zinc.

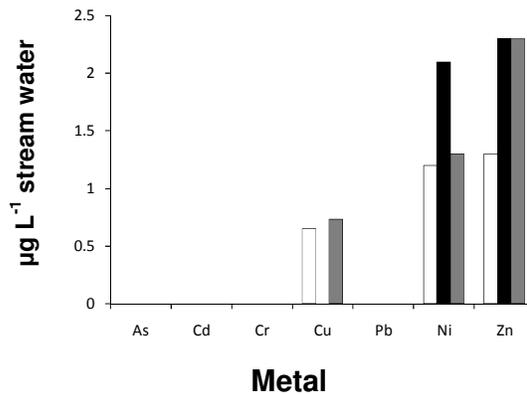
Figure 4.6.

Concentrations of As, Cd, Cr, Cu, Pb, Ni and Zn ($\mu\text{g L}^{-1}$ stream water) (\square) within Lucas Creek, upstream of the stormwater outlet; (\blacksquare) within Lucas Creek, downstream of the stormwater outlet; (\blacksquare) within the stormwater outlet. Data for each site are not replicated.

Concentrations of As, Cd, Cr and Pb were all below detection (<0.001 ppm, < 0.00005 ppm, < 0.0005 ppm and < 0.0001 ppm, respectively) in the streamwater and stormwater outlet (Fig. 4.6). Cu was detected within Lucas Creek, but not within the stormwater, indicating the Cu is derived from a source further upstream. Concentrations of both Ni and Zn exceeded 2 mg L⁻¹ water, however none of the metals exceeded trigger values for the protection of 95% of species in freshwater (1.4, 11 and 8.0 µg L⁻¹ for copper, nickel and zinc, respectively; ANZECC (2000)).

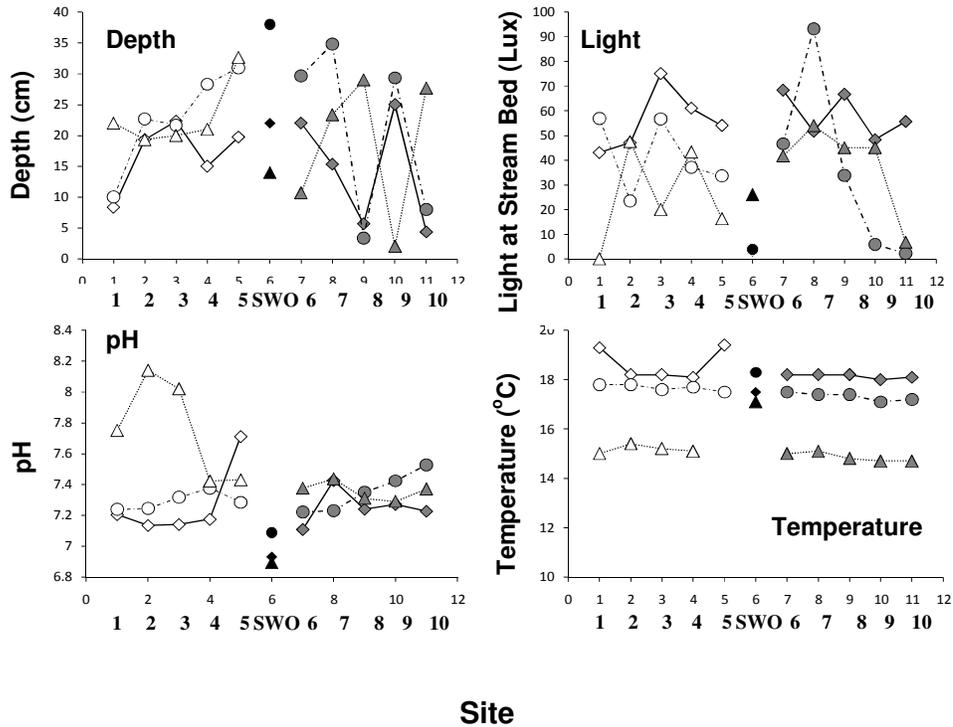
Figure 4.7.

Measurements of physical stream characteristics during (◇) January; (○) February; (△) March for sample sections located (white) within Lucas Creek, upstream of the stormwater outlet; (grey) within Lucas Creek, downstream of the stormwater outlet; (black) within the stormwater outlet.

The average depth of the stream was 20.0 cm and the average pH of the stream water was pH 7.34 (Figure 4.7; all sampling dates and locations combined). No significant differences in stream depth, pH or light at the stream bed were detected (student t-test, $P > 0.05$) between sampling dates or sections (pooling data obtained from upstream and downstream sampling locations; sites 1 to 5, and 6 to 10). Significant differences (student t-test, $P < 0.05$) in the temperature of the stream water were detected between sampling dates, being coolest in March (an average of 15.2 °C, all sampling locations combined), and 0.5 °C cooler within the downstream sampling locations (6 to 10), all sampling dates combined.

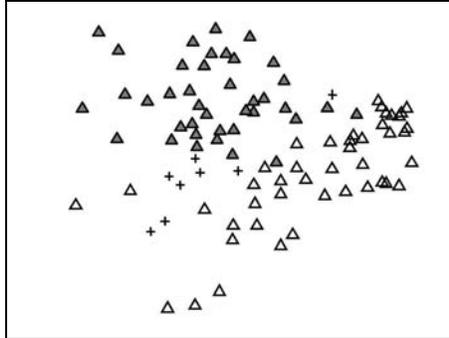
Figure 4.8:

Differences in bacterial community ARISA profiles from sections of Lucas Creek, combining data gathered on each sampling occasion (January, February and March, 2009). Plot is a non-metric multidimensional scaling of bacterial ARISA data derived from a Bray-Curtis matrix of samples. Data points refer to samples from (\triangle) upstream of the stormwater outlet; (\blacktriangle) downstream of the stormwater outlet; ($+$) the stormwater outlet. 2D stress = 0.21.

Significant differences in bacterial community structure were detected between sample sites located upstream, or downstream of the stormwater outlet (PERMANOVA, $P \leq 0.001$; Fig. 4.8). The bacterial community within the stormwater outlet was marginally more similar to the bacterial communities recorded downstream of the stormwater outlet, than communities upstream (similarities 43 and 41, respectively, where PRIMER similarity values ranged from 0 to 100 [perfect similarity]).

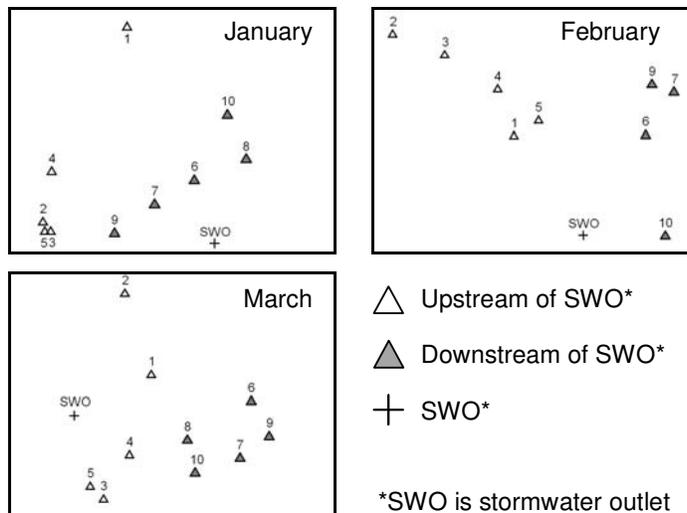
Figure 4.9:

Differences in bacterial community data from different sections of Lucas Creek, sampled in January, February and March, 2009. Plots are non-metric multidimensional scaling of bacterial ARISA data derived from a Bray-Curtis matrix of samples. Data points are averages (an average of three rocks per sampling site). Numbers on plot refer to sampling location within the stream. 2D stress = 0.06, 0.07 and 0.11 for January, February and March respectively.

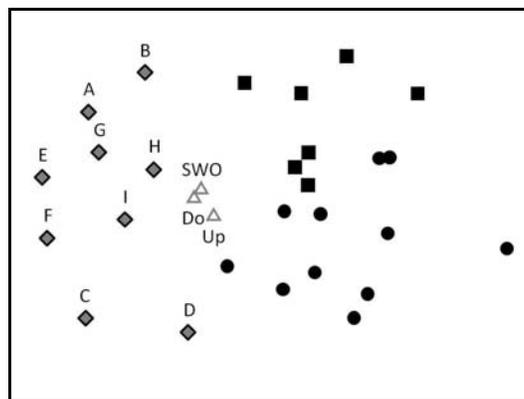
Figure 4.10:

Differences in bacterial community ARISA profiles from a range of Auckland streams located within: (■) predominantly rural catchments; (●) predominantly urban catchments; (△) sections of Lucas Creek analysed in this study; (◆) sections of the Albany park and Ride treatment train; (Do), sampling sections in Lucas Creek located downstream of the stormwater outlet; (Up), sampling sections in Lucas Creek located upstream of the stormwater outlet; (SWO), stormwater outlet from Albany Busway treatment train into Lucas Creek. Letters A to I refer to sampling locations within stormwater pipes of the Albany Park and Ride treatment train (as detailed in Fig. 3.1). Plot is derived using a Bray Curtis matrix. 2D stress = 0.19.

In Fig. 4.10 bacterial community data collected in this study is compared to data collected from 18 different Auckland streams, located in both rural and urban catchments (data from Lear *et al.* (2009)). Analysis of the ARISA data using multivariate dispersion values (PRIMER MVDISP) revealed similar variability (dispersion value = 1.020) in bacterial community structure among samples obtained from within the stormwater treatment trains (in which the greatest physical distance between sample sites was only 0.3 km), compared to between streams in which the greatest physical distance was ~100 km between sample sites (Ngakoroa Stream (nr. Pukekohe) and the Matakana River (nr. Matakana)) (dispersion value = 0.994).

Samples abstracted from sections of Lucas Creek used in this study varied little in comparison (dispersion value = 0.055) revealing that the stormwater outlet had relatively little effect on the bacterial biofilm community within Lucas Creek. Interestingly, samples from lower sections of the stormwater treatment train (e.g., H and I) were most similar to the communities within Lucas Creek (including sections located upstream of the stormwater outlet).

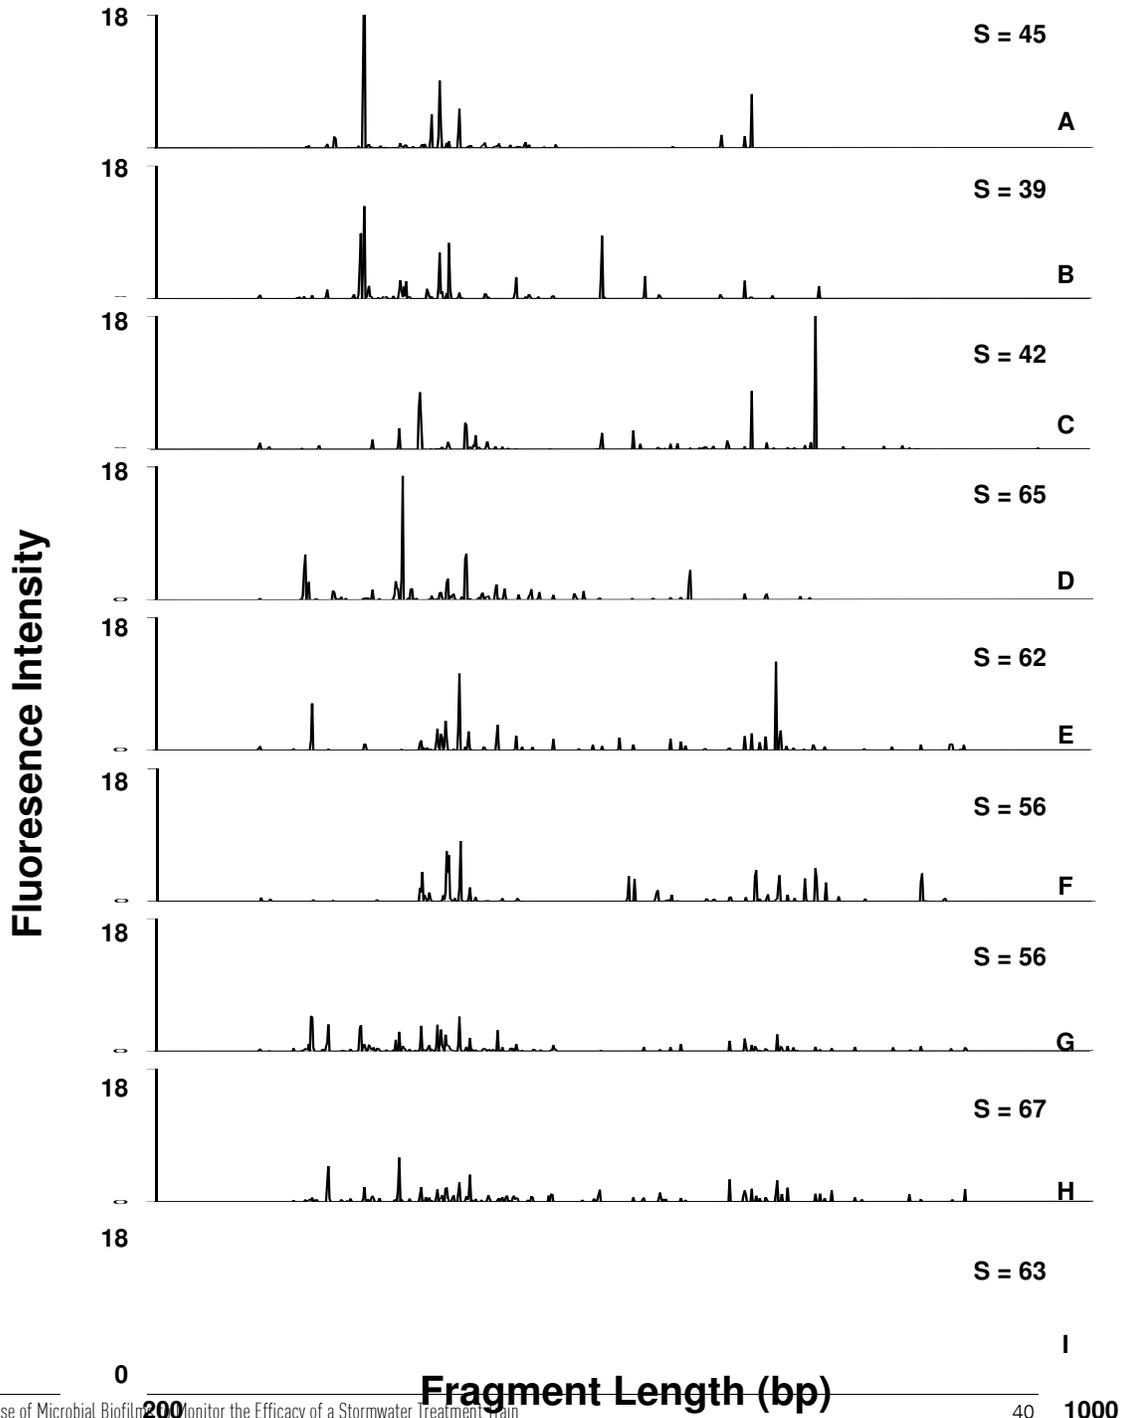
9.4 Bacterial ARISA Profiles – Jan 2009 – Treatment Train Samples

Comparison of ARISA traces obtained from different sections of the Albany Treatment Train (A to I). Data are peak height (fluorescence; y-axis) and fragment length (nucleotide base pairs; x-axis). Data are averaged for replicate samples. S refers to the number of peaks identified (analogous to taxa species richness).

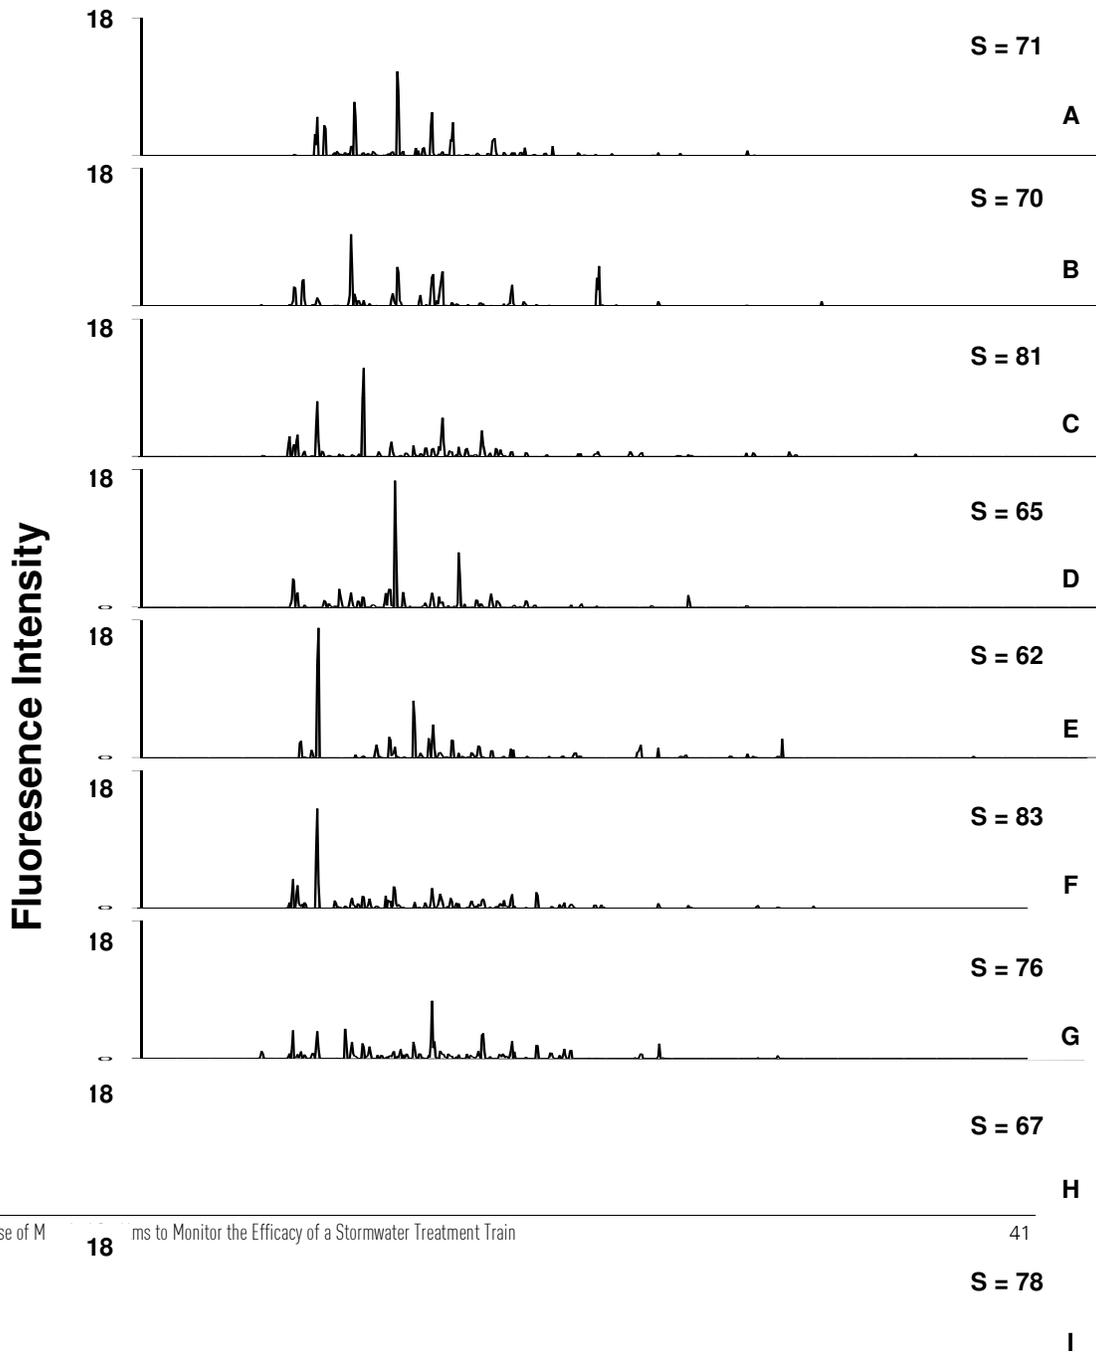
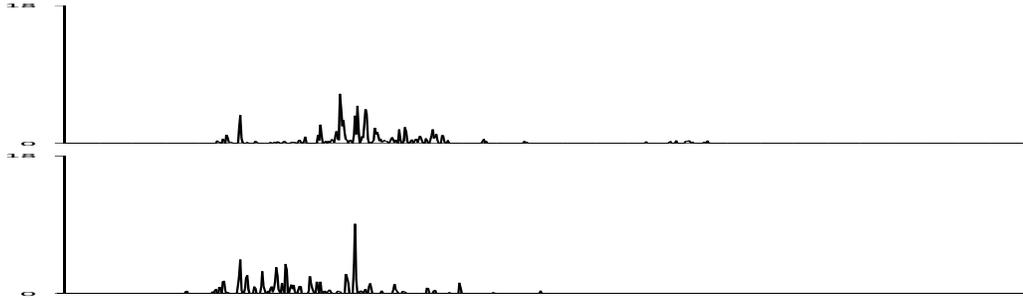
9.5 Bacterial ARISA Profiles – March 2009 – Treatment Train Samples

Comparison of ARISA traces obtained from different sections of the Albany Treatment Train (A to I). Data are peak height (fluorescence; y-axis) and fragment length (nucleotide base pairs; x-axis). Data are averaged for replicate samples. S refers to the number of peaks identified (analogous to taxa species richness).

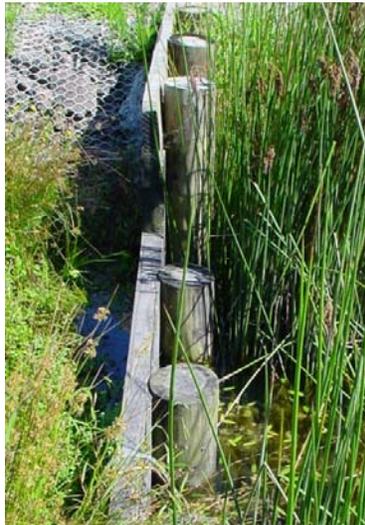
9.9 Photograph of treated wood barrier at the western, downstream end of the treatment wetland

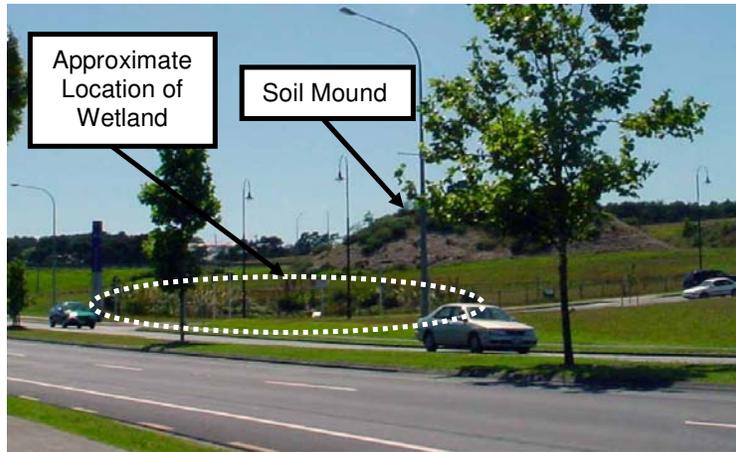
9.10 Photograph showing the large mound of disturbed earth south-west of the treatment wetland
