6 SEDIMENT SOURCES IN THE MAHURANGI CATCHMENT

A Survey of Sediment Sources on Streams in the Mahurangi Catchment TP 270

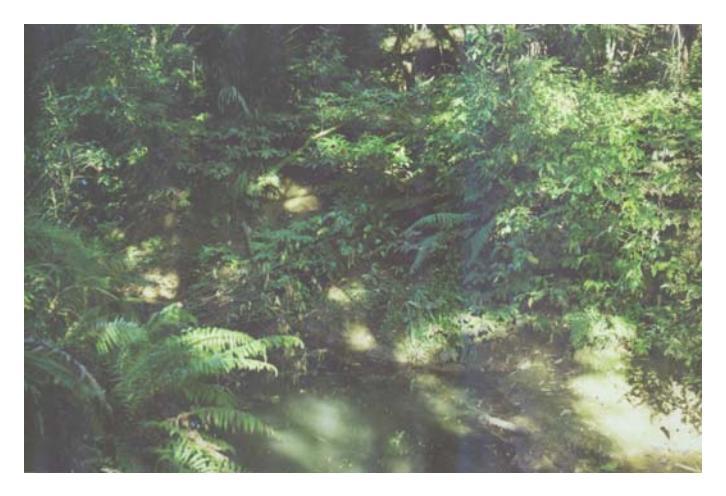
Removal of sediment by running water, exposing a clean surface of sediment or rock, not yet colonised by algal growth, aquatic plants or invertebrates (Photo 23). Present on 4% of sample reach length.

Photo 23: Natural scour of bed and bank

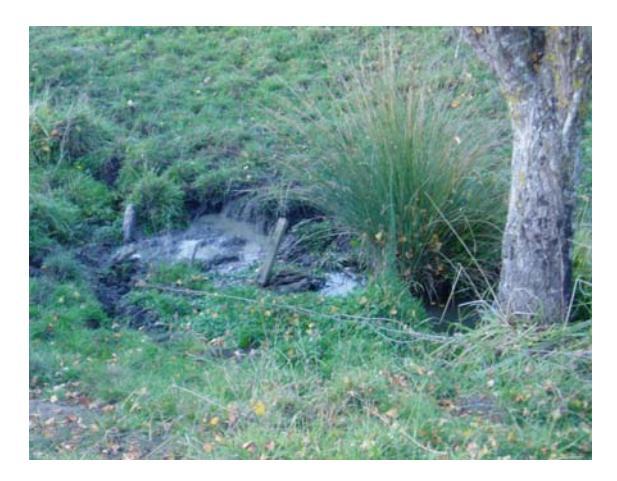
Exposure of sediment by livestock trampling (Photo 24), followed by scour of the exposed surface. Present on 2% of sample reach length.

Photo 24: Disturbance of bed by livestock

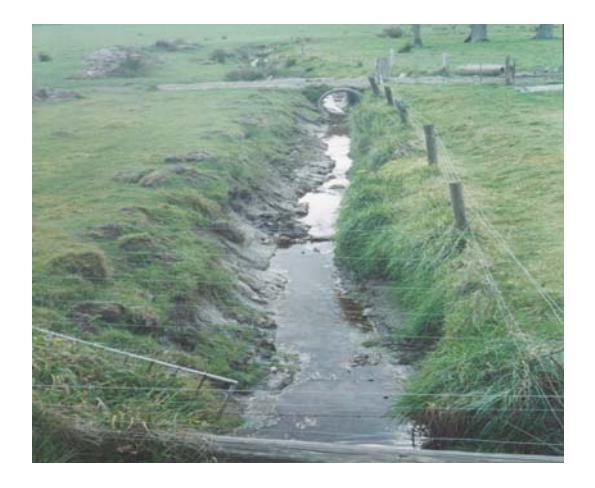
Photo 25: Disturbance of bed by excavation

Excavation of sediment (Photo 25), followed by scour of the excavated surface. Present on 2% of sample reach length.

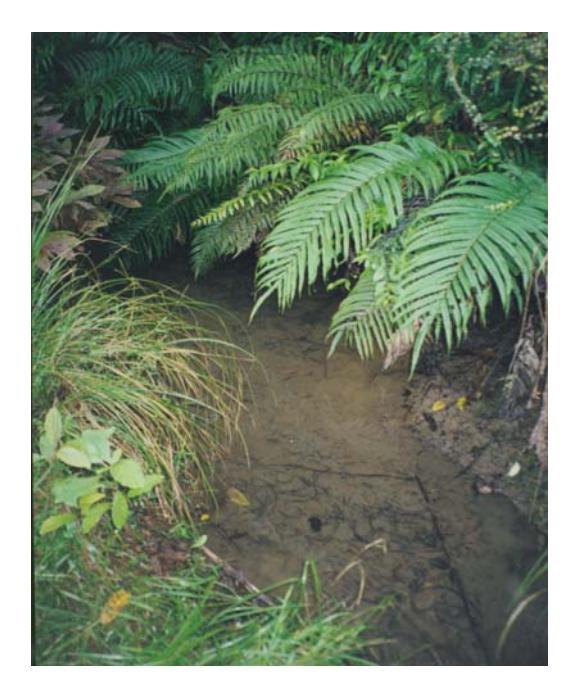
Fresh sediment naturally deposited in the channel, either as bars between pools, or as a layer in pool bottoms, or behind rock bars and other obstructions (Photo 26). Present on 3% of sample reach length.

Photo 26: Natural deposition on channel bed

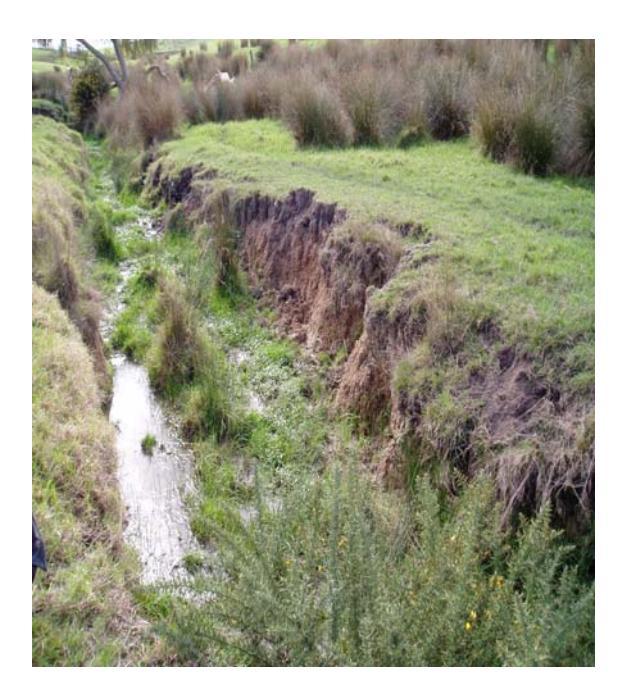
Photo 27: Sediment trampled by stock

Accumulation of sediment in a channel or on a bank, trampled by stock into a position where it can be re-worked by flowing water (Photo 27). Present on 7% of sample reach length.

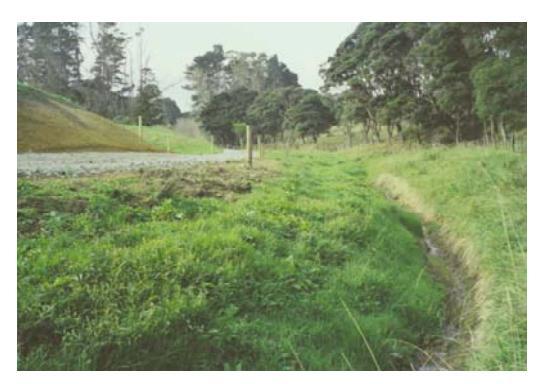
Sediment dumped in a channel or on a bank, in a position where it can be re-worked by flowing water (Photo 28). Present on 1% of sample reach length.

Photo 28: Sediment dumped after excavation

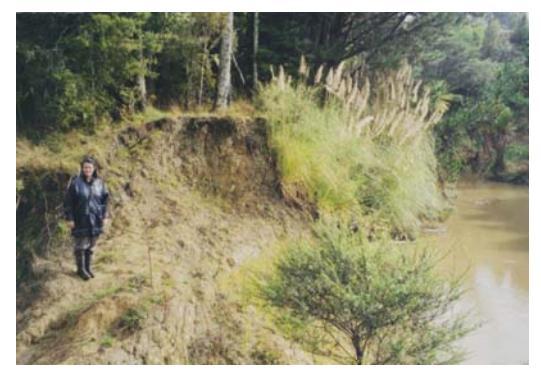
Photo 29: Natural bank collapse

Entry of sediment by natural collapse of a terrace edge, slumping of a footslope, or as debris transported from a slip farther upslope (Photo 29). Present on 2% of sample reach length.

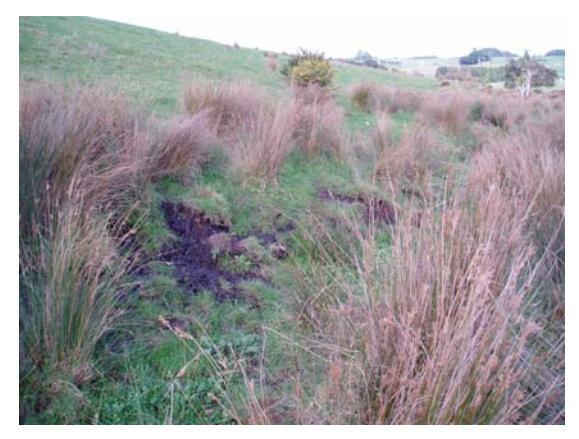
Entry of sediment from a terrace edge collapse, slump or slip that has been induced or exacerbated by stock trampling (Photo 30). Present on 2% of sample reach length.

Photo 30 Bank collapse exacerbated by stock

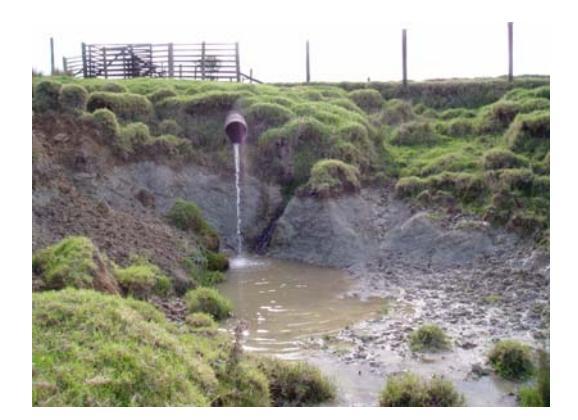
Photo 31 Bank collapse induced by earthworks

Entry of sediment from a terrace edge collapse, slump or slip that has been induced or exacerbated by machine-constructed earthworks (Photo 31). Examples are deflection of floodwater by a culvert or similar channel obstruction; build-up of soil pore water pressure in the vicinity of a blocked drain or pipe; undercutting of a slope by track excavation Present on <1% of sample reach length.

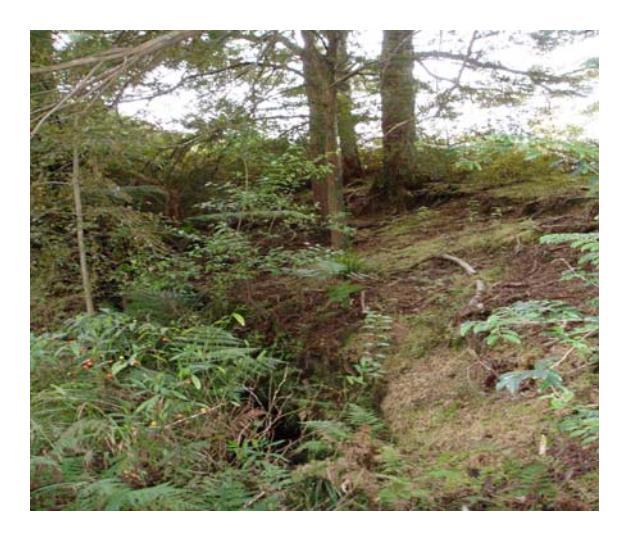
Bare soil, naturally exposed on an alluvial flat, terrace edge or footslope, in a position such that sheetwash can transport soil particles over the bank and into the channel (Photo 32). Present on 1% of sample reach length.

Photo 32: Natural exposure of soil to sheetwash

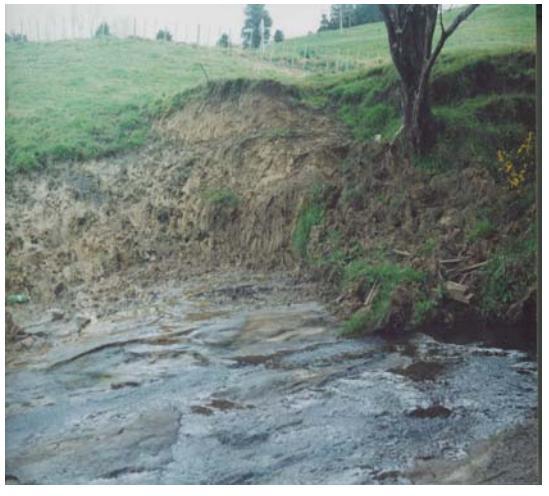
Photo 33: Soil exposed to sheetwash by stock trampling

Bare soil, exposed in similar positions by grazing pressure or stock trampling (Photo 33). Present on 5% of sample reach length.

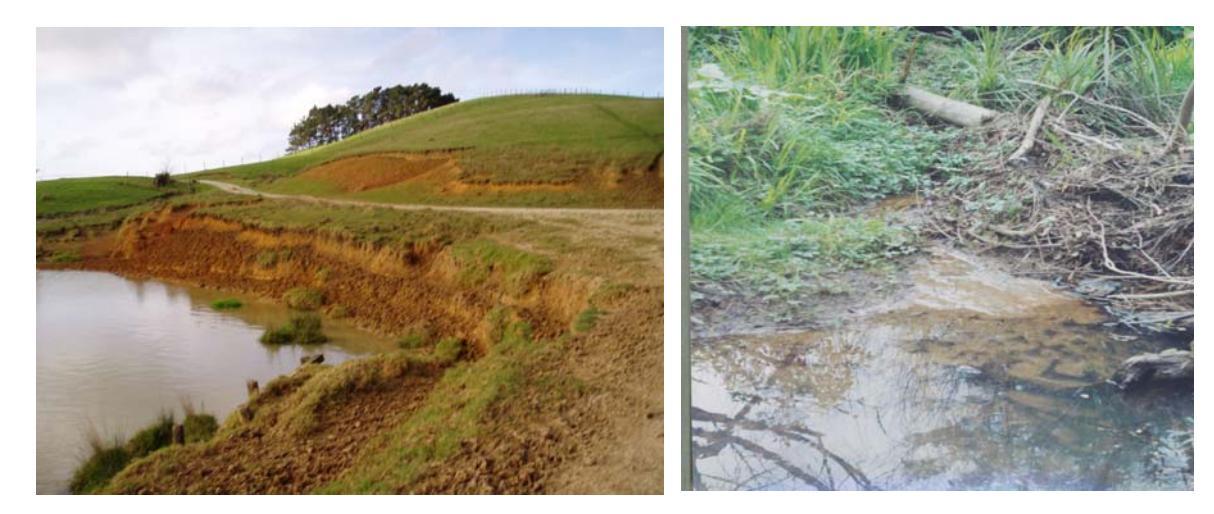
Bare soil, exposed in similar positions by machine-constructed stock races, farm or forest vehicle tracks, forest landing stages and similar (Photo 34). Present on 1% of sample reach length.

Photo 34: Soil exposed to sheetwash on excavated surface

Photo 35: Natural tributary delivering sediment

Tributary channel entering a reach from a terrace edge, footslope or hillslope, with natural scour upstream of its junction and sediment deposit downstream (Photo35). Present on <1% of sample reach length.

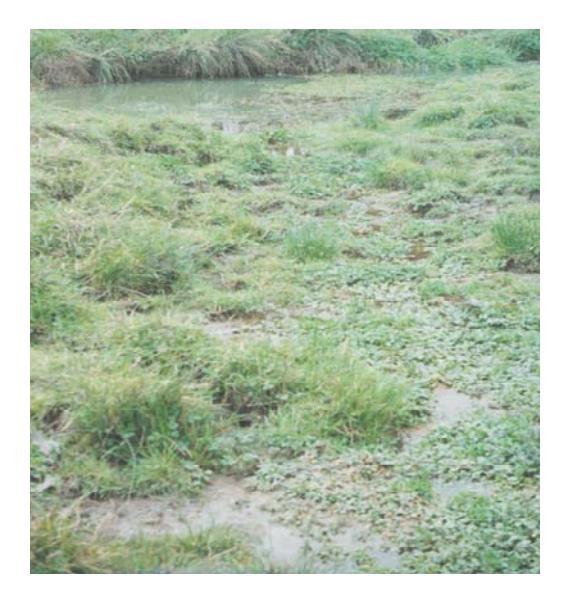
Tributary channel in one of the above situations, trampled by stock, with subsequent scour upstream of its junction and sediment deposit downstream (Photo 36). Present on <1% of sample reach length.

Photo 36: Stock-induced delivery of sediment from tributary

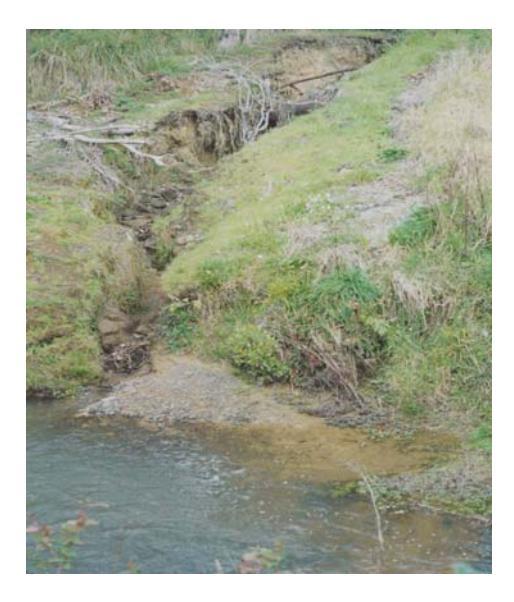
Tributary channel in one of the above situations, that has been excavated, deepened or straightened by machinery, with subsequent scour upstream of its junction and sediment deposit downstream (Photo 37). Includes drains. Present on <1% of sample reach length.

Photo 37: Machine-induced delivery of sediment from tributary
