Auckland Council District Plan (North Shore Section) Proposed Plan Change 38

Appendix 11A: Schedule of Buildings, Objects and Places of Heritage Significance

Name: Ngataringa Tennis Club Clubhouse **Address:** Stanley Bay Park, Stanley Bay

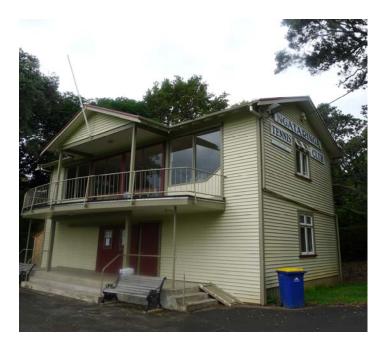
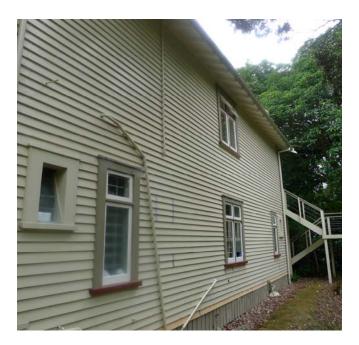
Two storeyed building, rectangular footprint with gabled roof and cross-gable over veranda/balcony, fanlight and casement type windows in addition to modern floor to ceiling doors and windows. Club name on end wall.

The clubhouse is a functional building, lacking in architectural pretensions but significant for its size and relationship to the courts.

The clubhouse stands on the eastern boundary of Stanley Bay Park, set against a backdrop of trees. Other notable structures in the park include the former Girl Guide den [late 1950s, see Girl Guide Den, Allenby Avenue, Devonport heritage record form], which is now the Junior Clubhouse, and the Pumping Station, which is believed to date from the 1930s. The Clubhouse is directly associated with the Club's five outdoor courts, which are situated to the north-west of the building.
