# Freshwater

## Lake monitoring programmes

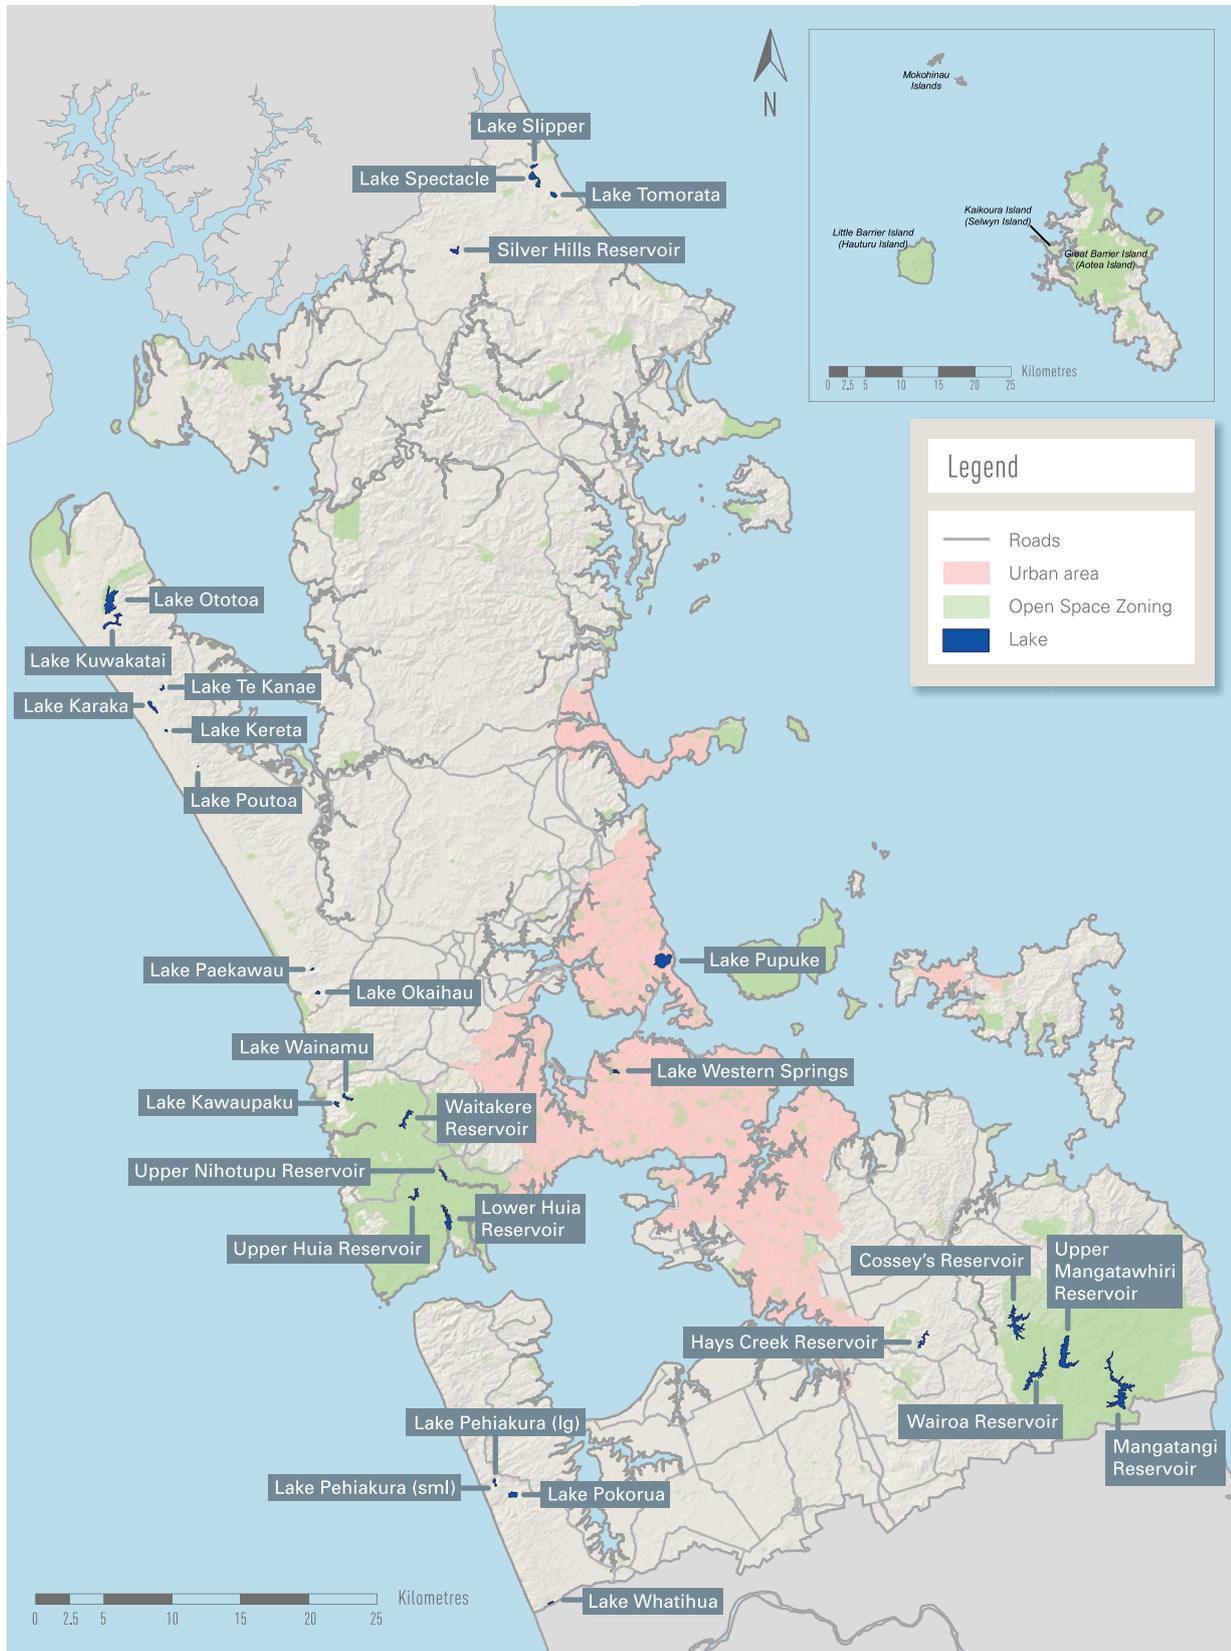
FIGURE 11 Locations of the lakes that the ARC monitors in the Auckland region. (Source: ARC).

The ARC operates two lake monitoring programmes in the Auckland region (see in Figure 11). These monitoring programmes are:

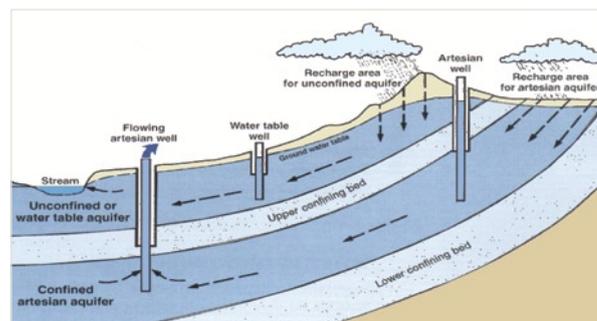
FIGURE 12 Groundwater Concepts (Source: ARC).

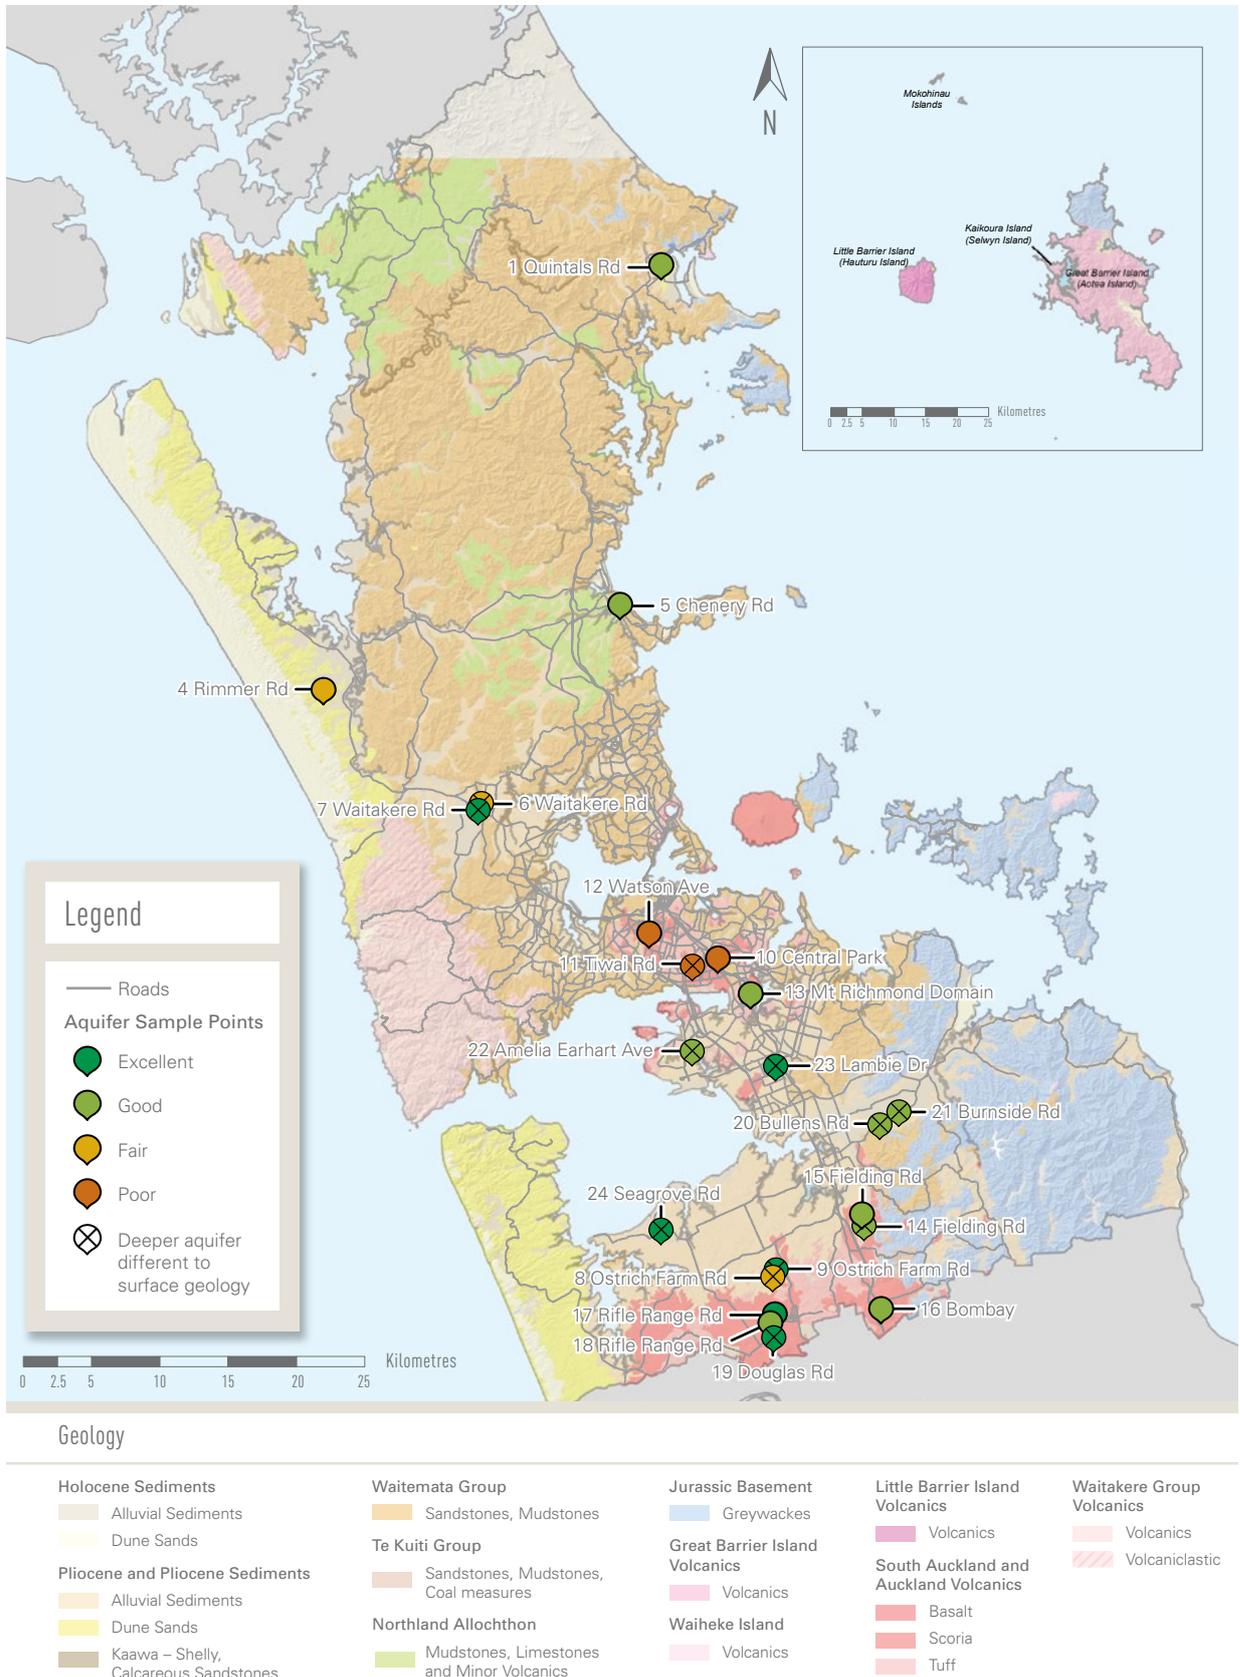
FIGURE 13 Aquifers and quality scores. (Source: ARC).

The Auckland region has many aquifers, typically of sedimentary or volcanic origin (Figure 13). Stored in these aquifers is groundwater used for municipal water supply, irrigation, geothermal energy, domestic and stock water supplies; they also contribute to the water in the rivers and other surface water bodies such as lakes and wetlands.
