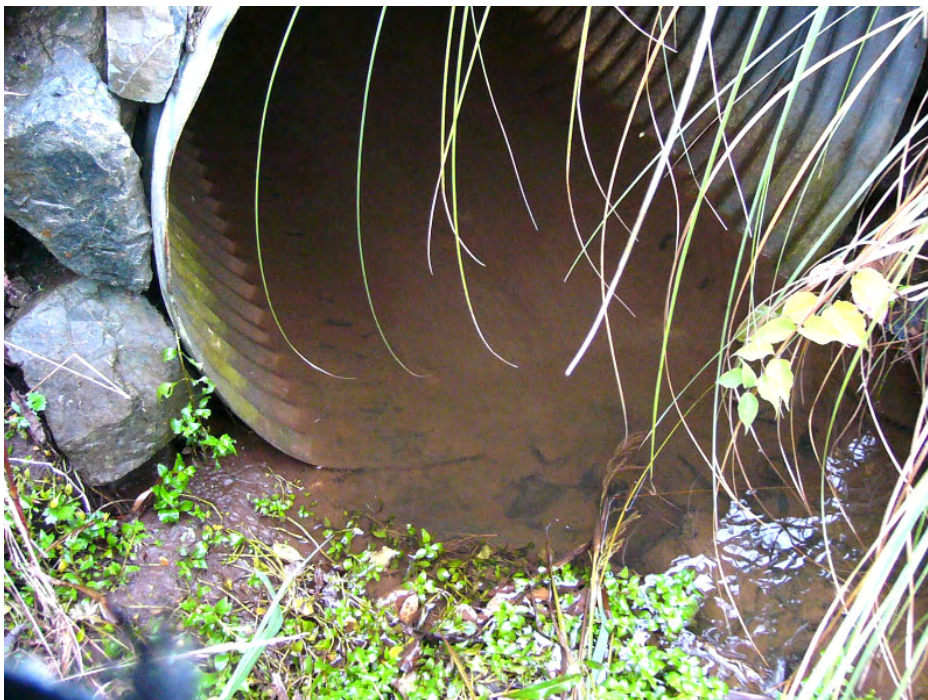
**Photo 4** Exotic forest site E1. Sediment taken from accumulation in culvert.

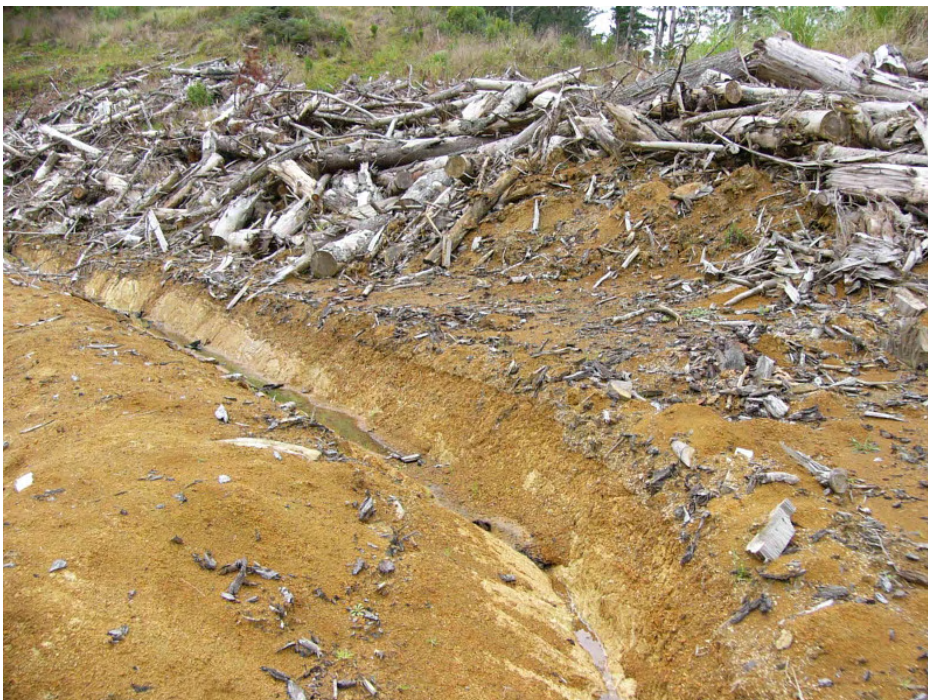
**Photo 5** Exotic forest site E2. Sediment taken from surface runoff drain in disused skidder pad.

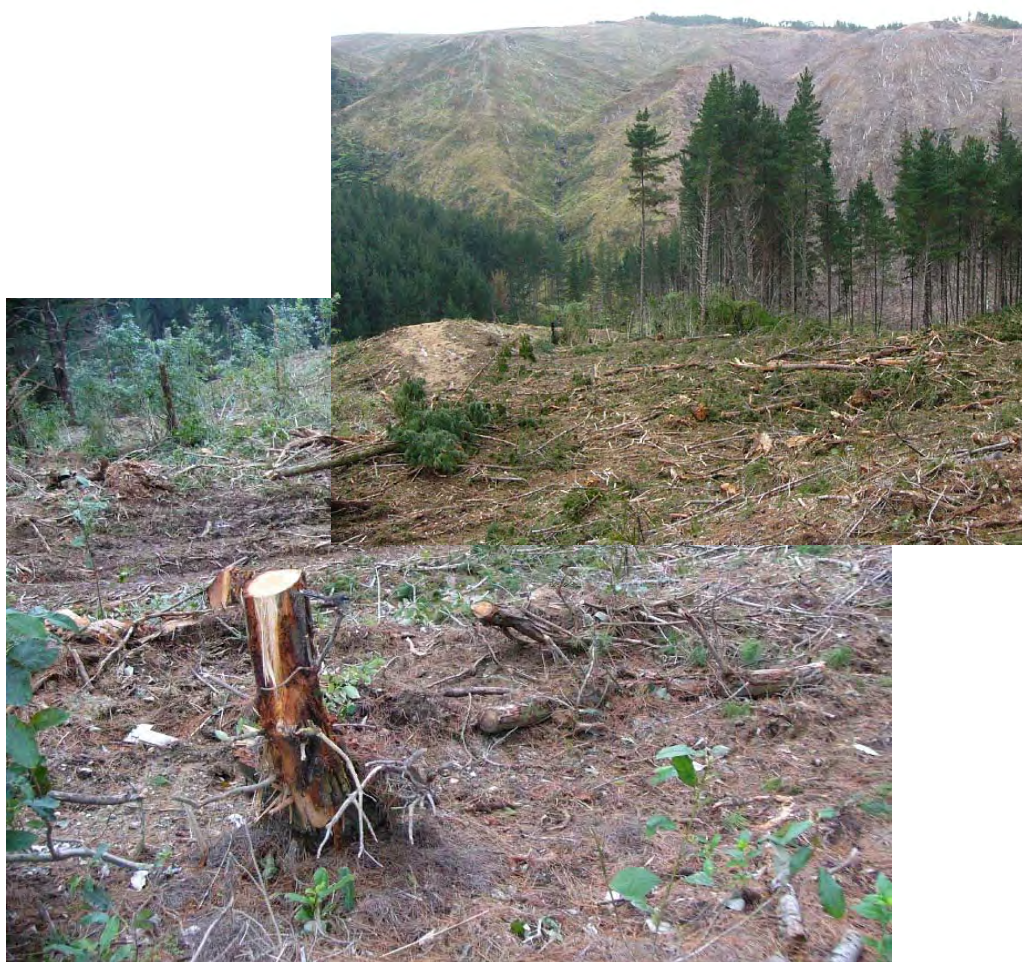
**Photo 6** Exotic forest site E3. Sediment taken from the exposed drag line groove on a recent clear fell logging site.

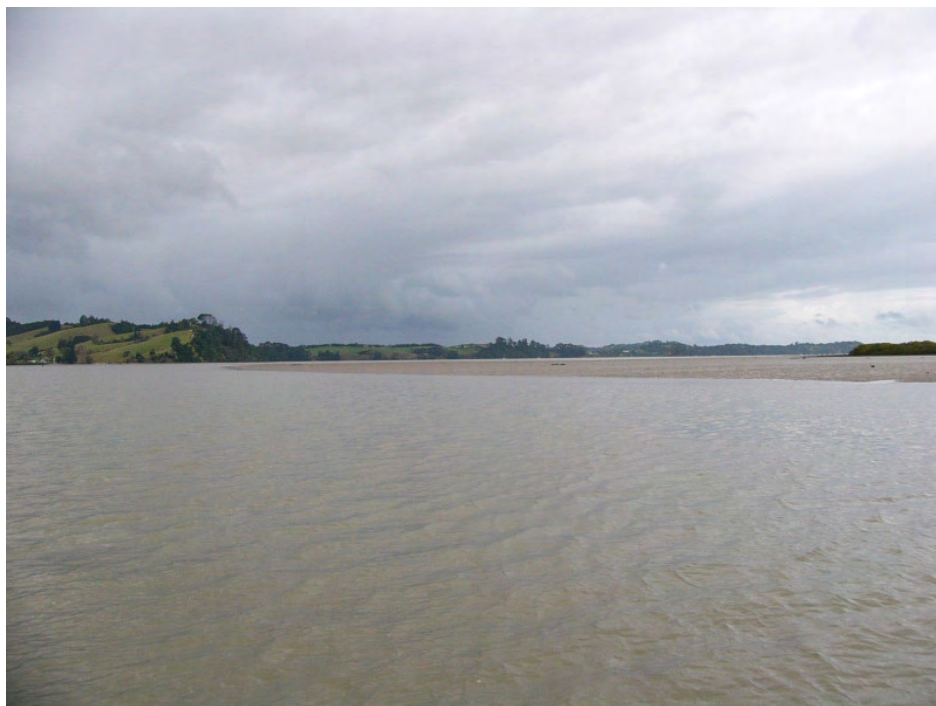
**Photo 7** Harbour site H. Sediment taken from outer edge of mudflat on rising tide.

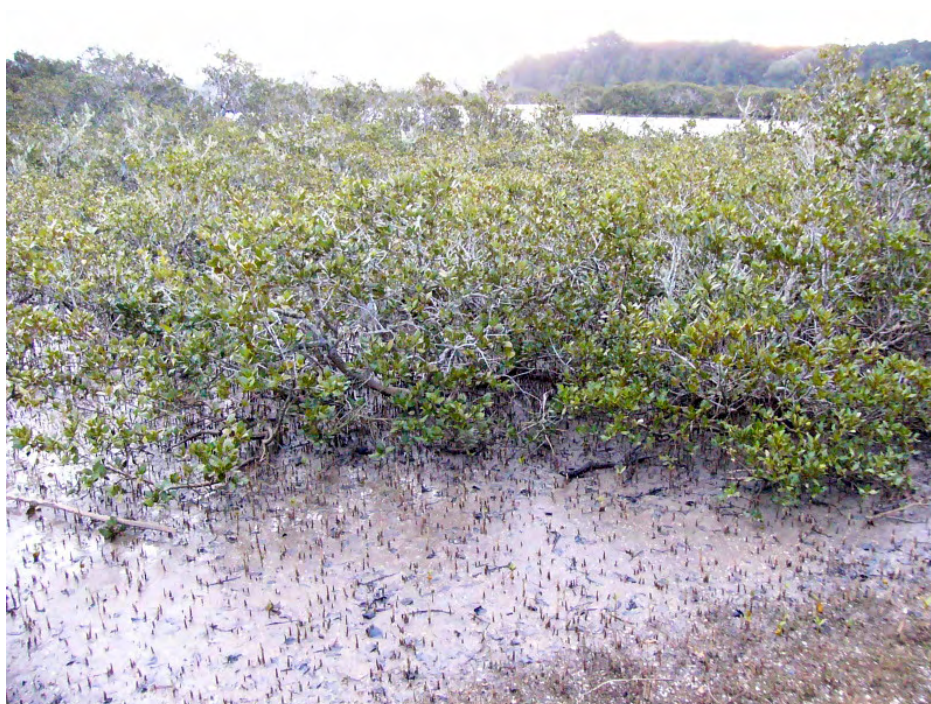
**Photo 8** Mangrove site M. Sediment scraped off surface beneath mangroves before tidal immersion of rising tide.

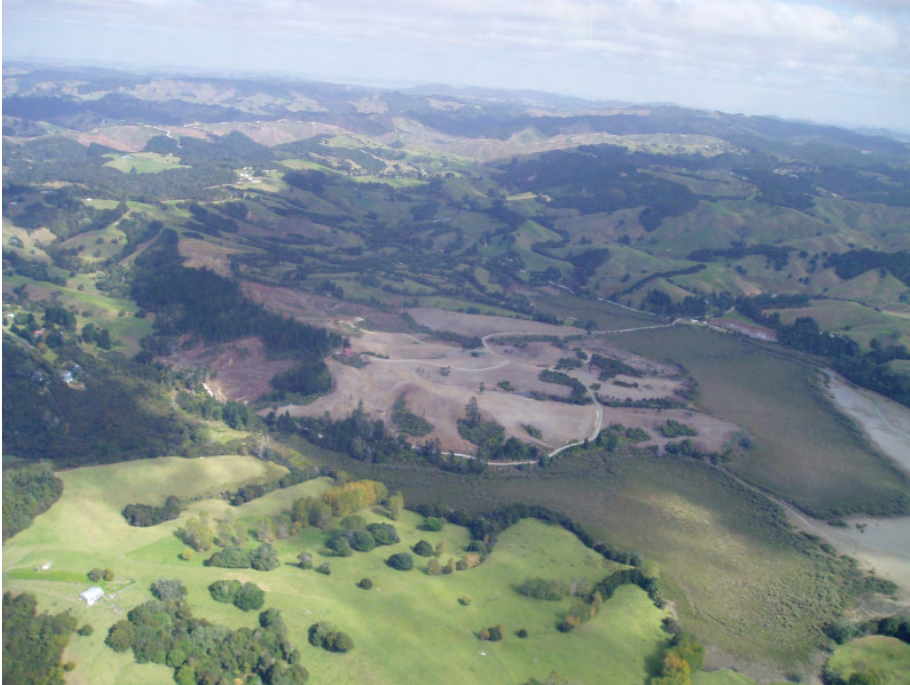
**Photo 9** General aerial view of catchment illustrating the difficulty in finding a pure land use type. (ARC photo).

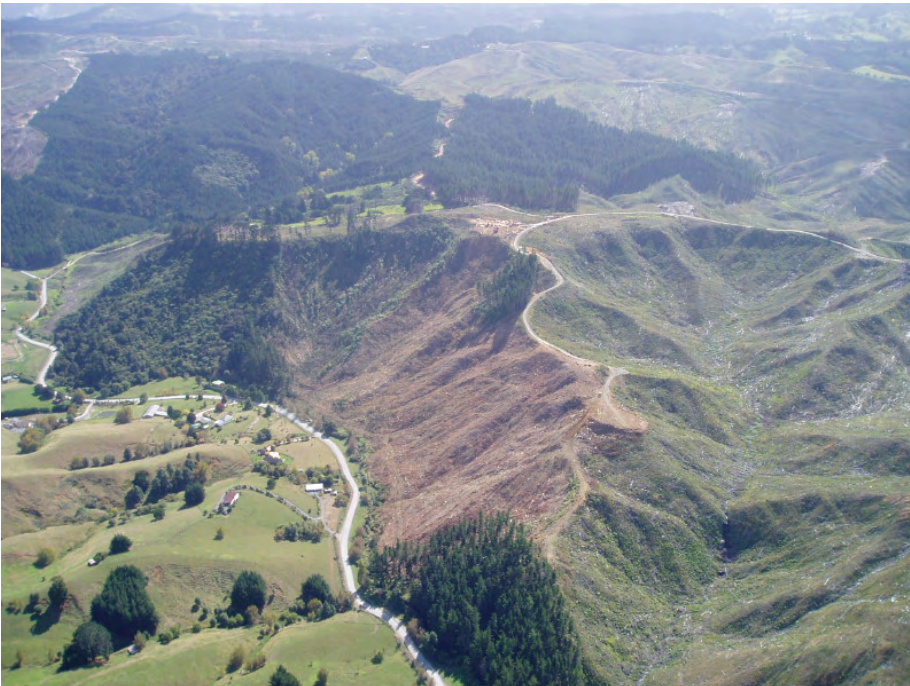
**Photo 10** Aerial view of clear-fell logging operation within the Mahurangi catchment and the degree of bare earth exposure for erosion during rainfall events. (ARC photo).

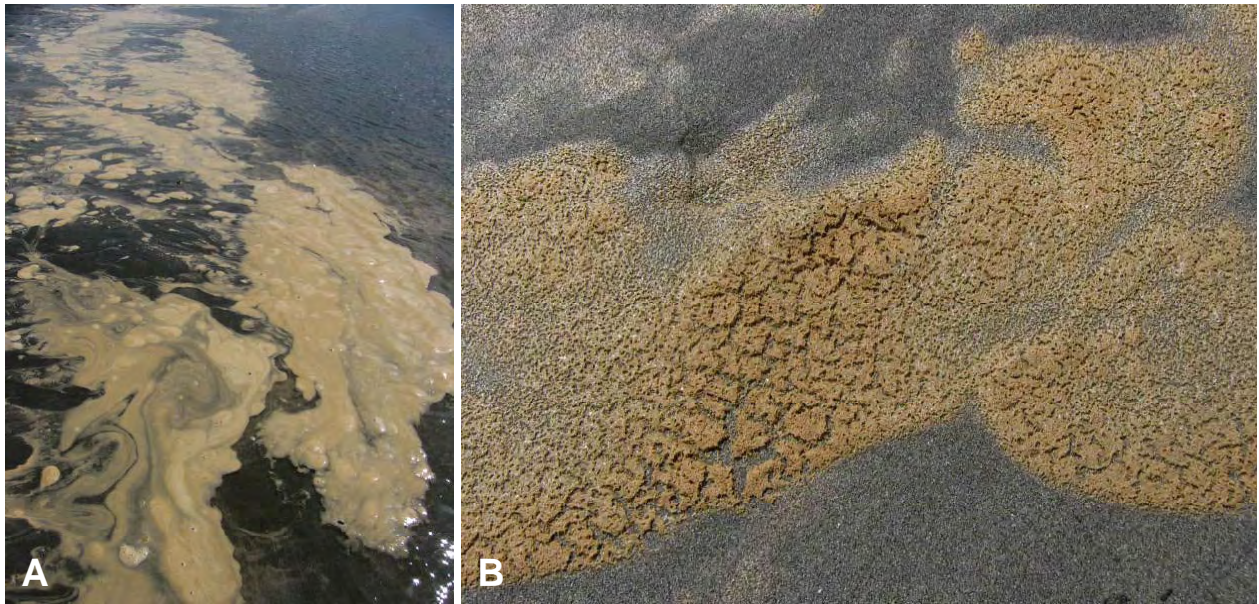
**Photo 11** Deposition mechanism of fine terrigenous sediment ('clay') from erosion during rainfall events. (A) 'Clay' trapped in the freshwater film exists as a floating scum on the surface of the estuarine water until wave action breaks the scum and mixes it into the water column. (B) If the freshwater layer is not broken up, when the saline water recedes from beneath the freshwater over a shallow intertidal zone, the 'clay' scum is left behind as a discrete layer on the sediment surface. On exposure to the sun the 'clay' dries and loses the freshwater buoyancy, becoming more firmly bound into the sediment surface and thus resistant to resuspension on the next tidal cycle, unless there is wave action.
