AUCKLAND City Council
 NEWMARKET PARK
 SLOPE REMEDIATION
 NEWMARKET
 Typical Failure Types

SCALES (AT A1 SIZE) NTS	DWG. No. 26259-102	REV. 0
----------------------------	-----------------------	-----------

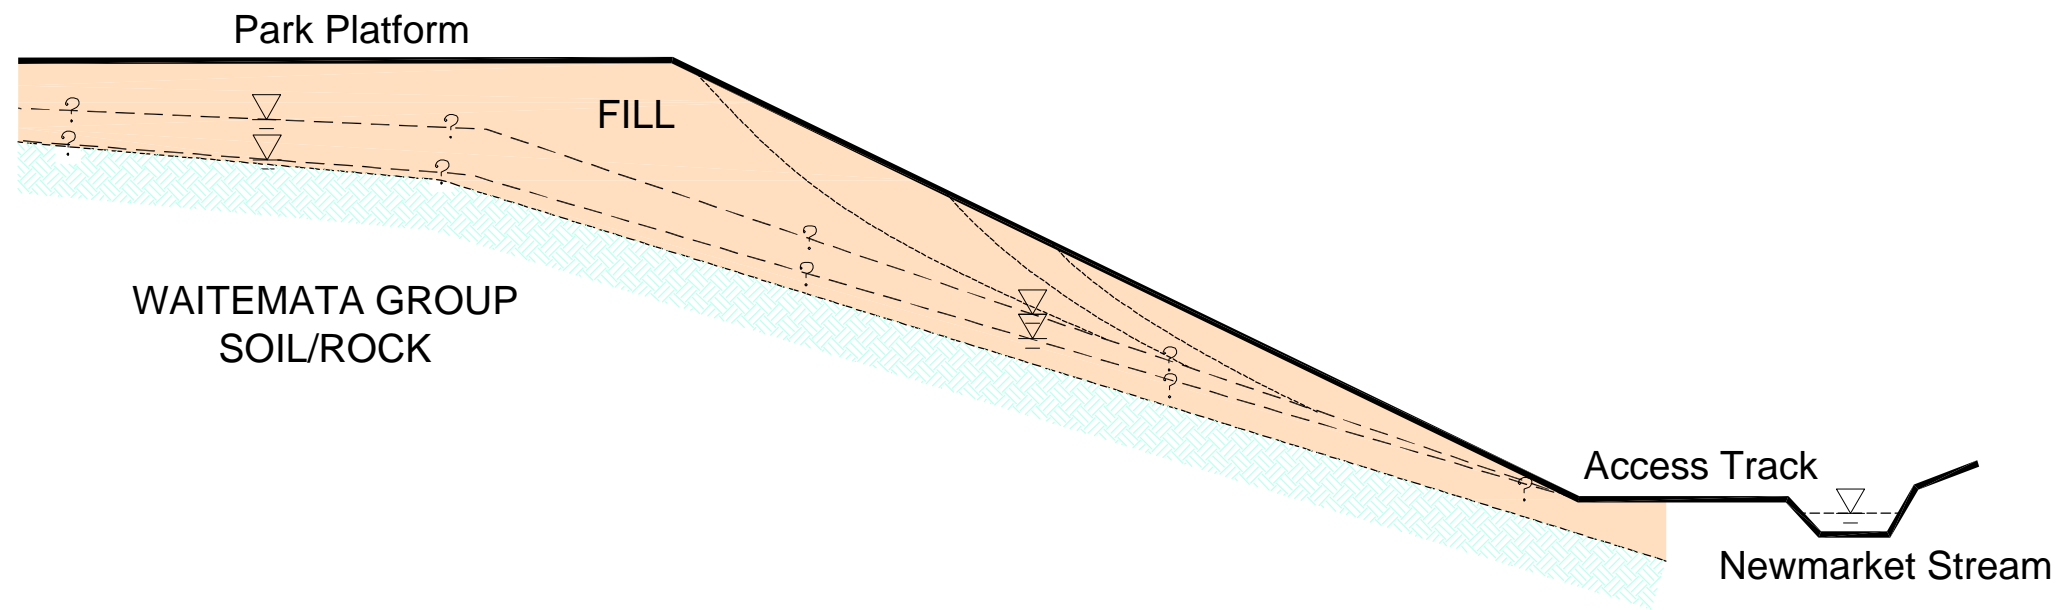
SHALLOW TYPE FAILURE

- Typical full height failure plane
- - - Typical shallow failure planes
- ▽ Inferred groundwater table

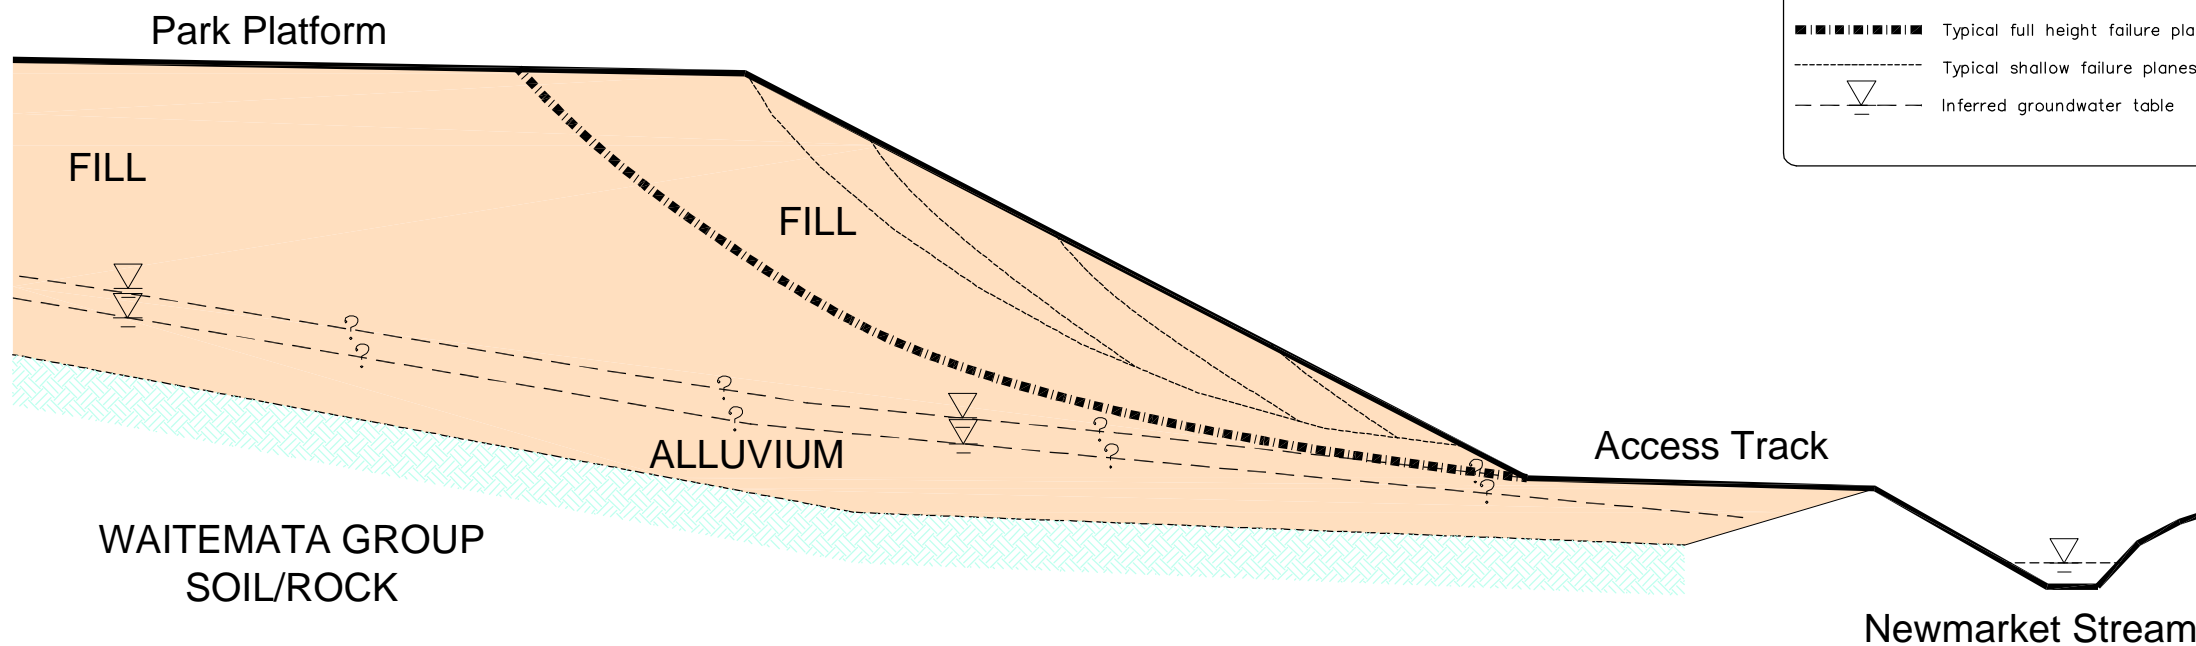
FULL HEIGHT TYPE FAILURE
